Cambria Community Services District Regular Board Meeting August 23, 2018

Wastewater Department

Cambria Community Services District

Water
Department
Infrastructure
Projects

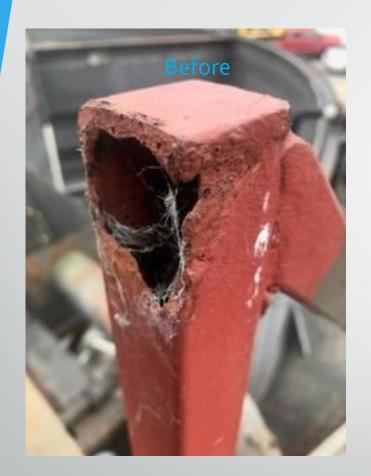
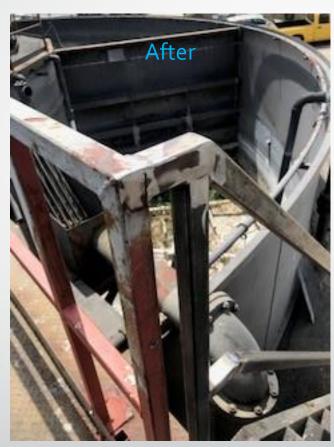
A welder replaced the hand rails on the stairs and fixed a few holes. This wasn't apart of the contract and needed to be done. The total cost for the additional work was \$4,175.

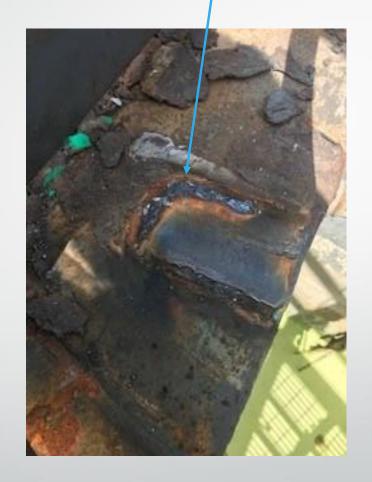
This was a large hole that was allowing air to escape. The department had several holes like this covered up.

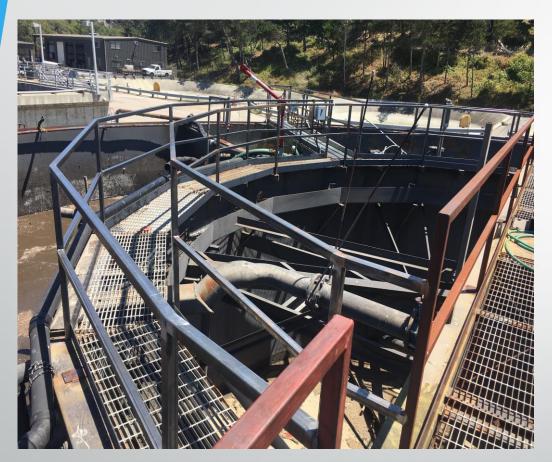
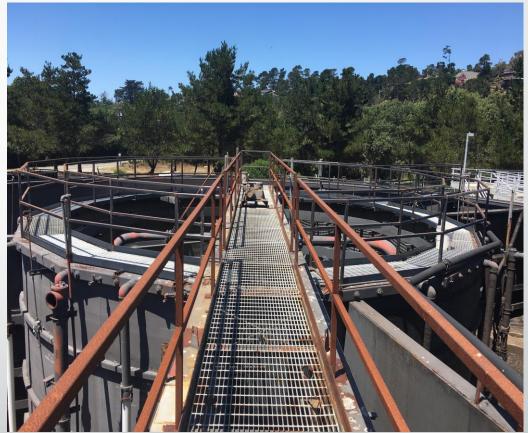
The handrails have been completed at the center ring catwalk areas of the sludge digesters. The orange colored railings in the foreground were replaced last fiscal year.

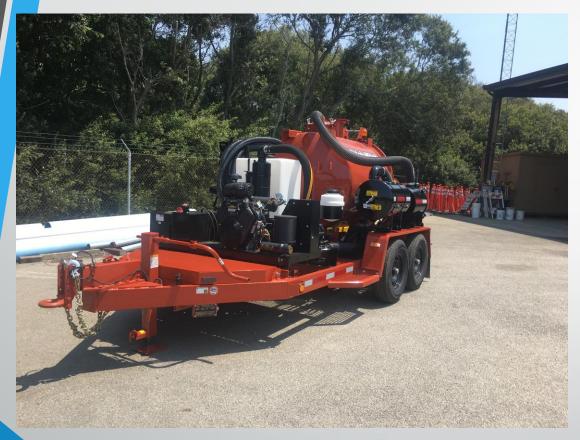
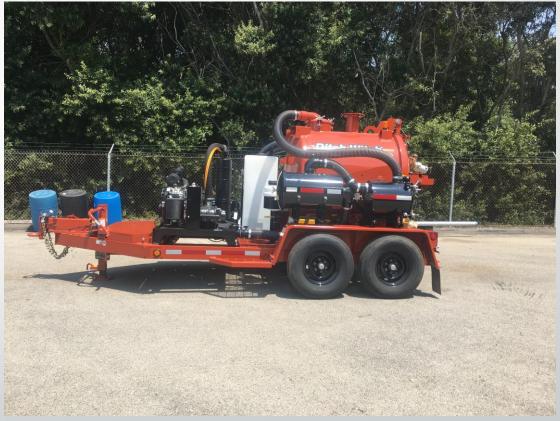
This is the new Ditch Witch vacuum excavator. This machine will be very helpful in repairing leaks as well as in emptying valve cans so we can operate and exercise valves.

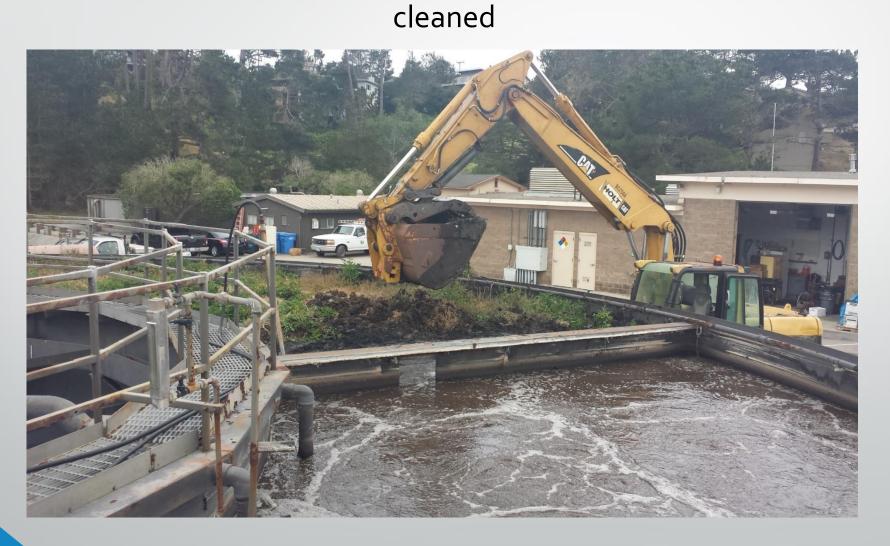
Wastewater Treatment & Collection System Plant Improvements December 2015 Put digester into proper operational status. It had never been

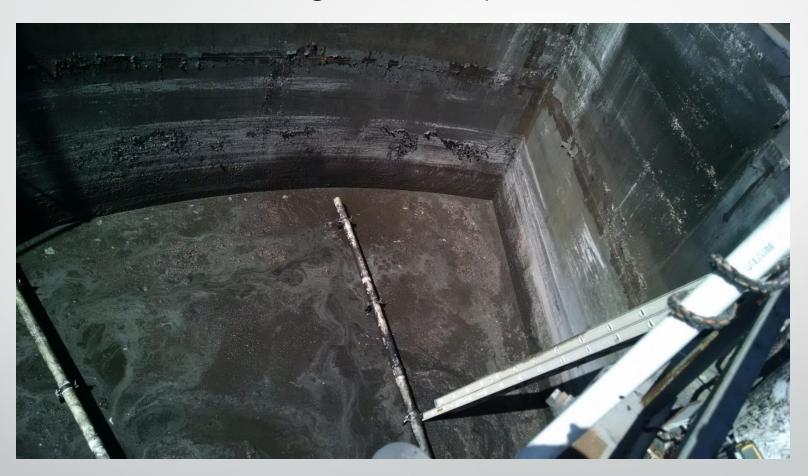
Wastewater Treatment & Collection System Plant Improvements December 2015 Cleaned digester and repaired lines

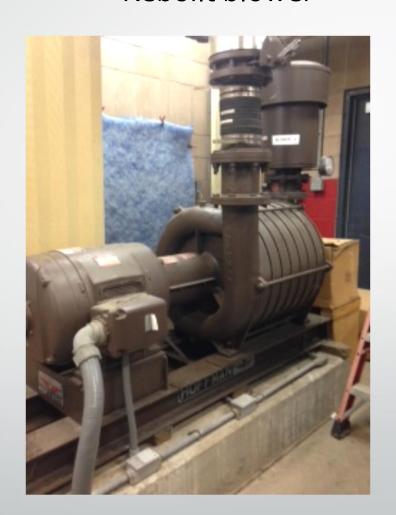
Wastewater Treatment & Collection System Plant Improvements December 2015 Rebuilt blower

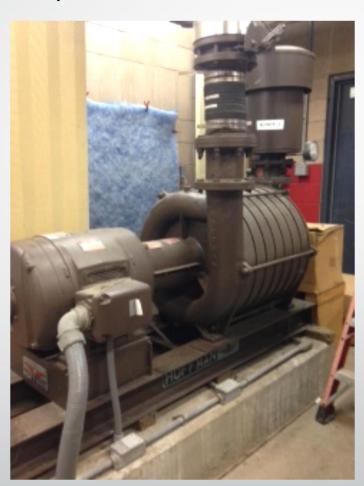
Wastewater Treatment & Collection System Plant Improvements December 2015 Repaired the smaller blower

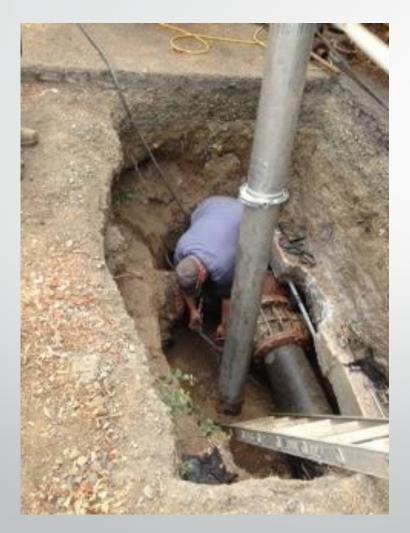
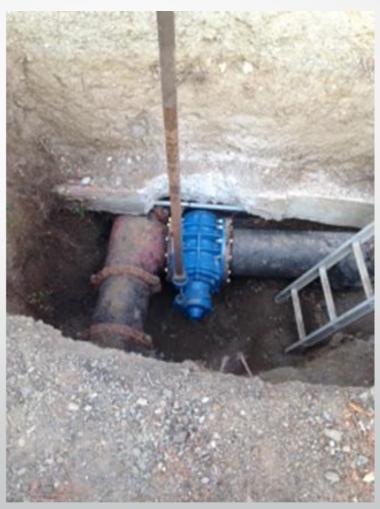
Wastewater Treatment & Collection System Plant Improvements August 2016 Replaced the bypass valve at the grit chamber

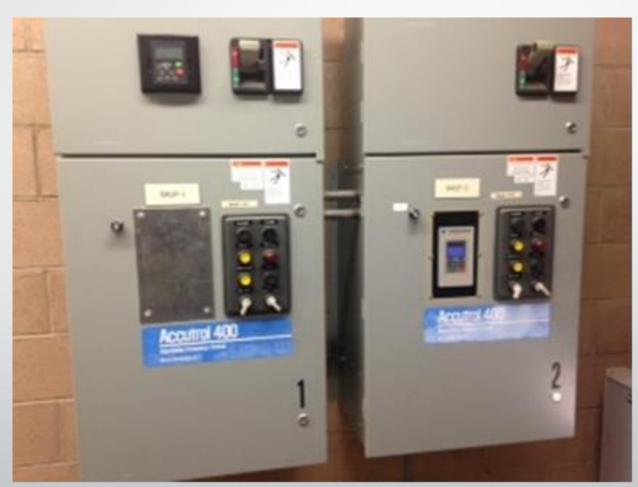
Wastewater Treatment & Collection System Plant Improvements August 2016 Installed variable frequency drives

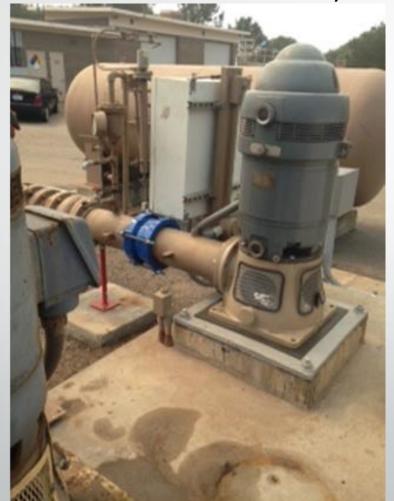
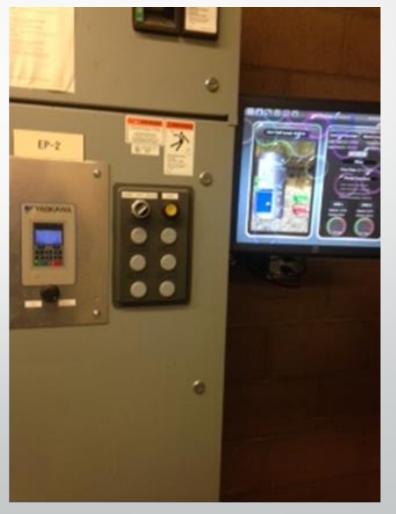
Fixed both effluent pumps and variable frequency drives. Pumps replaced and fully automated

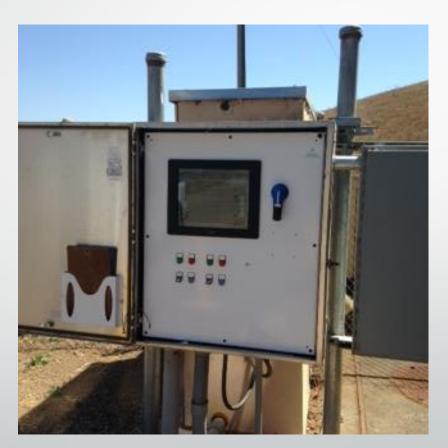
Wastewater Treatment & Collection System Plant Improvements September 2016 Installed new controls at lift station B4

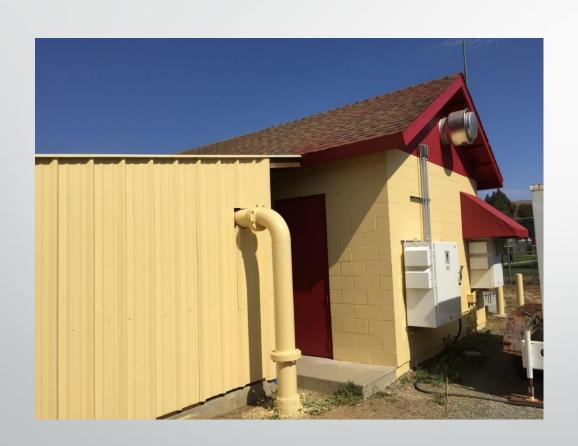
Completely rebuilt SR4 well and fully automated with fail safe capability. They also painted the SR4 building

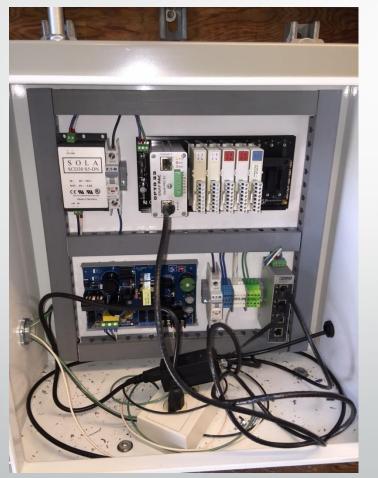
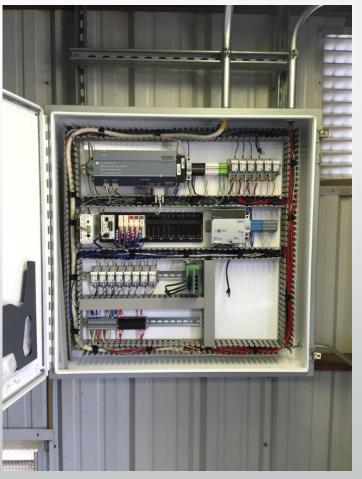
Improvements to the control panels before and after pictures

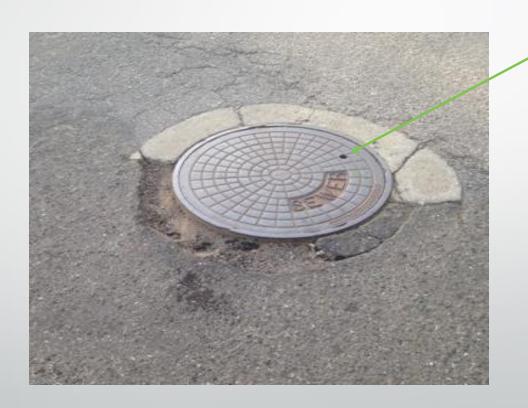
At least 45 manholes have been repaired and replaced
Twenty manhole inserts have been installed, thus reducing intrusion and
infiltration

This hole represents 5 gallons per minute of flow

or 7200 gallons per day from one mahole

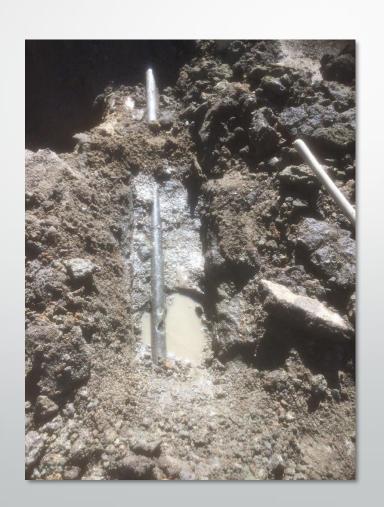
The 2" abandoned pipe on Pineridge was repaired on November 2, 2016
Ongoing repairs to the distribution system continue

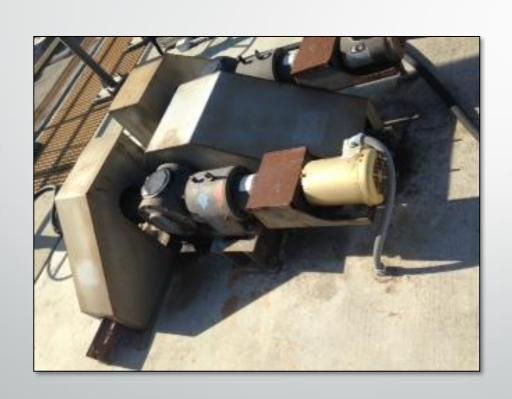
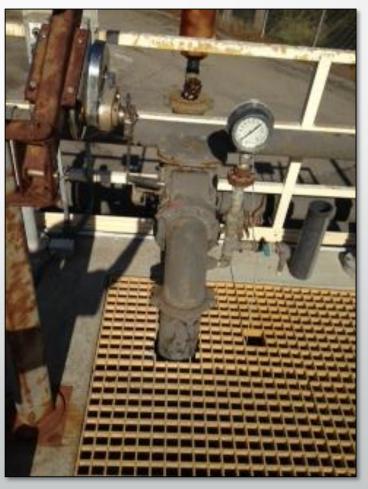
Both drive motors were replaced for clarifiers 1 and 2 Both waste activated sludge pumps were replaced

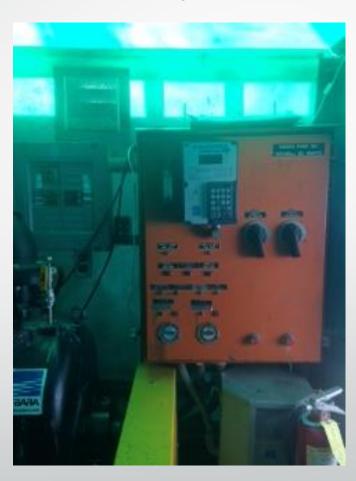
Wastewater Treatment & Collection System Plant Improvements December 2016 The old lift station panel 9 was replaced

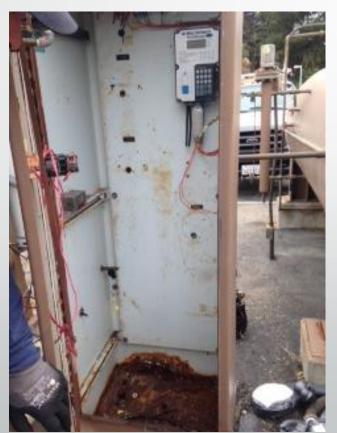
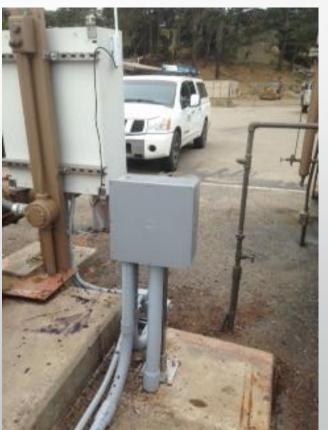
Effluent pump #1 had a new discharge and was rebuilt
Both pumps had new 95% efficient motors installed
The old Miltonic's level control along with the rusted control panels was replaced with a transducer and a small junction box

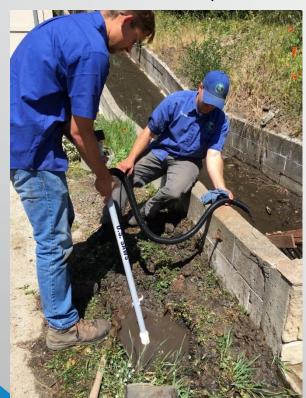
This leak was fixed at Kent Street (behind the Shell station)

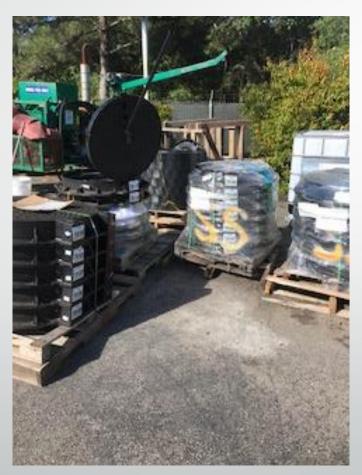
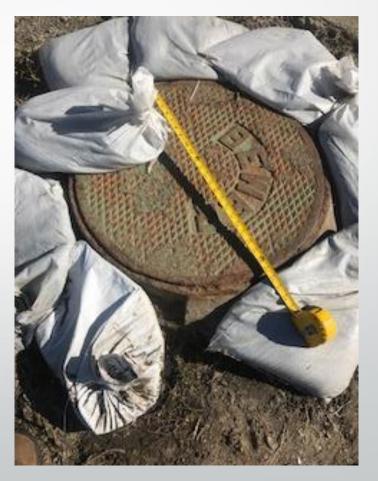
Twenty five new PamRex water proof manhole covers were replaced on the 25 most needed manhole lids in the collection system

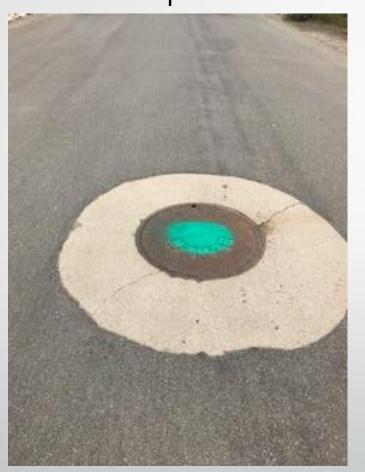
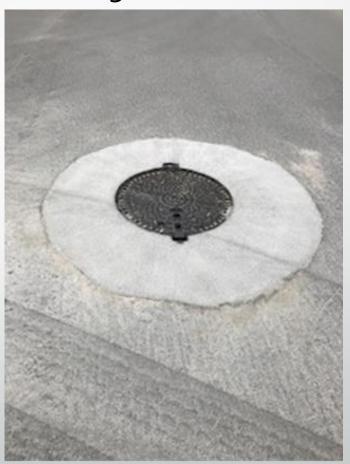
The department was unable to remove this welded manhole cover, so they replaced it with a water tight cover

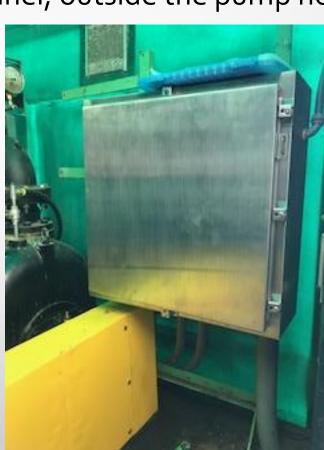
A new panel was installed and is being used as a pull box All the breakers are now in the panel, outside the pump house

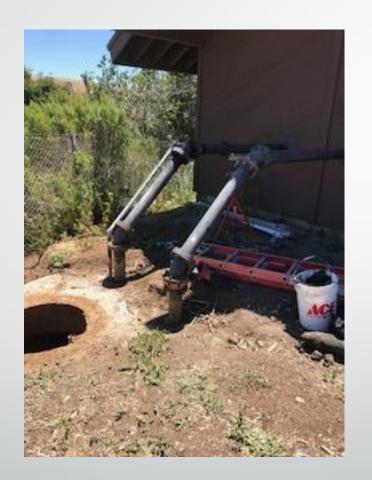
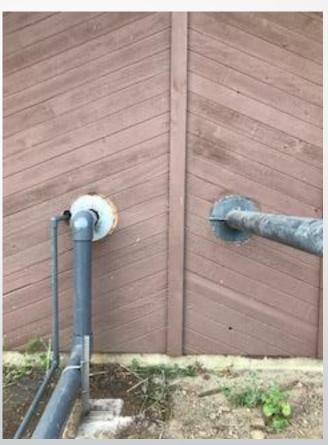
Wastewater Treatment & Collection System Plant Improvements July 2017 The first suction line was replaced at lift station B-3

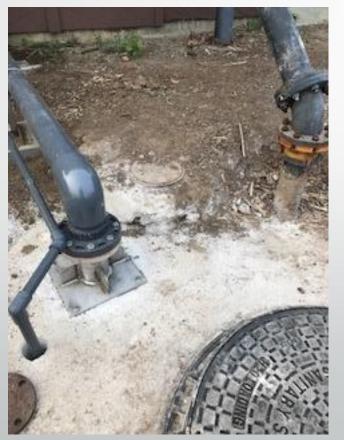
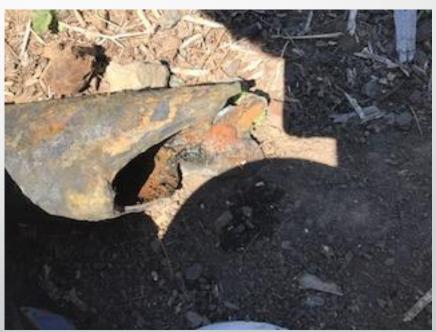
This is a section of the suction line that failed FRM was the contractor that installed the stainless steel suction line at the lift station CCSD staff replaced the 4 inch cast iron piping with PVC Holes had to be bored around the old piping to remove it

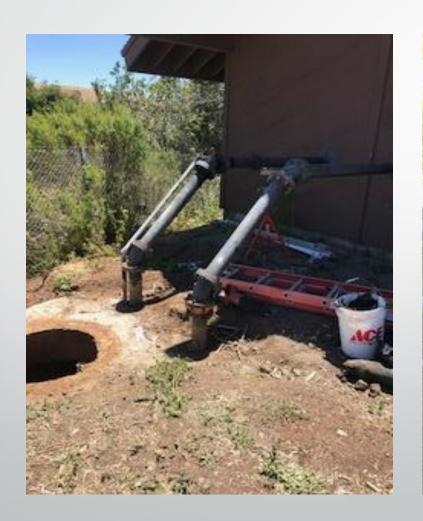
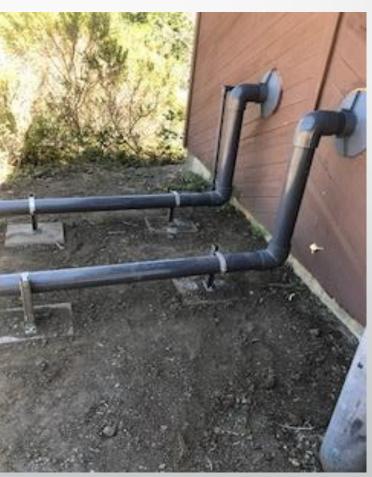
Wastewater Treatment & Collection System Plant Improvements July 2017 The new suction line was installed

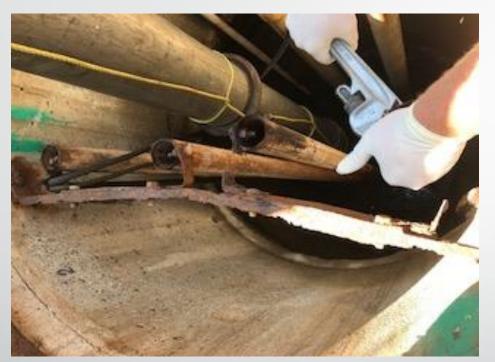
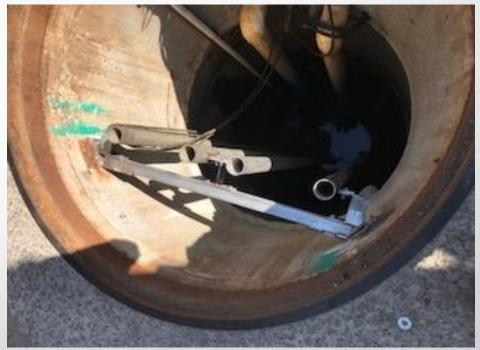
Wastewater Treatment & Collection System Plant Improvements July 2017 The lift station 8 guide rails were replaced with stainless guide rails

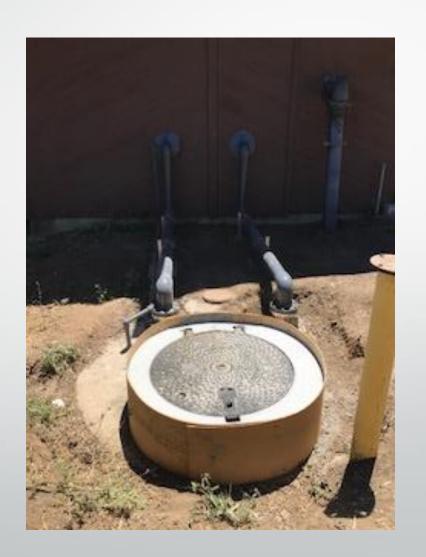
This is manhole cover was lifted 8 inches and the lid was replaced

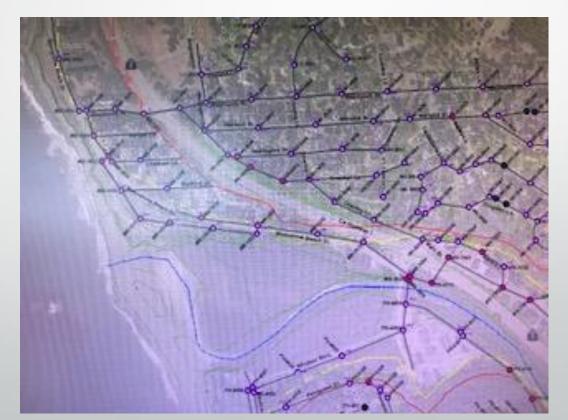
This is a snapshot of the GIS map for the collection system

The program was added to the collection system

The department can step onto a manhole and find out what needs to be done and what has been done over the last year
