**Cambria Community Service District
Adaptive Management Plan
Biological Bi-Monthly Monitoring Report**

August 4, 2022

AMP Monitoring Locations

San Simeon and Van Gordon Creeks

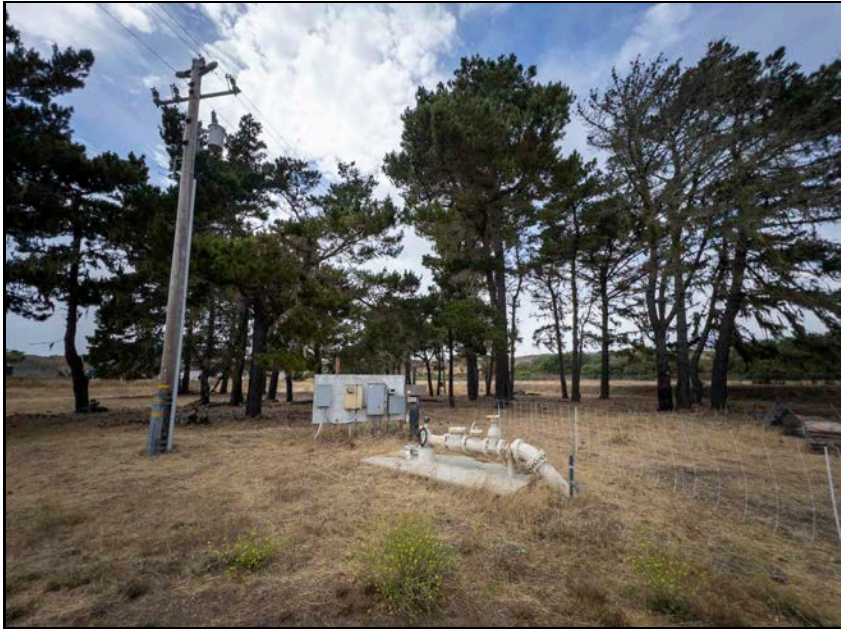
9P7 Well

121° 6'33.42"W	121° 6'53.39"W	121° 6'54.29"W	121° 7'4.04"W	121° 7'14.25"W	121° 7'13.85"W	121° 7'9.81"W
*Site 6 is on State Parks property and is not accessible at this time.							
9P7 Soil Moisture †							
North (%)	3.9						
East (%)	0.0						
South (%)	0.0						
West (%)	0.0						
†Moisture measured on each side of well casing. Max reading is 50%.
