2024 Watershed Sanitary Survey Update

Cambria Community Services District

October 10, 2024

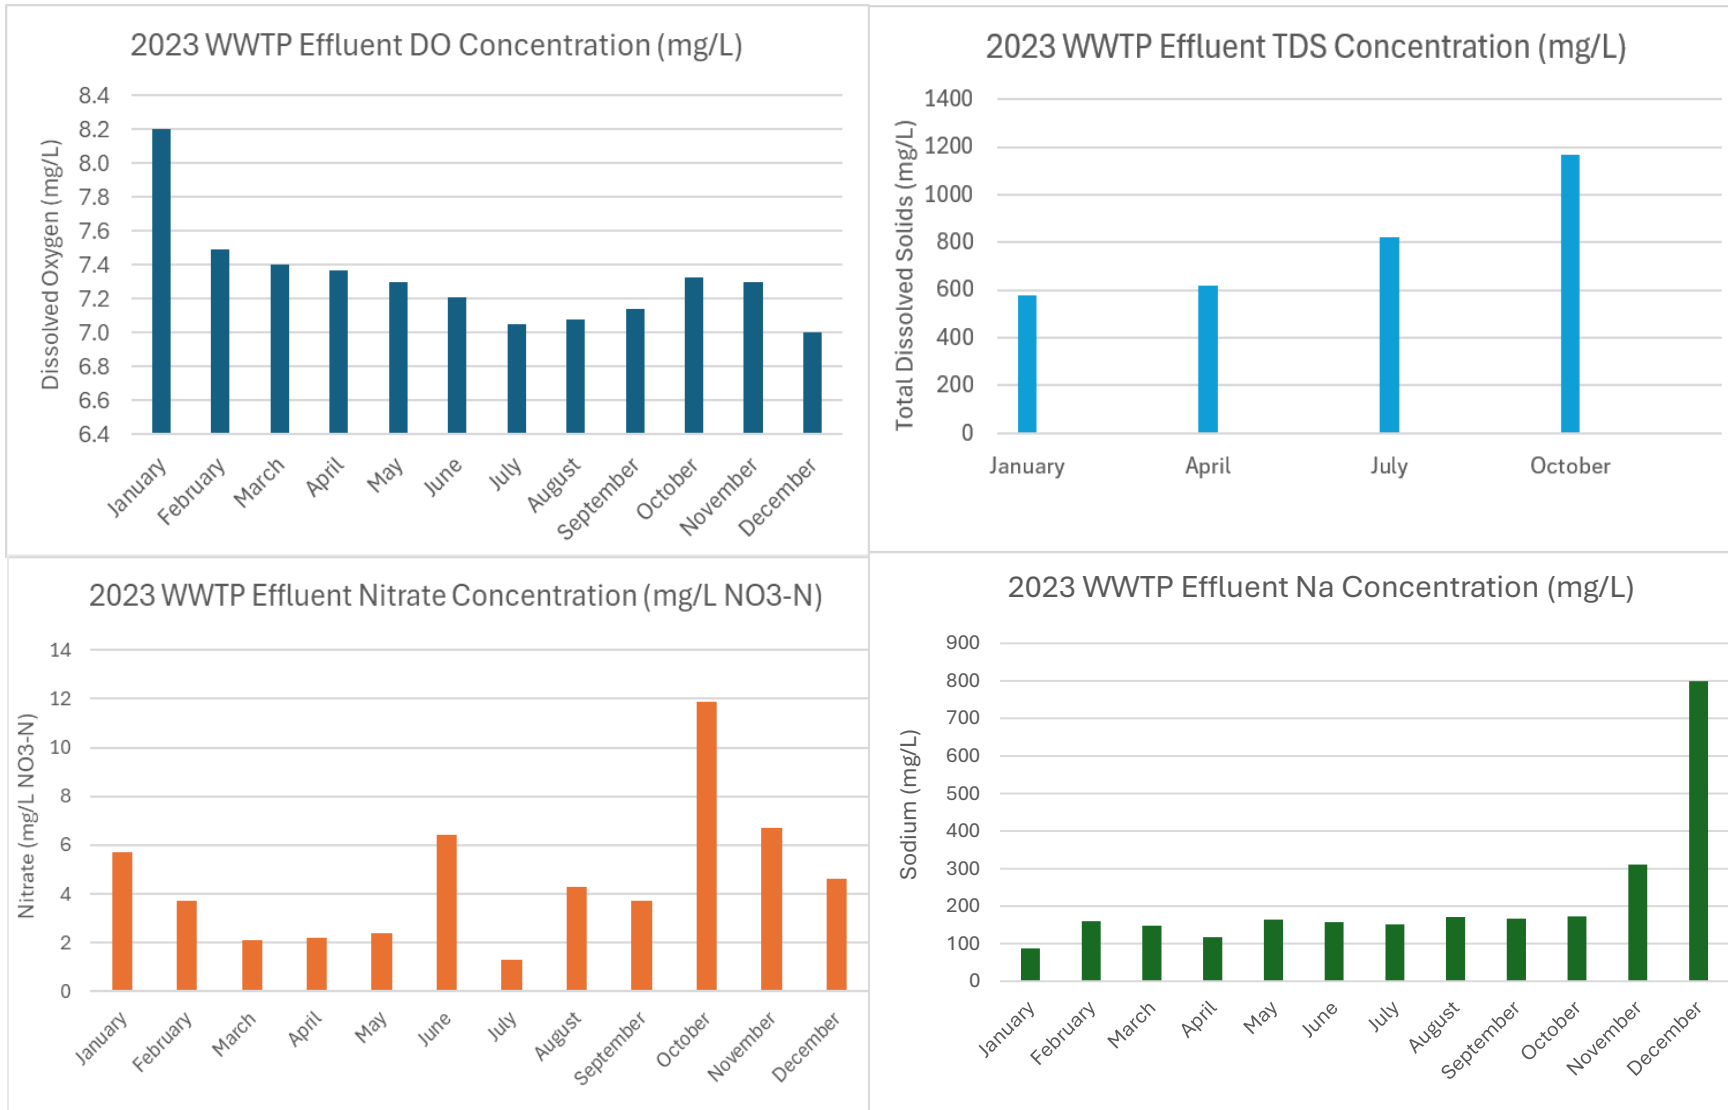
Figure 10. Charts of 2023 WWTP Effluent Water Quality for DO, TDS, NO₃-N, and Na

The San Simeon Valley Groundwater Basin water quality can be impacted by effluent from the District's WWTP effluent, which is disposed of via percolation ponds in close proximity to the SSC. WWTP Effluent water quality data for 2023 is shown in Figure 10 and Table 18 below. Each parameter is monitored monthly or quarterly, as required by the Draft San Simeon Creek TMDL report, to demonstrate that the percolated WWTP effluent is not adversely impacting the San Simeon Valley Groundwater Basin. The data was obtained from the District's WWTP Annual Reports. Higher concentrations in TDS in the October sample can be attributed to high TDS in stormwater capture during the beginning of the wet season in middle to late fall.
