**Cambria Community Services District
Water Reclamation Facility
Adaptive Management Plan
Annual Report
2021**

January 31, 2022

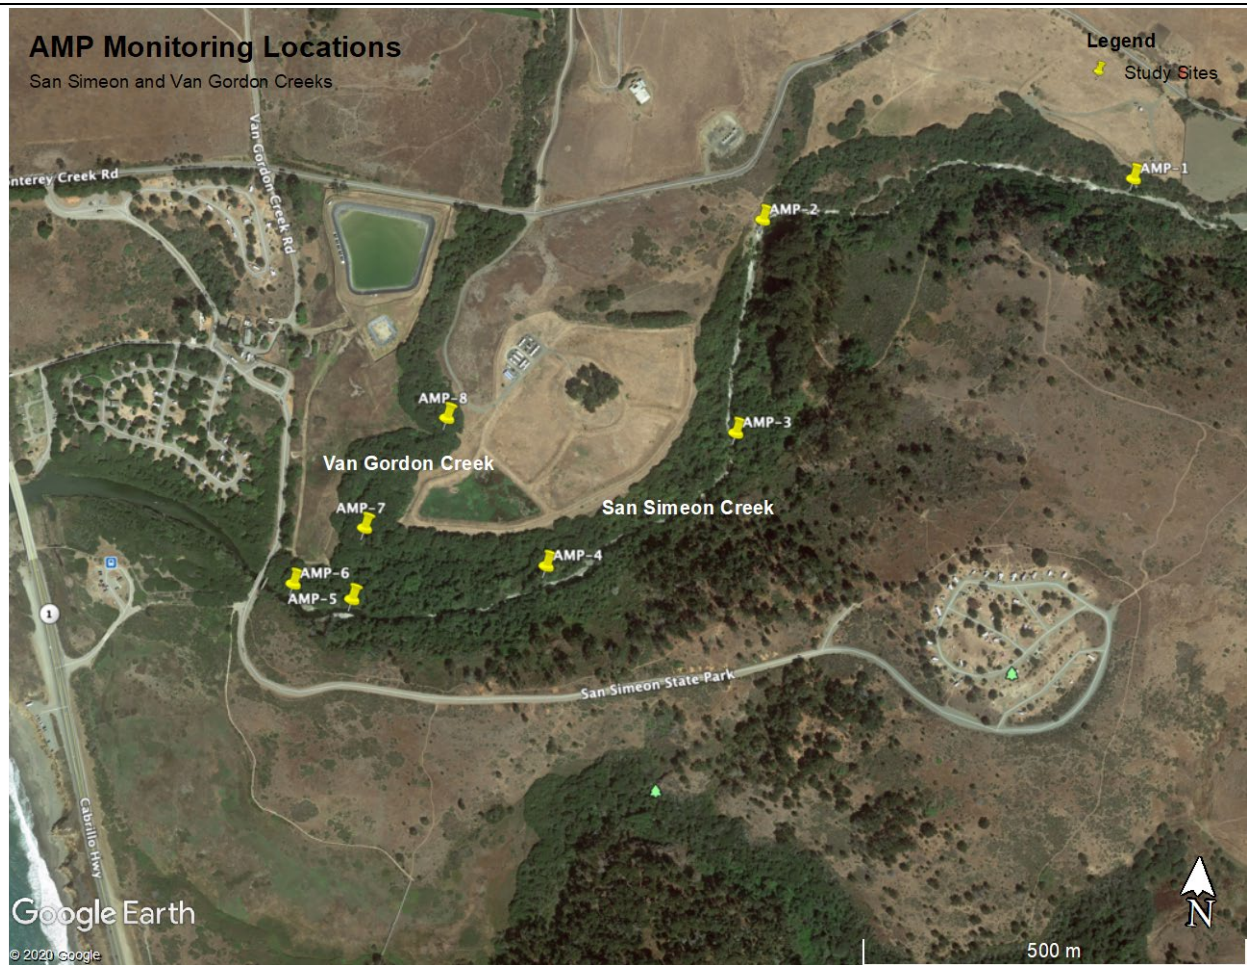
Per methods described in the AMP, biological surveys were conducted at 7 survey sites twice a month to collect habitat, hydrological, water quality, and species information (Figure 2).

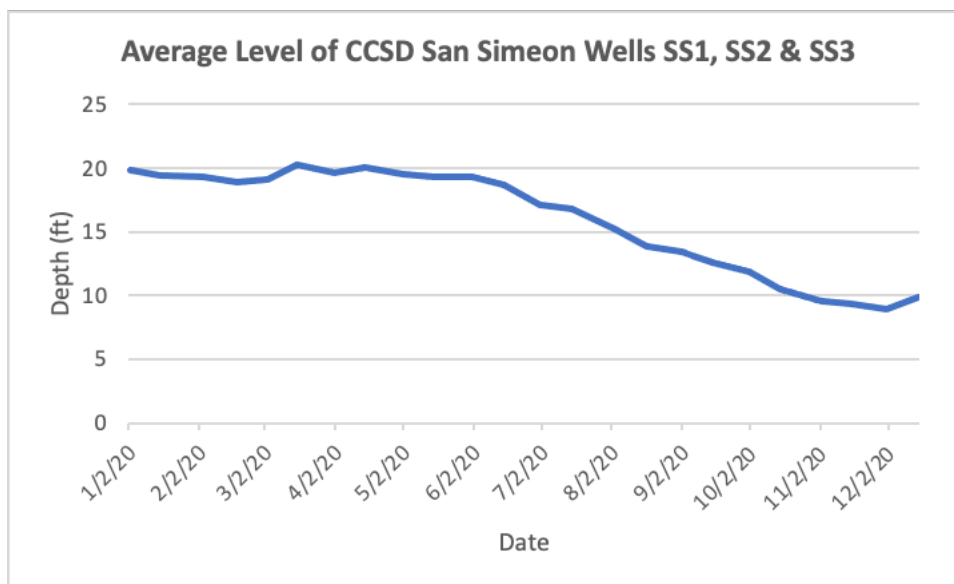
Figure 3. Graph showing average depth levels of wells SS1, SS2, and SS3.

CCSD production well data is presented below for average depth (in feet) for 2020. Well levels will be used for baseline data (Figure 3).

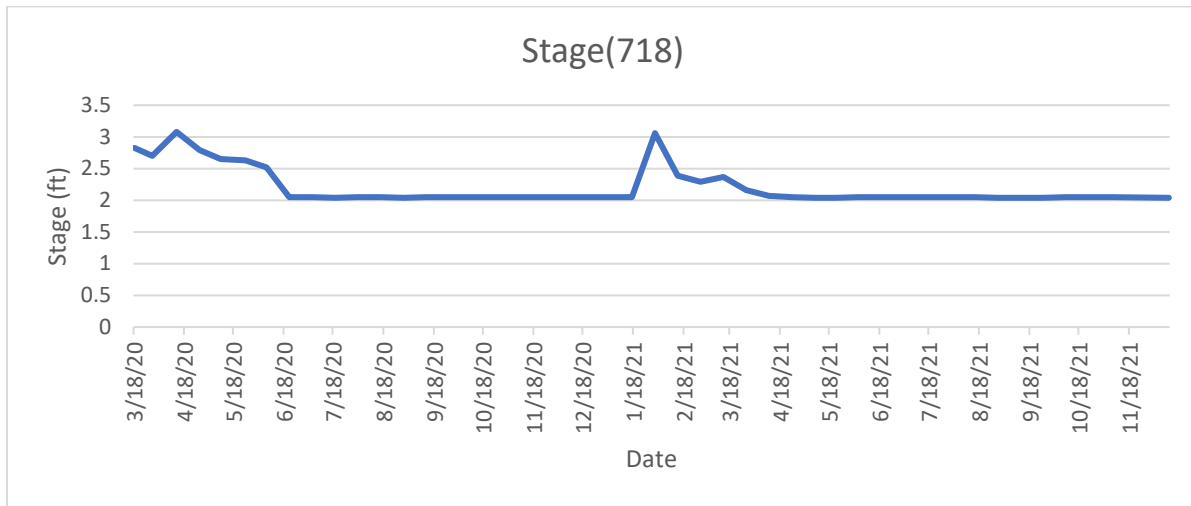
Figure 7. County of San Luis Obispo Water Sensor 718.

San Simeon Creek County of San Luis Obispo Sensor 718 water level is presented in the graph below. This water level sensor is located just upstream of Site 2 (Figure 7).

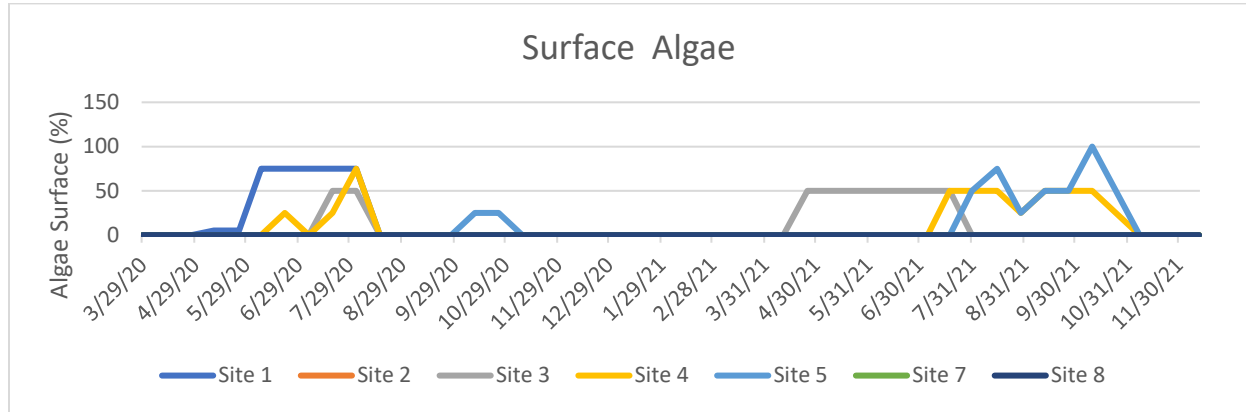
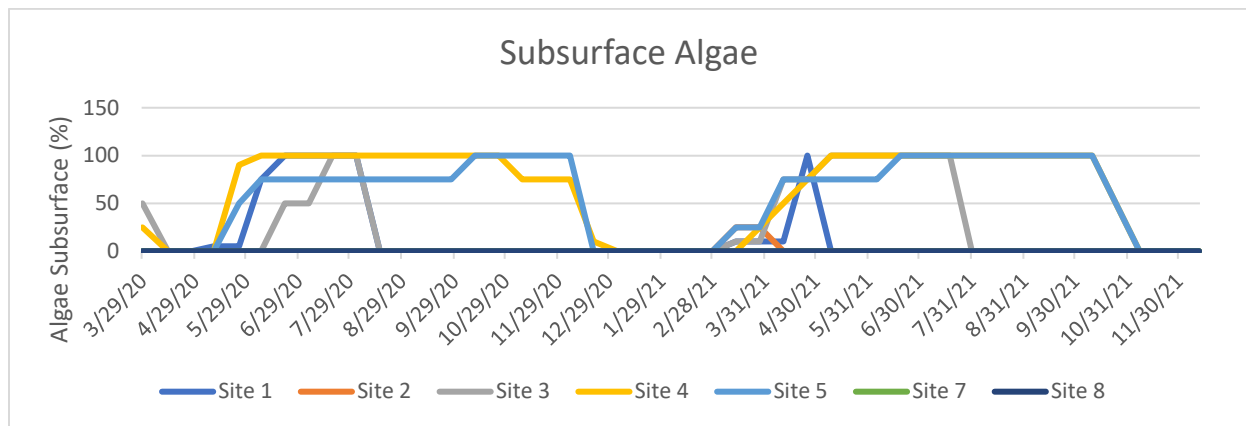
Surface and subsurface algae percentages for each survey site are also presented. Surface algae appears correlated with daylight hours and low flows. Subsurface algae follows a similar correlation but is more persistent in the winter months (Figures 8 and 9).

Figure 8. Surface algae.

Figure 9. Subsurface algae.

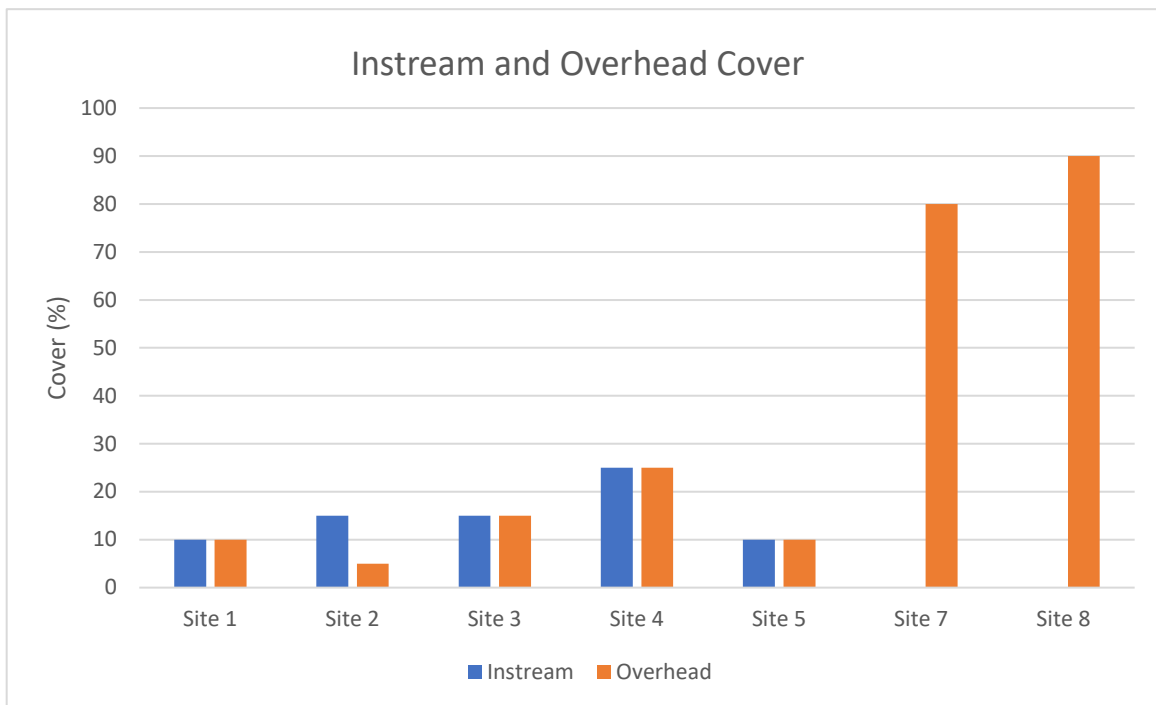
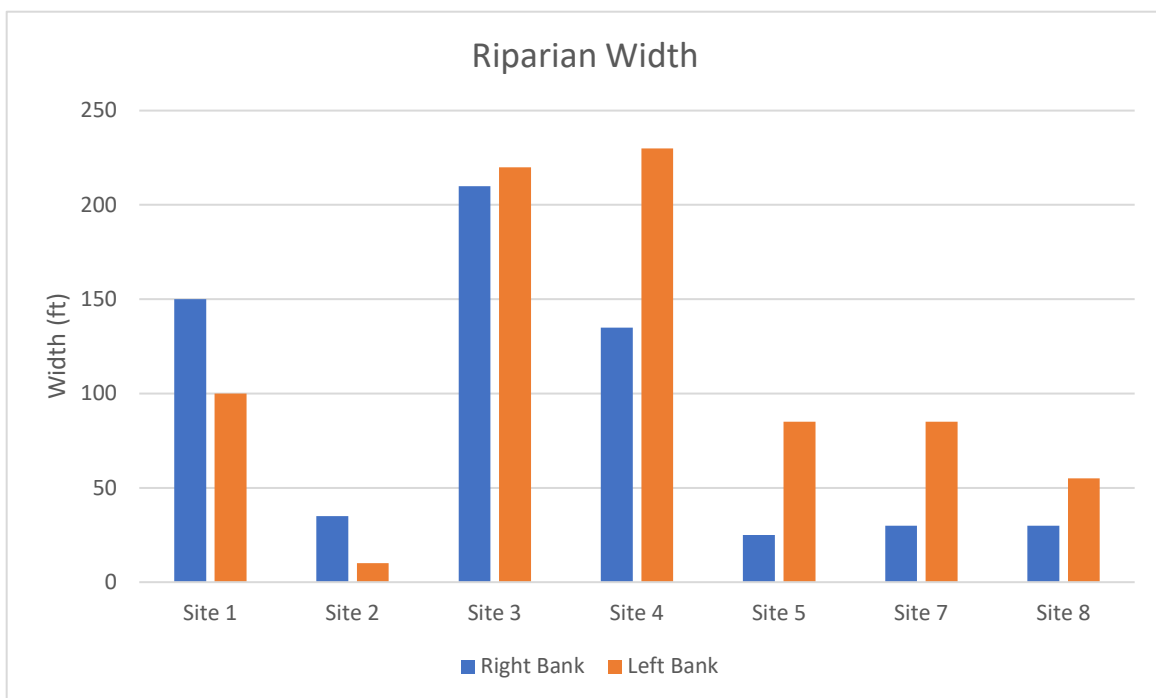
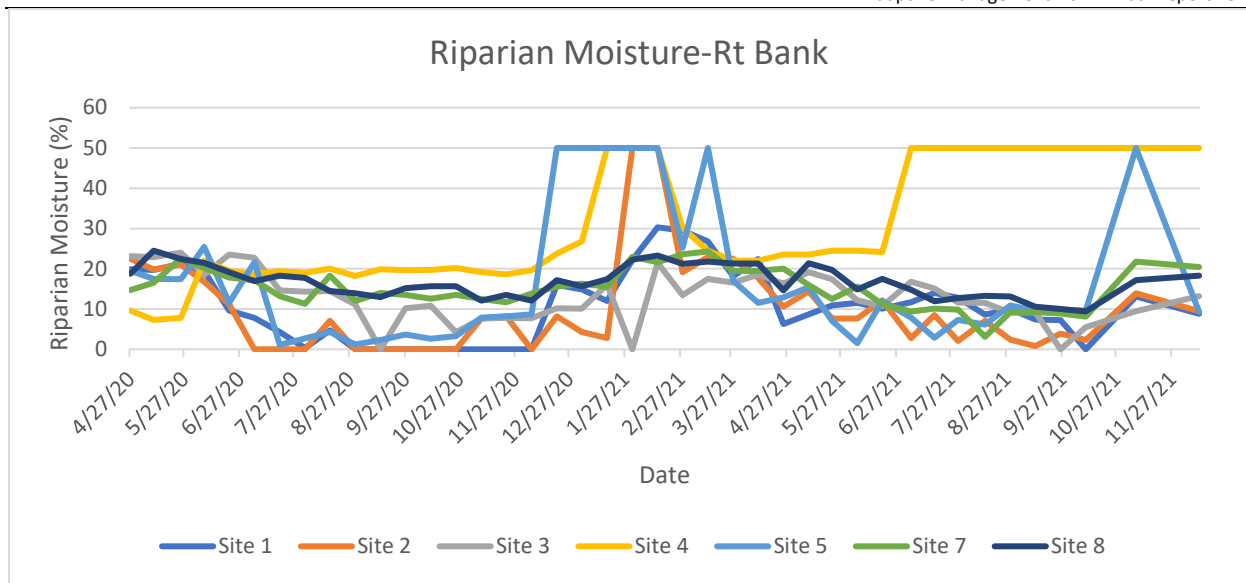
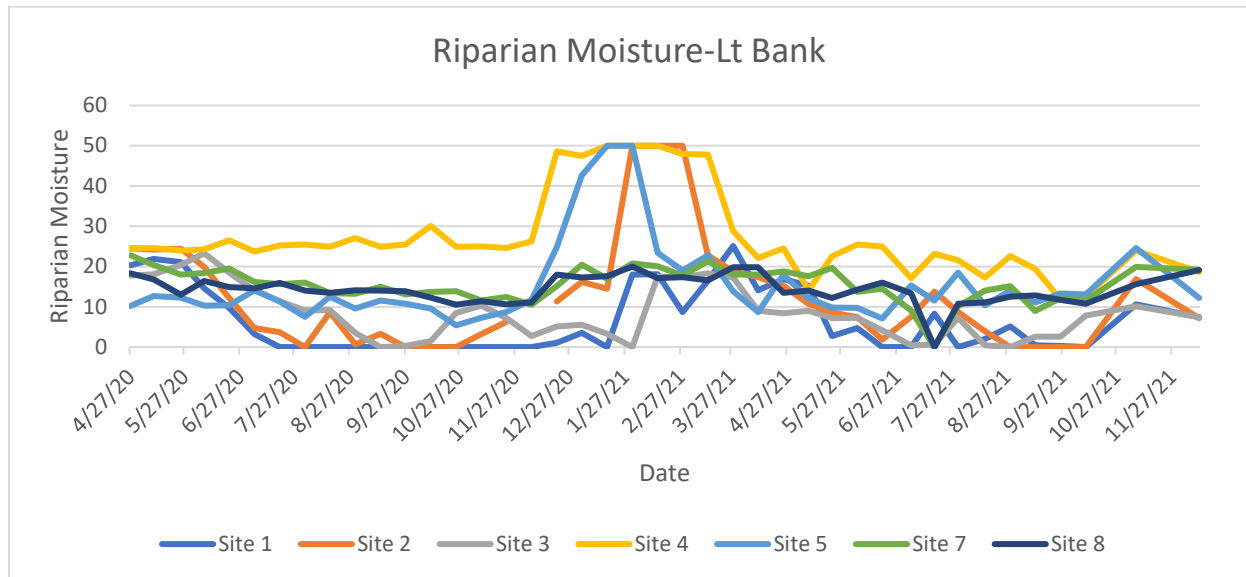
The graphs below present data on instream and overhead cover, riparian width, and riparian moisture (Figures 10 through 13). Instream and overhead cover and riparian width did not change during the year. Riparian moisture changed often – sometimes the change was due to weather, but the readings would also vary if measurements were taken within inches of each other; the usefulness of this data is in question. Aerial photos of riparian vegetation were analyzed with no observed significant changes.

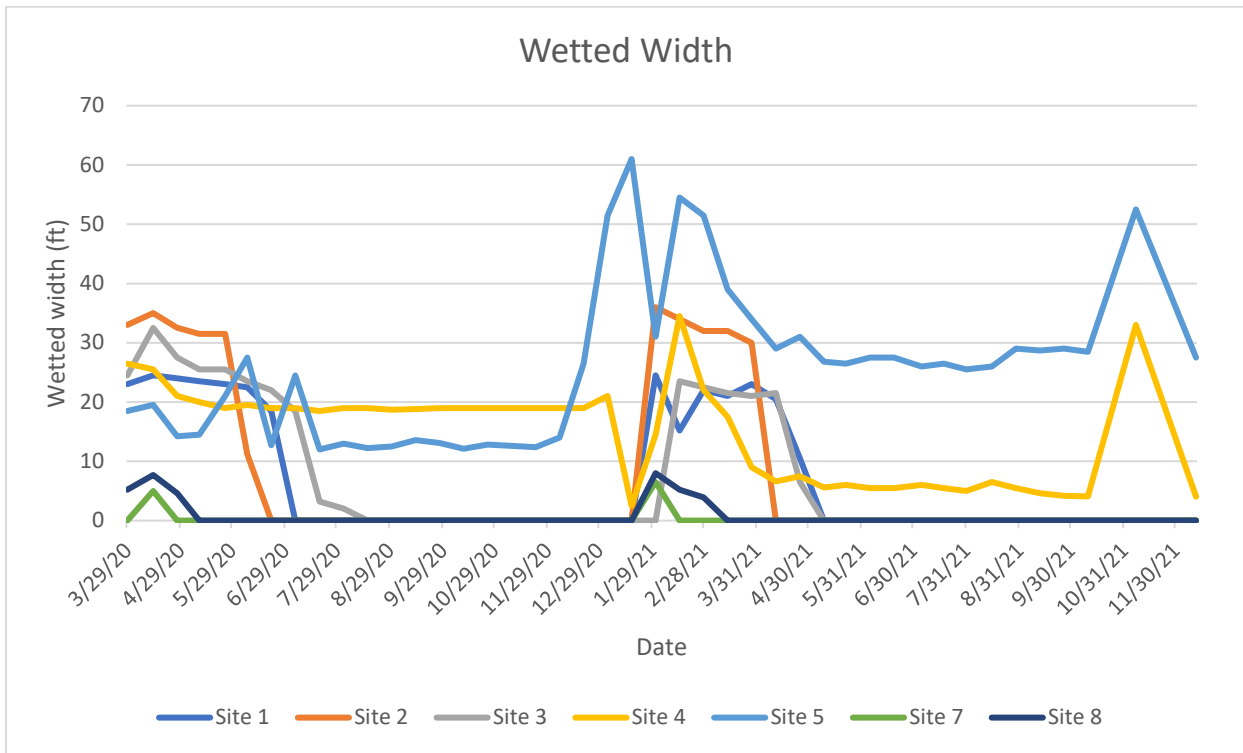
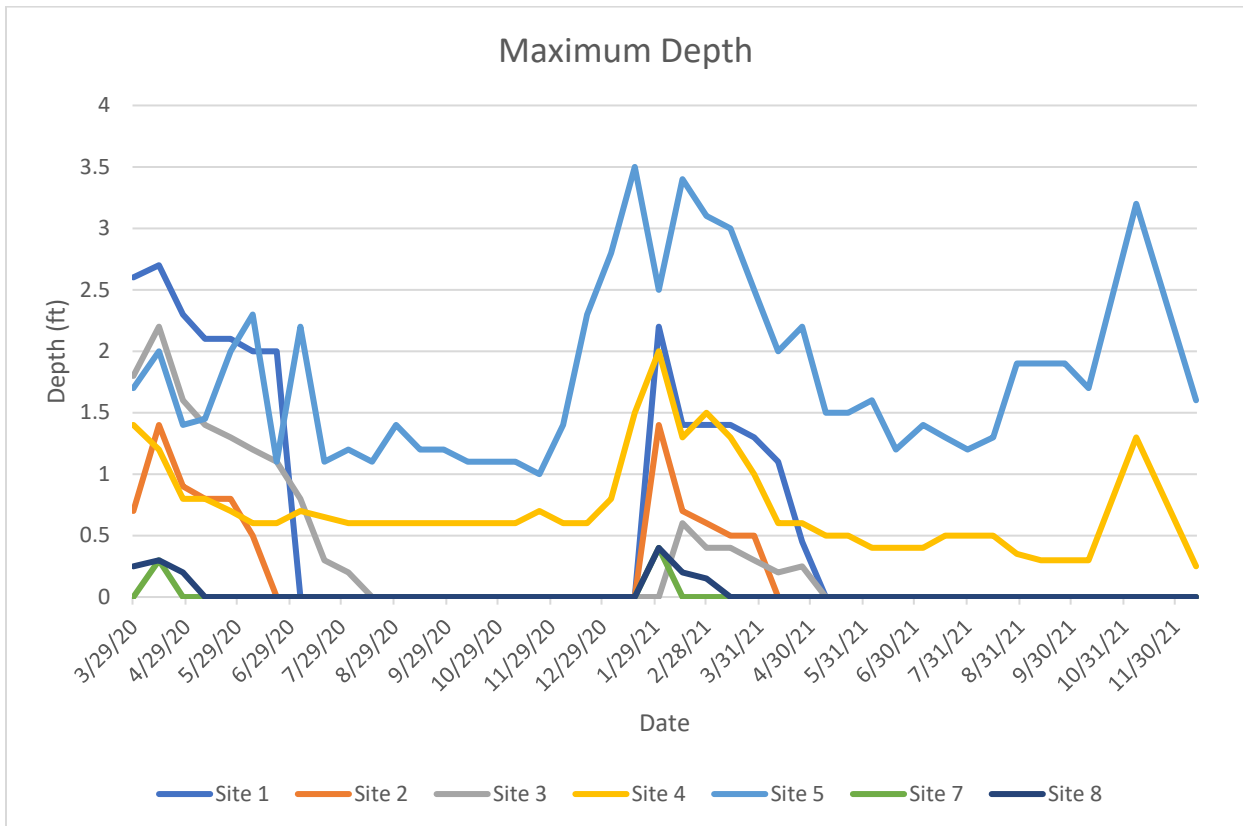
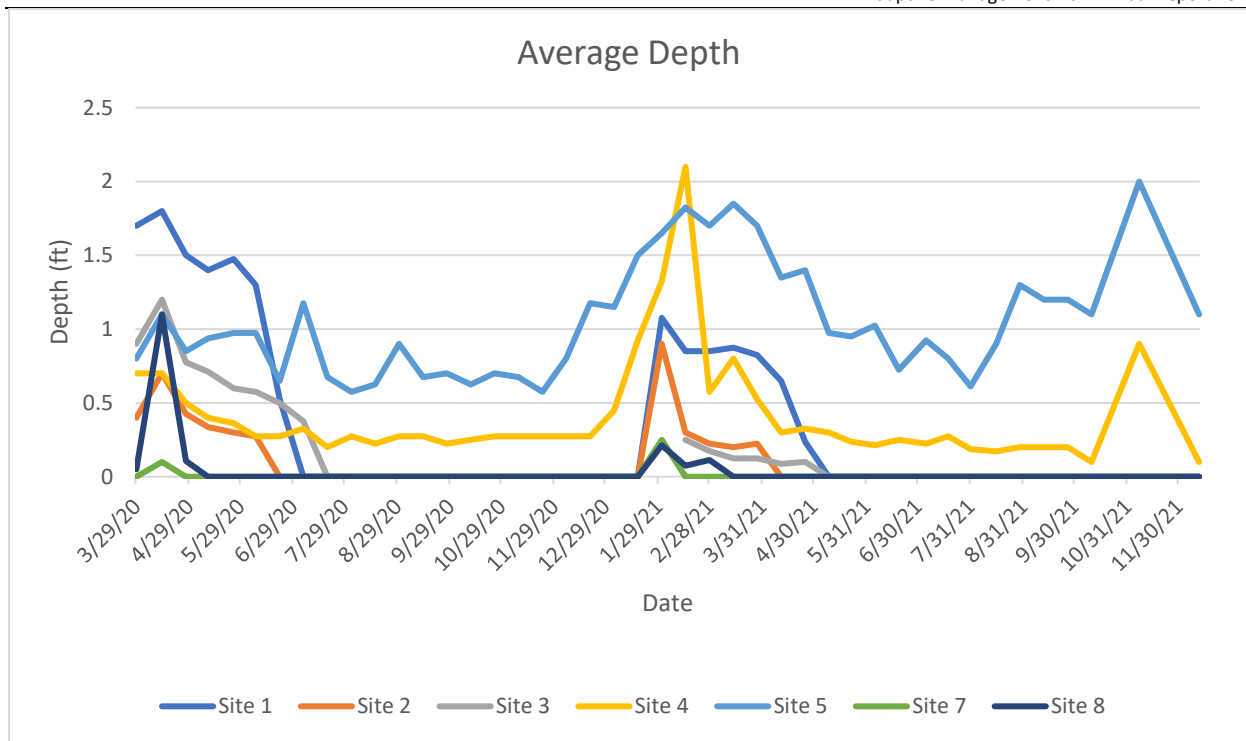
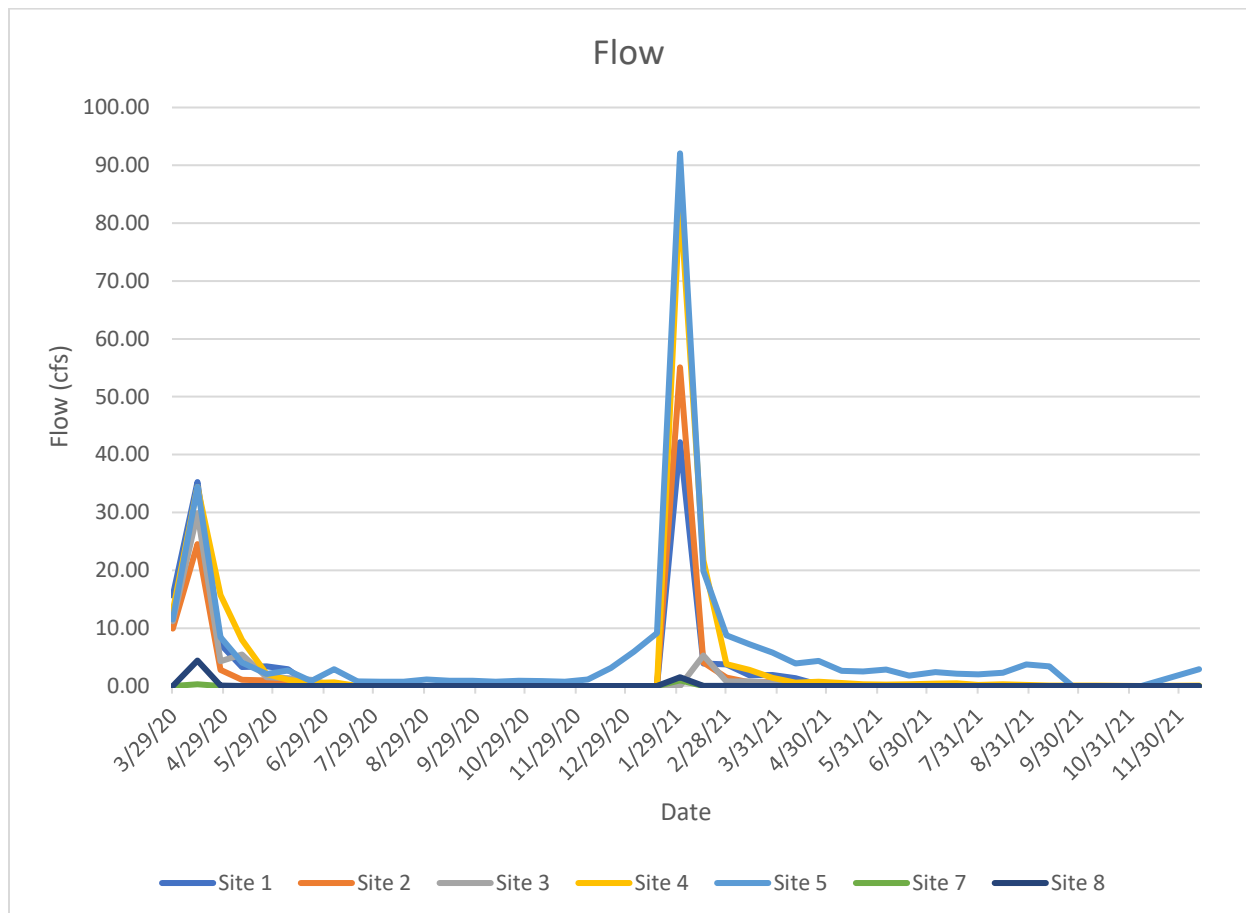
Wetted width, maximum depth, and average depth were measured year-round at Sites 4 and 5; other survey sites went dry in the following order from first to last: Site 7, 8, 2, 1, 3. The graphs below show seasonal variation. They also show that there were more months of flow in 2020 than in 2021. And even though 2021 had fewer wetted months, the width, depth, and flow were greater than the previous year, most likely attributed to a change in stream morphology.

All of these graphs, especially the flow data, show the rapid rise and fall of a typical coastal creek. Further discussion of Sites 4 and 5 follows (Figures 14 through 17).

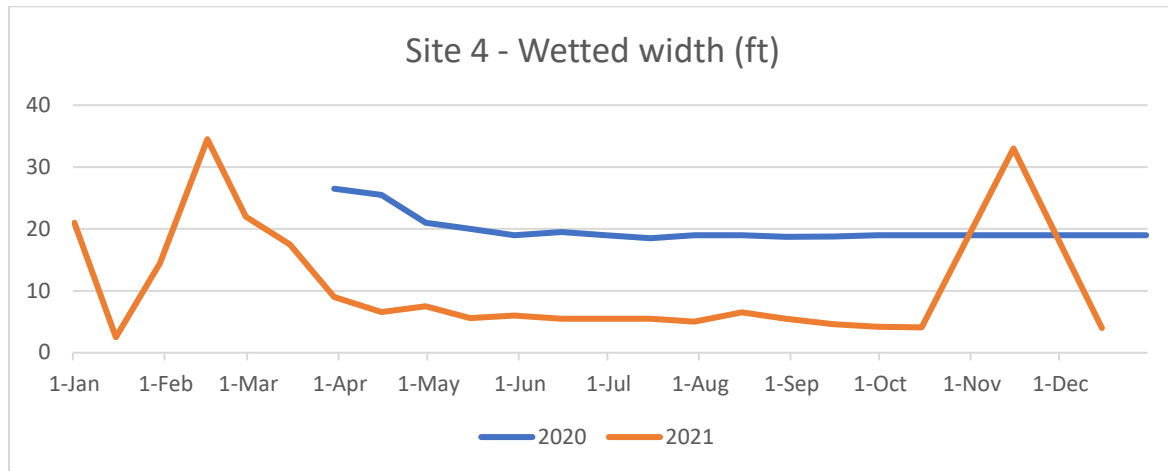
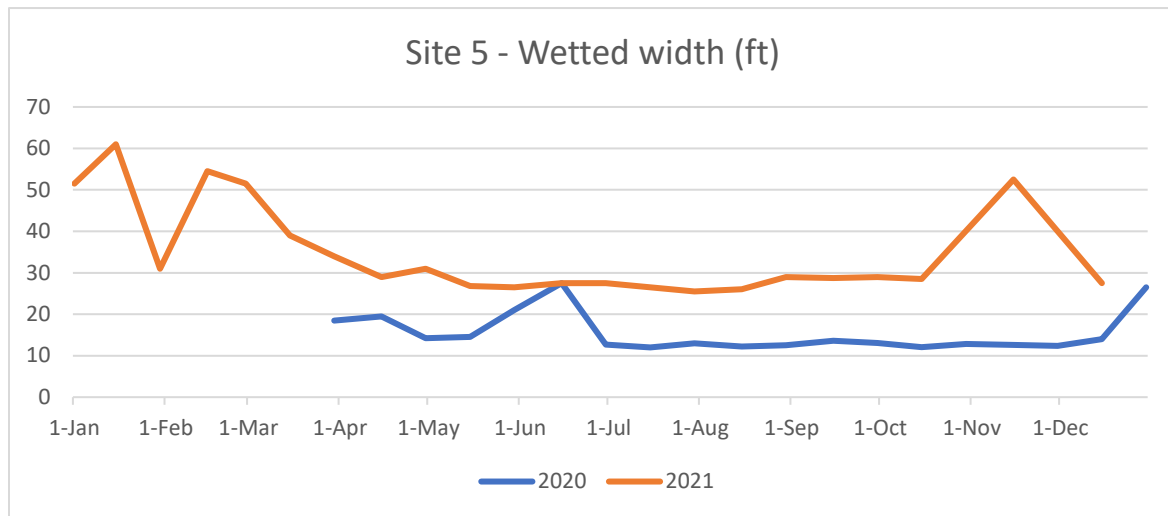
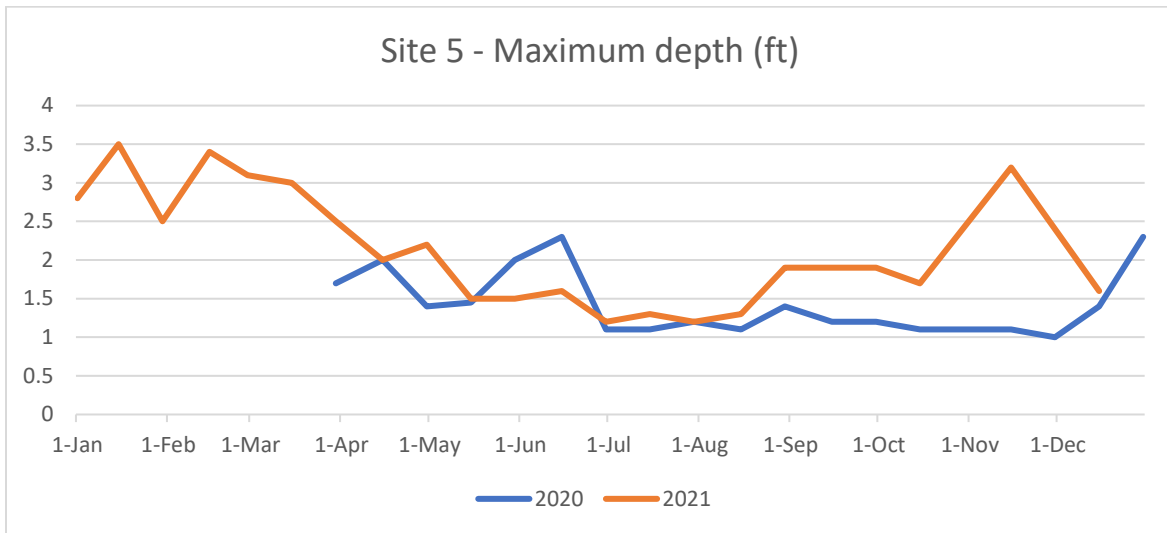
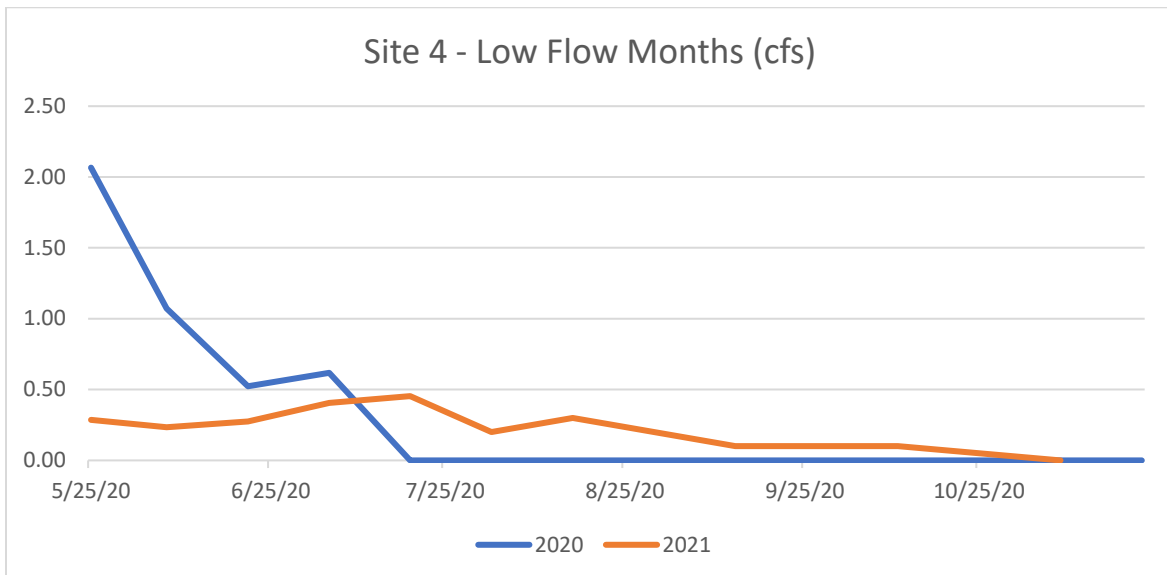
These two sites have year-round water providing habitat for aquatic species. Comparing two years of data shows more annual variation in wetted width than in wetted depth. Site 4 was wider in 2020 which may be due to a shorter high flow season in 2021 or the change in habitat due to a tree falling directly on the site. Site 5 showed just the opposite, with a greater width in 2021. This may be due to the sandbar opening to the ocean for only one month and causing water to back up. This theory is supported by higher salinity levels in 2021, indicating more of a tidal effect further upstream than in 2020. Wetted depth was similar during both years at Site 4. At Site 5, the depth increased during higher tides in the winter months.

Flow data is presented for low flow months of May through November. Site 4 showed a steady decline inflow. Site 5 had more fluctuation because of tidal influence which, due to a greater wetted area, calculated a greater flow. Flow is a measurement of stream rate times wetted area.

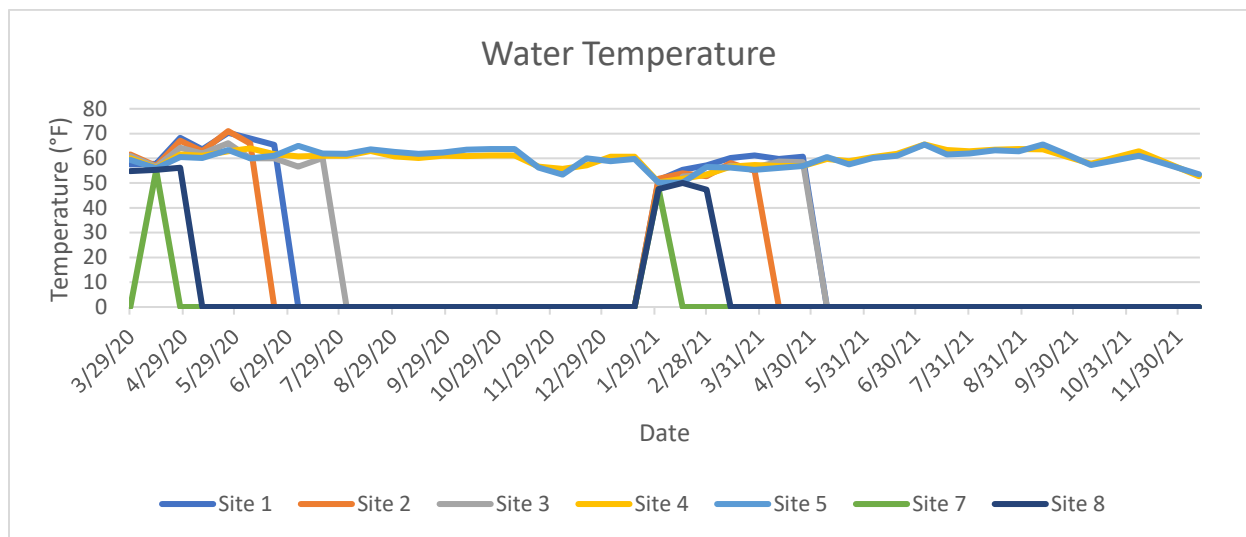
Over the two years of monitoring, water temperatures and oxygen levels followed a similar pattern (Figures 24 and 25). Water temperature at Sites 4 and 5 had a low of 50.2 °F at the end of January. Site 4 peaked at 65.6 °F in July 2021, while Site 5 peaked at the same temperature in September 2021. Other sites had similar temperatures.

Dissolved oxygen at Sites 4 and 5 typically ranged between 2.5 and 10.5 ppm. Dissolved oxygen tends to decrease when temperature or salinity increase. It can also decrease with a reduction in inflow. This relationship of dissolved oxygen and salinity was observed in November 2021 when dissolved oxygen dropped in one sample to 0.25 ppm and salinity increased to 20.7 ppt. On this sample date, it appears that salinity had more of a lowering effect on dissolved oxygen than did temperature, as shown in the charts below.

Water temperatures were within range for the listed species. Dissolved oxygen levels dipped below optimal habitat requirements during the summer for steelhead trout. Salinity was also within range for the listed species, except for Site 5 on the last reading that was influenced by tides and the closed sandbar.

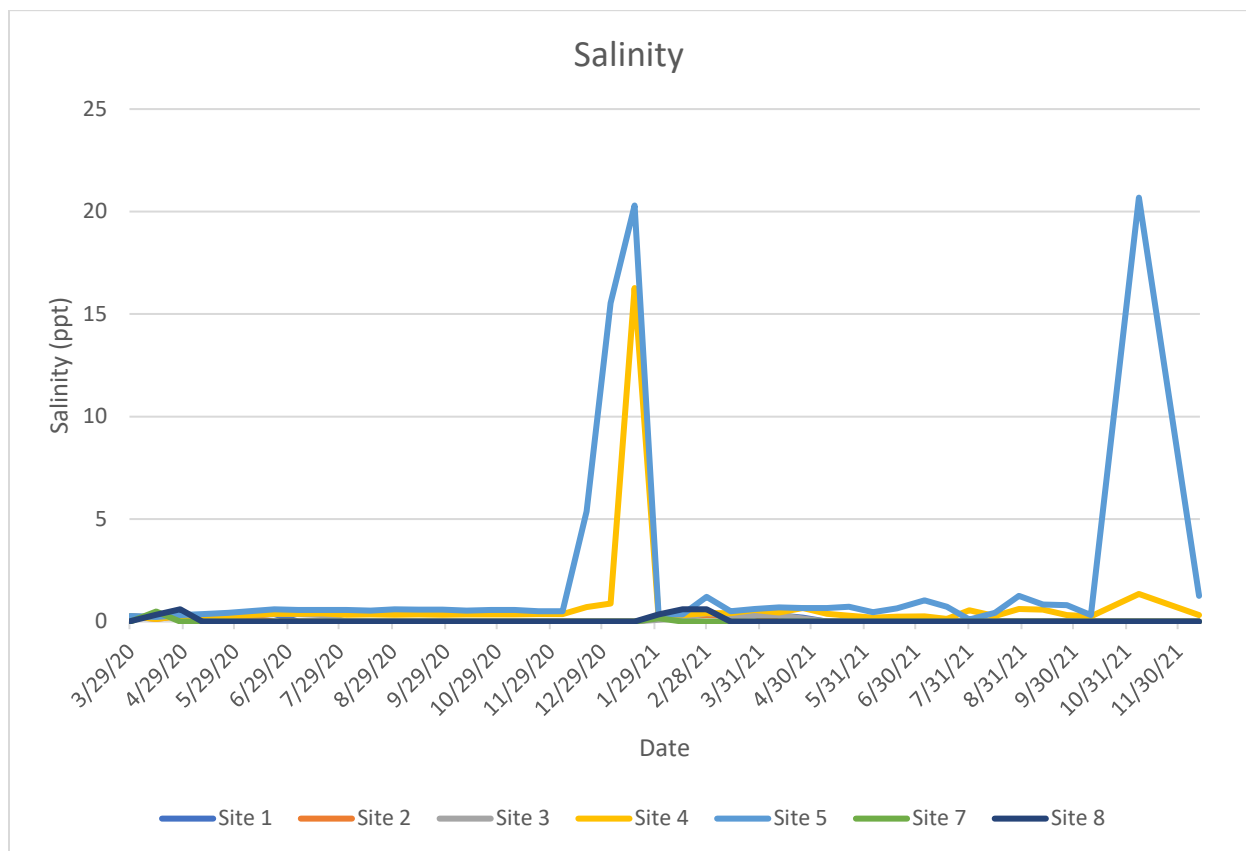
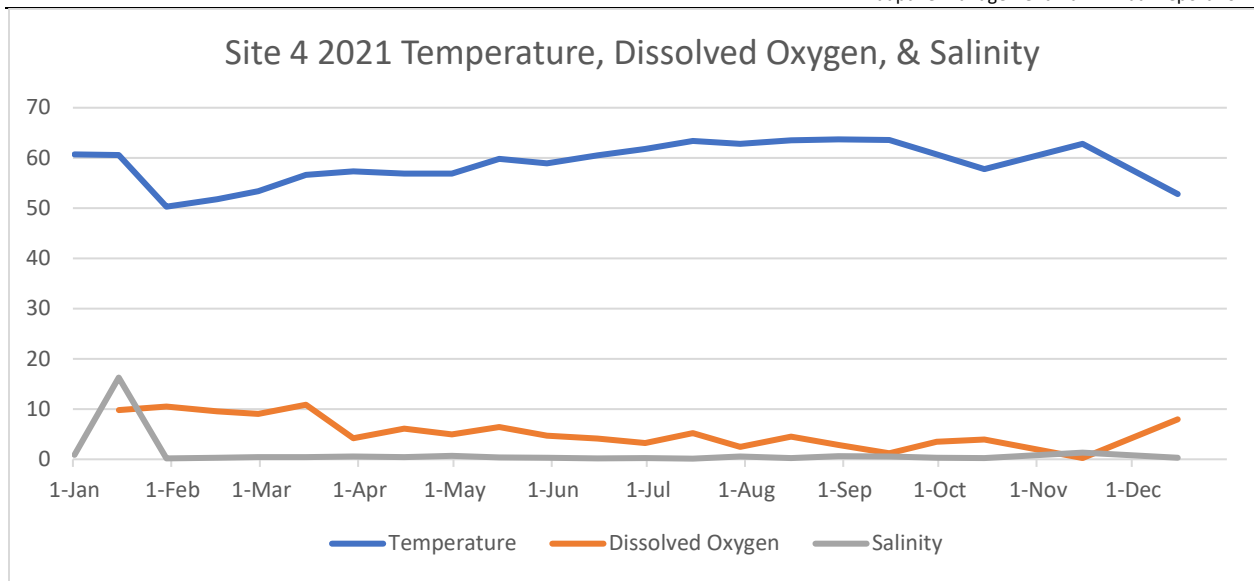
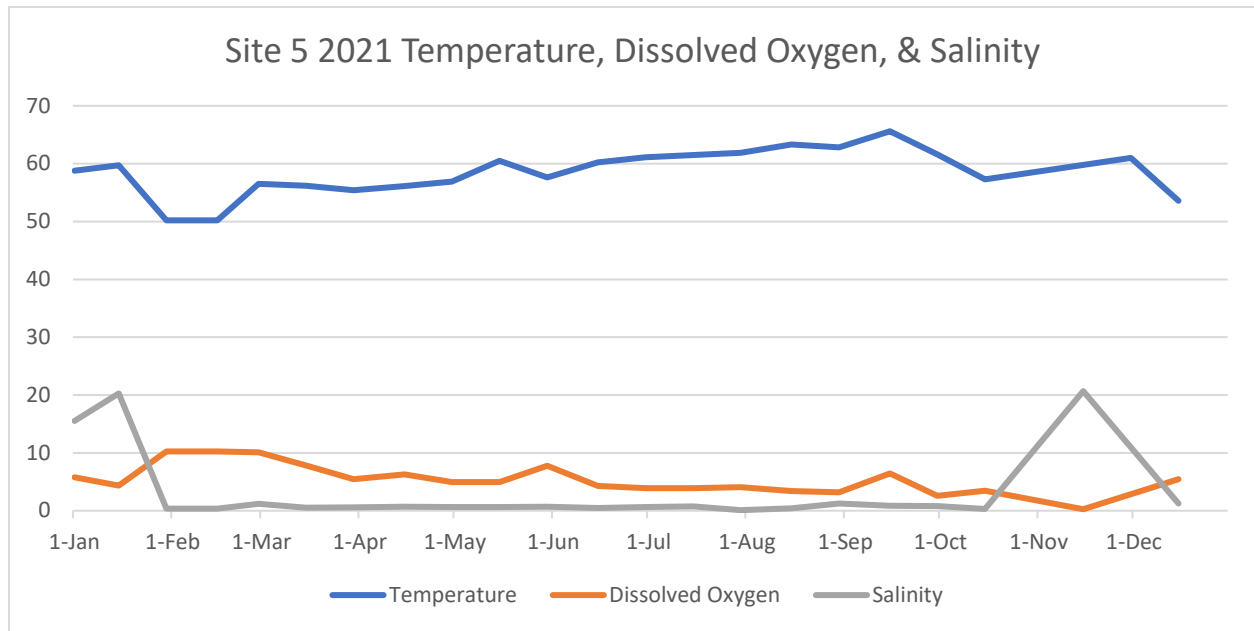
Salinity usually ranged from 0.2 to 0.6 ppt (Figure 26). Towards the end of the year at Site 5, it began to increase and reached a level of 20.7 ppt in November, probably a result of tidal influence and a closed sandbar. Site 4 had high salinity readings in January 2021, indicating that tidal influence reached this far upstream (Figures 27 and 28).

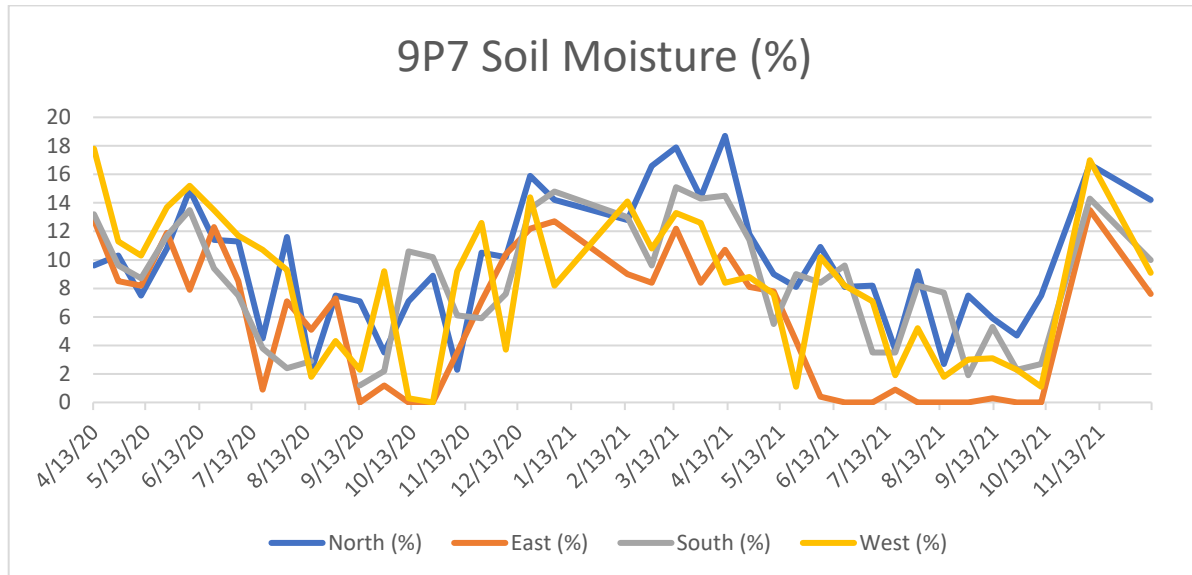
Figure 29. 9P7 Soil moisture.

Soil moisture at the 9P7 well is presented in the graph below (Figure 29). As with other soil moisture measurements, the usefulness of this data is in question. The maximum moisture reading is 50%.
