CCSD Monthly Creek Monitoring

Monthly monitoring of San Simeon Creek, Van Gordon Creek, the San Simeon Estuary, and the Evaporation Pond

Cambria Community Service District Adaptive Management Plan Biological Bi-Monthly Monitoring Report

AMP Monitoring Locations

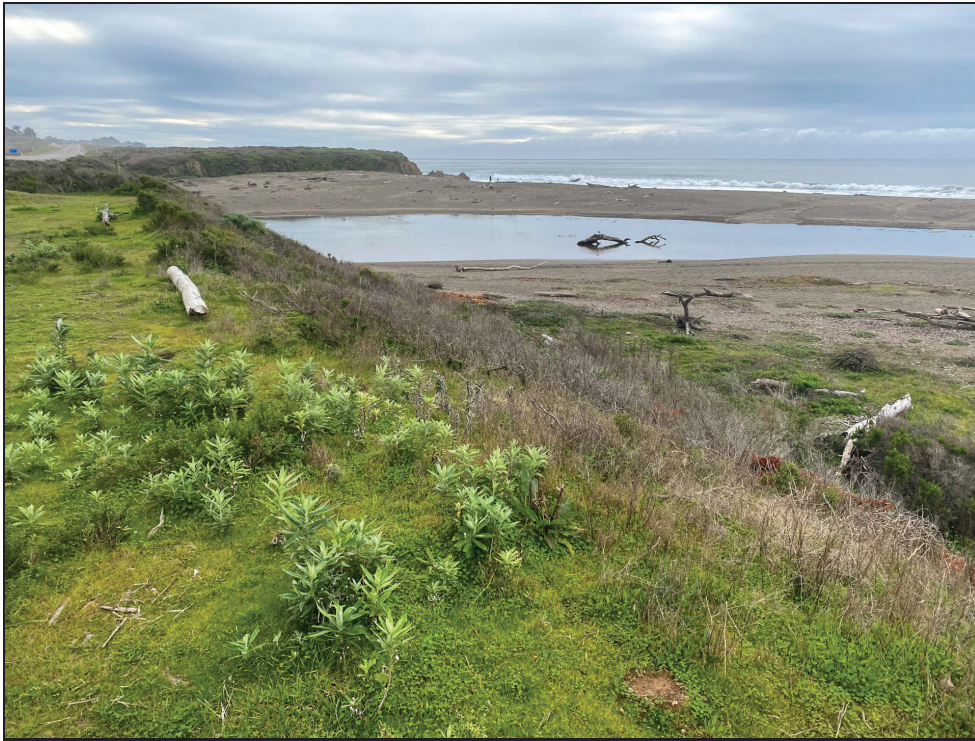
Estuary

Cleveland Biological	
Cindy & Paul Cleveland	
	1/20/20
	9:30 AM
<u>Estuary</u>	
Comments	4.38 receding tide. Sandbar is breached.
<u>Van Gordon Confluence</u>	
Water Depth (ft)	1.5
Stream Width (ft)	29
Water Temp (F)	53
Species Noted	1 Kingfisher
Stream Type	Run
Algae % Surface/Subsurface	0/0
Substrate	Cobble, Gravel, and Silt
Substrate embededness %	50
Comments	Stage (718) 2.73
<u>Red Legged Pool</u>	
Water Depth (ft)	2.1
Stream Width (ft)	22.5
Water Temp (F)	53
Species Noted	2 Snowy egrets
Stream Type	Run
Algae Surface/Subsurface (%)	0/0
Substrate	Cobble, Gravel, and Silt
Substrate embededness %	50
Comments	
<u>Evaporation Pond</u>	
Species Noted	None
Water Temp (F)	NA
<u>General Comments</u>	
Comments	Some water from recent rain.
