**Cambria Sustainable Water Facility
Adaptive Management Plan
Annual Report
2020**

Cambria Community Services District
Ray Dienzo, P.E.
Cambria, CA
805.927.6119

Cleveland Biological, LLC
Arroyo Grande, CA
805.234.3759

February 15, 2021

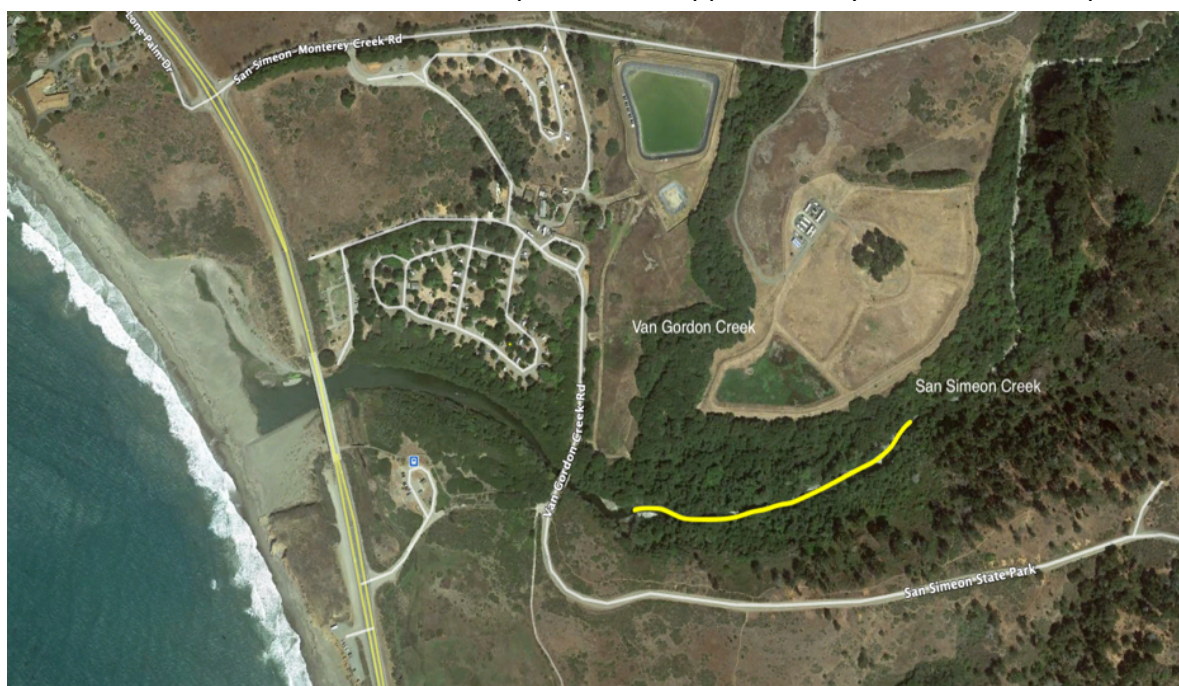
On March 18, 2020 and October 11, 2020 Cindy Cleveland and Paul Cleveland conducted daytime and nighttime California red-legged frog surveys following the protocol contained within the “Revised Guidance on Site Assessments and Field Surveys for the California Red-legged Frog” (USFWS 2005). The surveys were conducted within the study area that extended from the mouth of Van Gordon Creek upstream for approximately 900 feet, see map below.

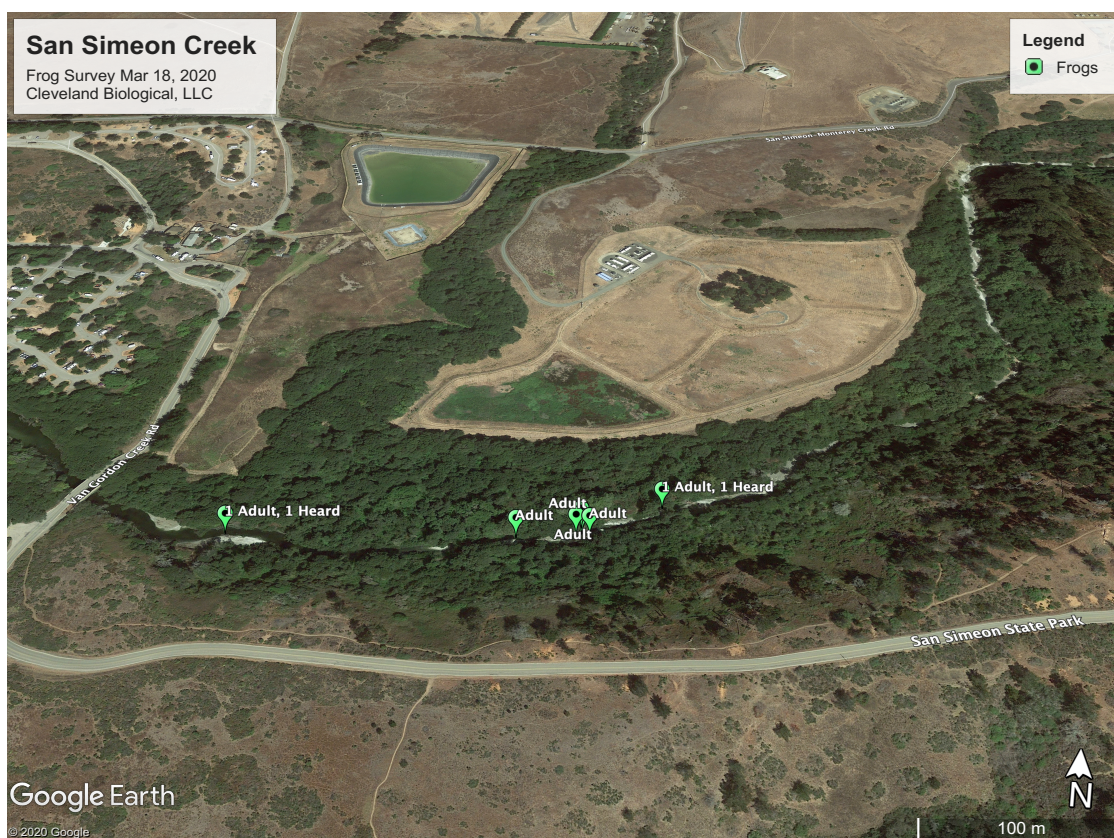
the daytime survey. The nighttime survey was completed at least one hour after sunset between the hours of 19:30 and 23:00. The moon phase was 32%, water temperature was 58 degrees Fahrenheit, humidity was 84%, and the wind was from the west and very light. The survey conditions were clear and calm. The stream flow was approximately 10 cfs with no algae and unembedded substrates. The deepest pool was approximately 5 feet with an average stream depth of 2 feet. Six adult California red-legged frogs were observed during the night survey and two other frog “plops” were heard but the species was not identified (see map below). No bullfrog “squawk” was heard when the unidentified frogs jumped, but based on professional experience, we find that bullfrogs often do not squawk when they jump into cover. One California red-legged frog advertisement call, with ending growls, was observed and recorded at night. The frog was sitting on a branch over a deep pool near the confluence of Van Gordon and San Simeon Creeks.

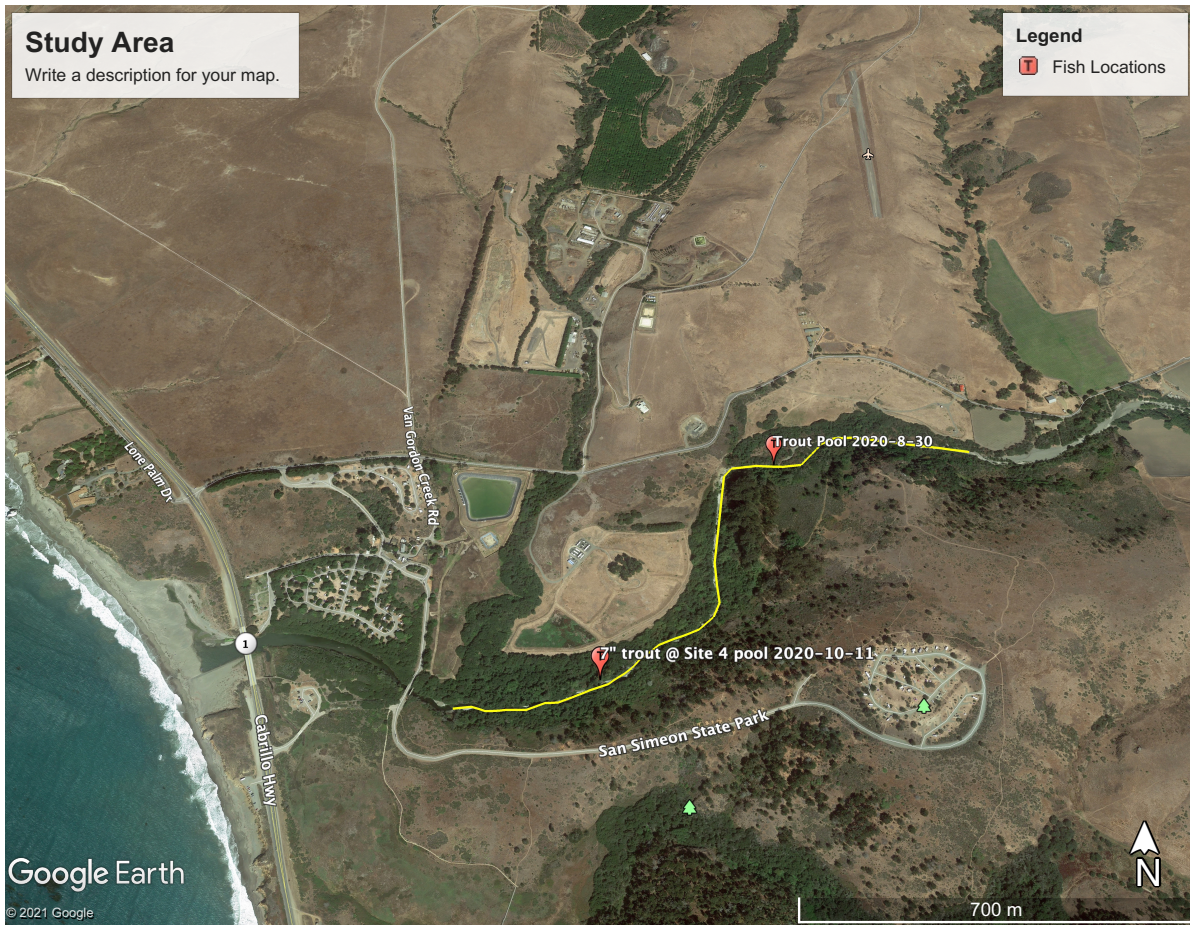
The October 11, 2020 survey was from 0:900 to 13:00. The high tide of 3.98 feet was at 07:51; the sandbar was not breached. The air temperature was 68 degrees Fahrenheit at the beginning of survey and was 80 degrees Fahrenheit at the end of the survey. The skies were clear for the entire survey. The water temperature was 63.5 degrees Fahrenheit at the Van Gordon and San Simeon Creek confluence and 60.9 degrees Fahrenheit where the streamflow ended near the middle of the survey area. The surveyed habitats were a mix of pools, runs, and riffles with mostly cobble and gravel substrates. The substrate embeddedness was on average 50%, there was no surface algae at any survey site and almost 100% subsurface algae over the entire survey area. The instream cover on average was 15% and overhead cover on average was 15%. The maximum depth was 1.1 feet, average depth was 0.5 feet, and flow was 0.1 ft/sec. Dissolved oxygen ranged from 2.52 to 4.35 ppm, total dissolved solids ranged from 461 to 700 mg/L, and salinity ranged from 0.35 to 0.54 ppt. Observed fish include many stickleback, one 8" steelhead trout, and one 4" prickly sculpin, see map below.

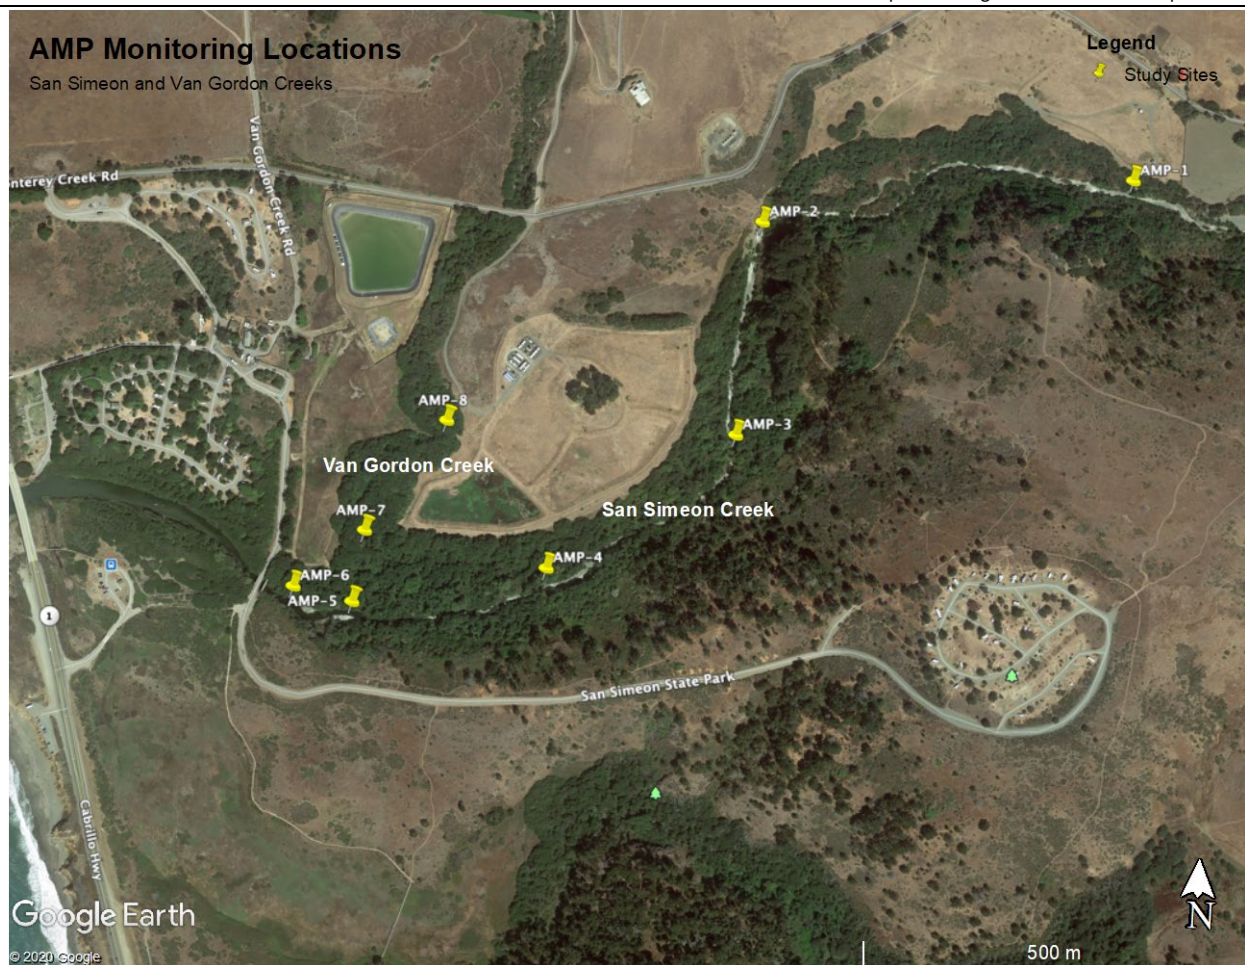
Per methods described in the AMP, biological surveys were conducted at 7 survey sites twice a month to collect habitat, hydrological, water quality, and species information (Figure 2).

As identified in the AMP, survey sites are located on San Simeon Creek and Van Gordon Creek within CCSD property. The survey sites are described below by survey site number, creek, access description, site description, and GPS coordinates.

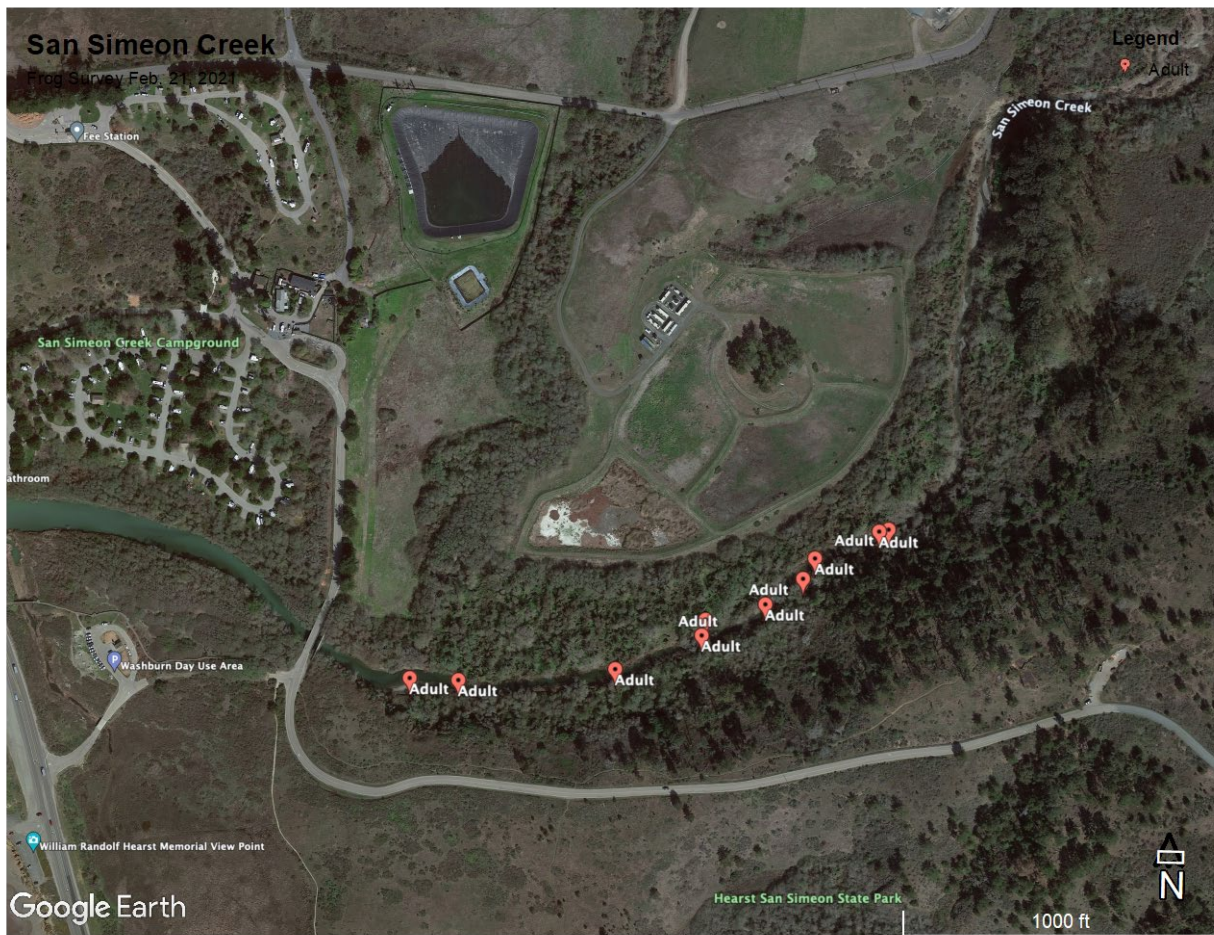
Figure 4. CRLF survey February 2, 2021.

The February 21, 2021, survey was from 10:00 to 13:00 and 18:30 to 20:00. The moon phase was 30%, the air temperature was 58 degrees Fahrenheit, the water temperature was 56 degrees Fahrenheit, the humidity was 80%, and the wind was from the west at 1-2 mph. The survey conditions were clear and cool. The average depth was 1 foot, and the maximum depth was approximately 3.1 feet. The survey conditions were calm. Stream flow was 0.2 cfs, and the water was clear. Ten California red-legged frogs, all adults, were observed, and two frogs were heard jumping into the creek (Figure 4).

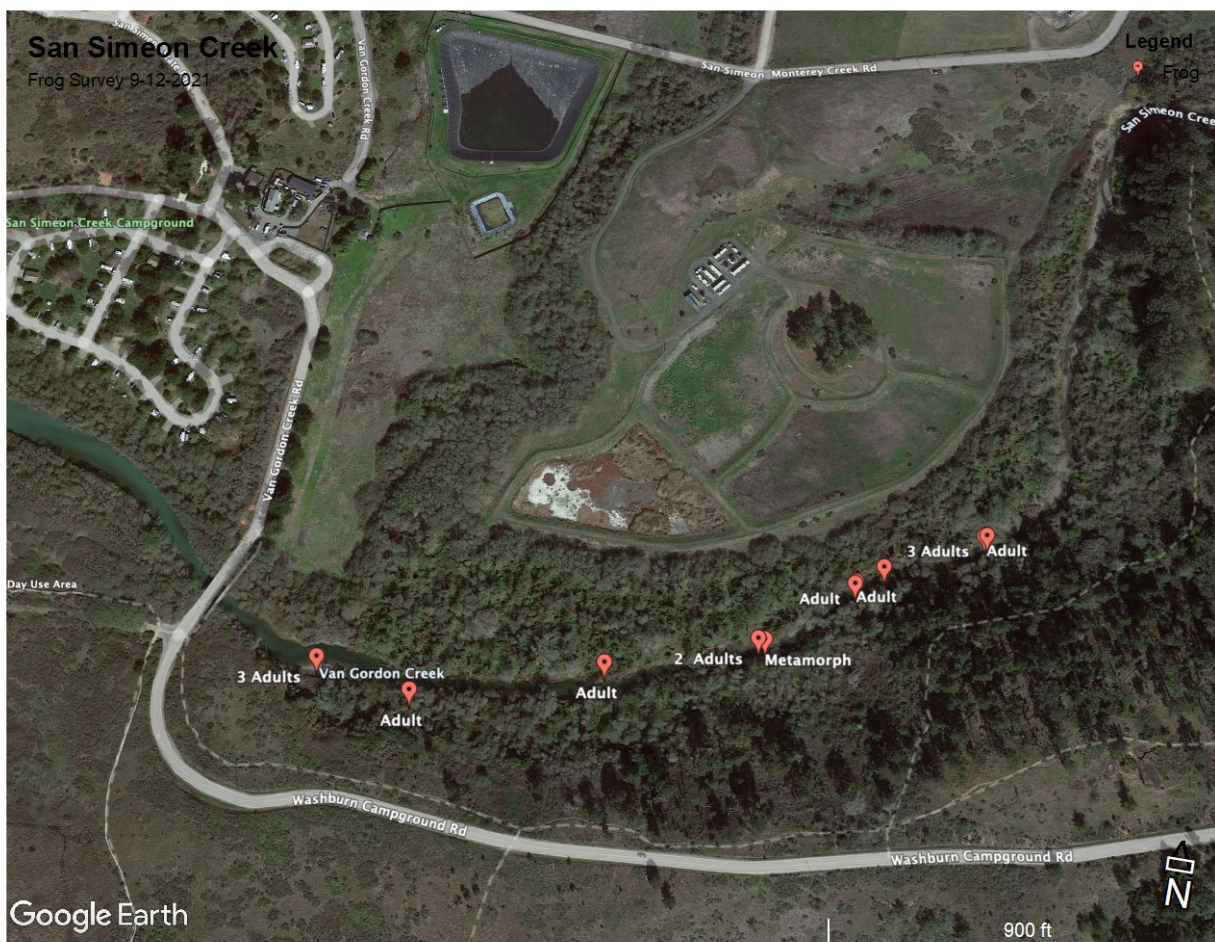
Figure 6. CRLF survey September 12, 2021.

The September 12, 2021 survey was from 21:00 to 23:30. The moon phase was 41%, the air temperature was 65 degrees Fahrenheit, the water temperature was 65 degrees Fahrenheit, the humidity was 79%, and the wind was from the west at 1 mph. The survey conditions were clear and calm. The average depth was 1 foot, and maximum depth was approximately 3 feet. Stream flow was 0.1 cfs, and the water was clear. Sixteen small adult and subadult and one metamorph CRLFs were observed (Figure 6).

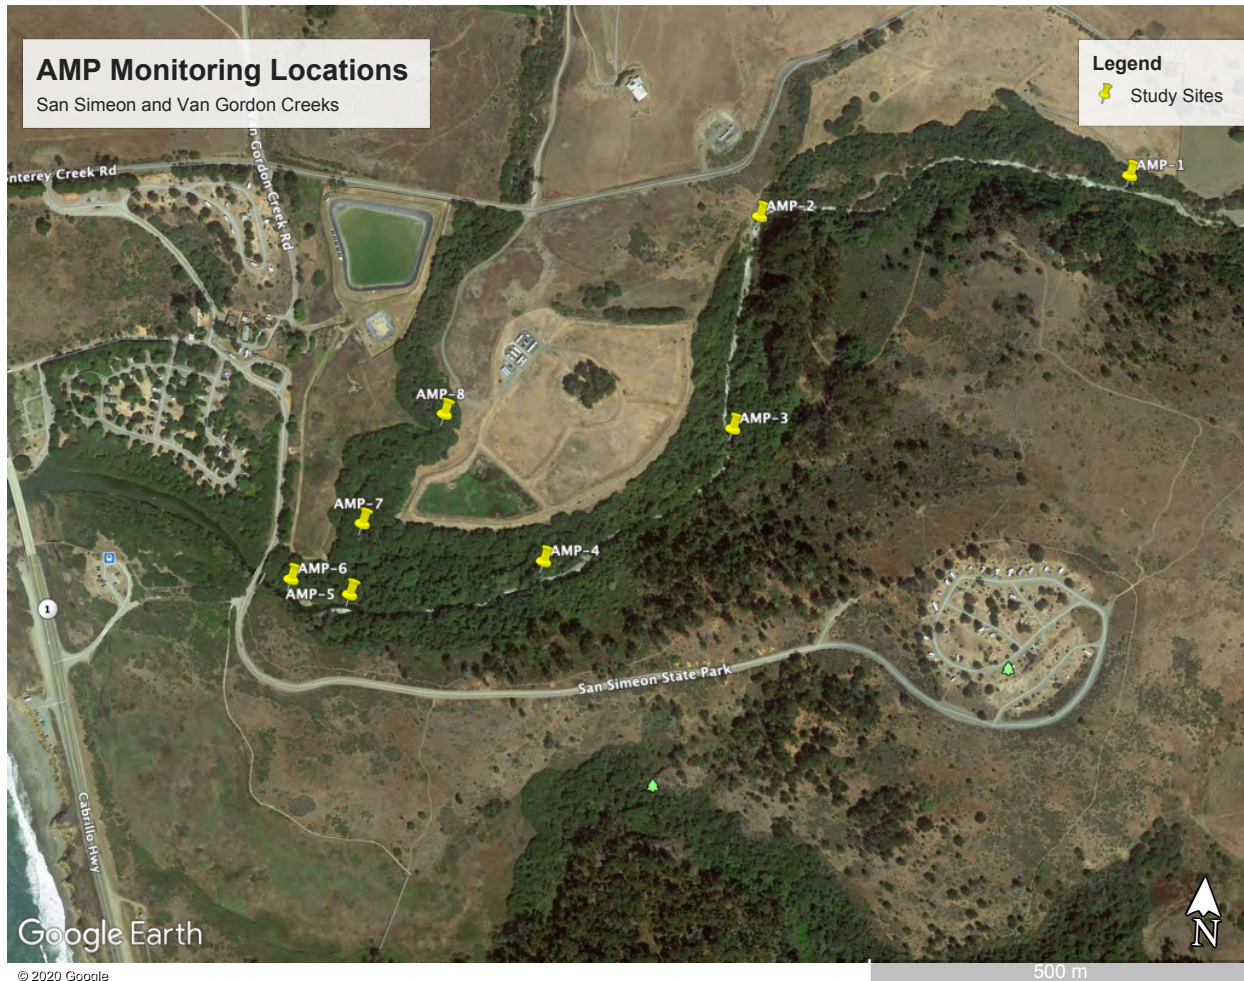
Figure 2. AMP monitoring survey site locations.

Per methods described in the AMP, four biological surveys were conducted at seven survey sites to collect habitat, hydrological, water quality, and species information (Figure 2).

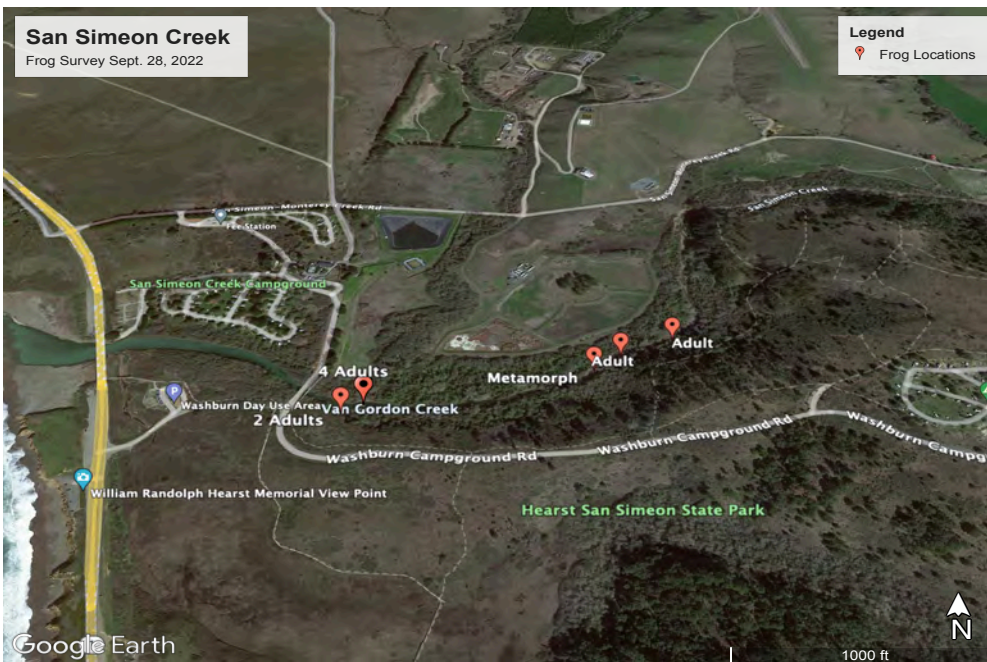
Figure 4. CRLF survey September 28, 2022.

One fall California red-legged frog survey was completed in 2022. The September 28, 2022, nighttime survey was from 19:30 to 21:05. The moon phase was 14%, the air temperature was 57 degrees Fahrenheit, the water temperature was 62 degrees Fahrenheit, the humidity was 91%, and the wind was from the north-northwest at three mph. The survey conditions were clear and calm. The average depth was 10 inches, and the maximum depth was approximately 2.5 feet. Eleven small adults or subadults and one metamorph CRLF were observed (Figure 4).
