## A. GEOLOGY AND SOILS

This section was prepared by Cleath and Associates, and includes an analysis of geologic and soils hazards including landslides and slope stability; seismic induced landslides and rock falls, fault displacement, ground shaking and liquefaction; mineral hazards; and expansive soils. Published geologic reports, aerial photographs, the *Soil Survey of San Luis Obispo County (Coastal Part)*, and bluff retreat studies were reviewed prior to assessing these hazards. A geologic site reconnaissance was conducted, the distance to known faults was determined, and the information regarding the geologic subgrade were all used to evaluate seismic hazards.

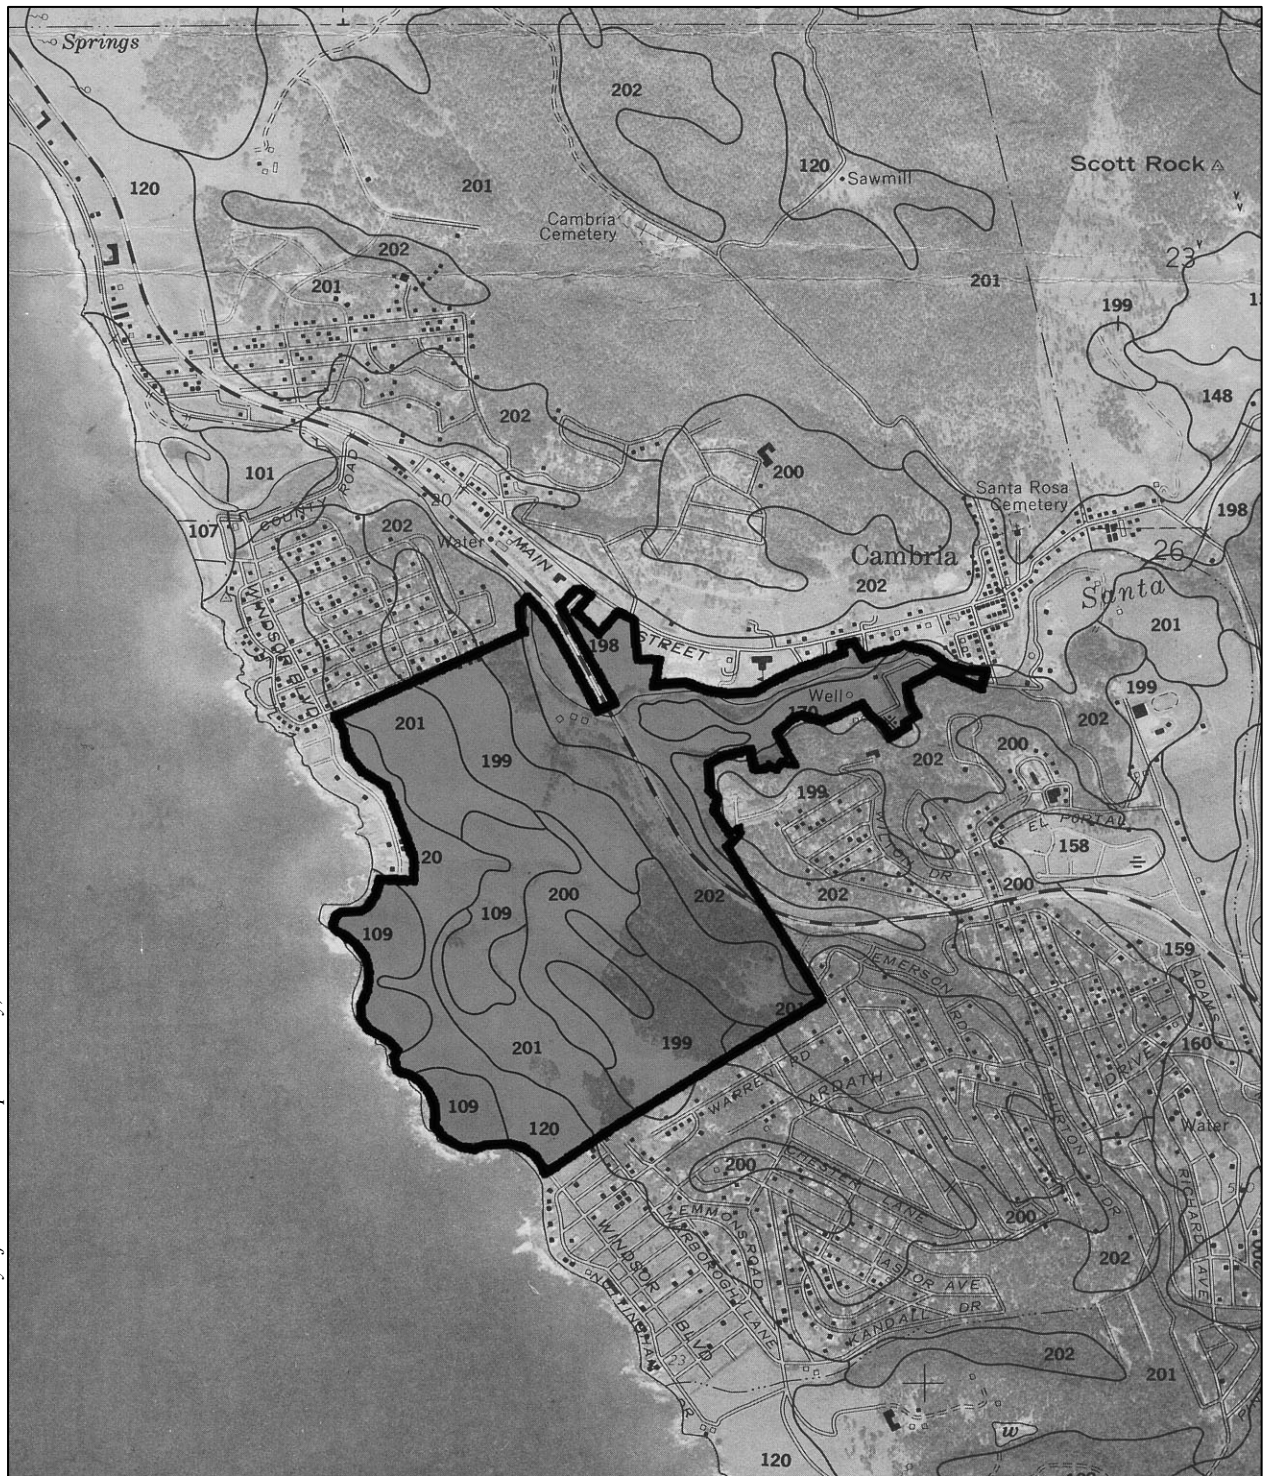
Source: Soil Survey of San Luis Obispo County, Coastal Part – Sheet 4

**SOIL KEY**

- 109** Briones-Pismo loamy sands, 9 to 30% slopes
- 120** Concepcion loam, 2 to 5% slopes
- 170** Marimel silty clay loam, drained
- 198** Salinas silty clay loam, 2 to 9% slopes
- 199** San Simeon sandy loam, 2 to 9% slopes
- 200** San Simeon sandy loam, 9 to 15% slopes
- 201** San Simeon sandy loam, 15 to 30% slopes
- 202** San Simeon sandy loam, 30 to 50% slopes

- *Briones-Pismo loamy sands (109)* are found on the moderate slopes along most of the coastal bluffs and inland of the coast about 1,000 to 2,000 feet. These are shallow to moderately deep, somewhat excessively drained, and rapidly permeable soils that formed in residual material weathered from soft sandstone. The hazard of water erosion is moderate or high, and the hazard of soil blowing is high.

- *Concepcion loam (120)* is found in the gentle slopes above the bluff and several hundred feet inland of the bluff. It is generally very deep, moderately well drained, very slow permeable soil formed in old alluvium weathered from sedimentary rocks. The hazard from water erosion is slight. Because of the high clay content, the soil has a high shrink-swell potential in the subsoil.

- *San Simeon sandy loam (201)* is found in the steeper sloping areas between the coastal terrace and the upland areas of the site, and in the moderately to steeply sloping upland areas in the southeast corner of the site. The soil is moderately deep, moderately well drained, and the permeability is very slow. It formed in residual material weathered from sandstone. Surface runoff is rapid, and the hazard of water erosion is high. The shrink-swell potential of the subsoil is high.

- *San Simeon sandy loam (200)* is located in the slightly upland areas of the site in areas of gentle to moderate slopes. The soil is moderately deep, moderately well drained, and the permeability is very slow. It formed in residual material weathered from sandstone. Surface runoff is medium, and the hazard of water erosion is moderate. The shrink-swell potential of the subsoil is high.

- *San Simeon sandy loam (199)* is located in the upland, gently sloping areas of the site. The soil is moderately deep, moderately well drained, and the permeability is very slow. It formed in residual material weathered from sandstone. Surface runoff is slow or medium, and the hazard of water erosion is slight or moderate. The shrink-swell potential of the subsoil is high. There is a stand of Monterey pines on this soil in the southeast portion of the site, and because of the limited rooting depth between twenty and forty inches, wind damage to trees can be a problem on exposed locations.

- *San Simeon sandy loam (202)* is found in the steeply northeast sloping portions of the site. The area extends from the north to the southeast corner, in the vicinity of Highway 1. The soil is moderately deep, moderately well drained, and the permeability is very slow. It formed in residual material weathered from sandstone. Surface runoff is rapid, and the hazard of water erosion is high. The shrink-swell potential of the subsoil is high. Because of the loamy surface layer and clayey subsoil, this soil is subject to gully erosion. The soil is mostly covered with Monterey pine and understory vegetation. Because of the limited rooting depth between twenty and forty inches, wind damage to trees can be a problem on exposed locations.

- *Salinas silty clay loam (198)* is found in the gently to moderately sloping northeast corner of the site. Highway 1 crosses over this soil. The soil is very deep, well drained, and the permeability is moderately slow. It formed in alluvium weathered from sandstone and Franciscan Complex rocks. Surface runoff is slow or medium, and the hazard of water erosion is slight or moderate. The shrink-swell potential is moderate. The effective rooting depth is sixty inches or more.

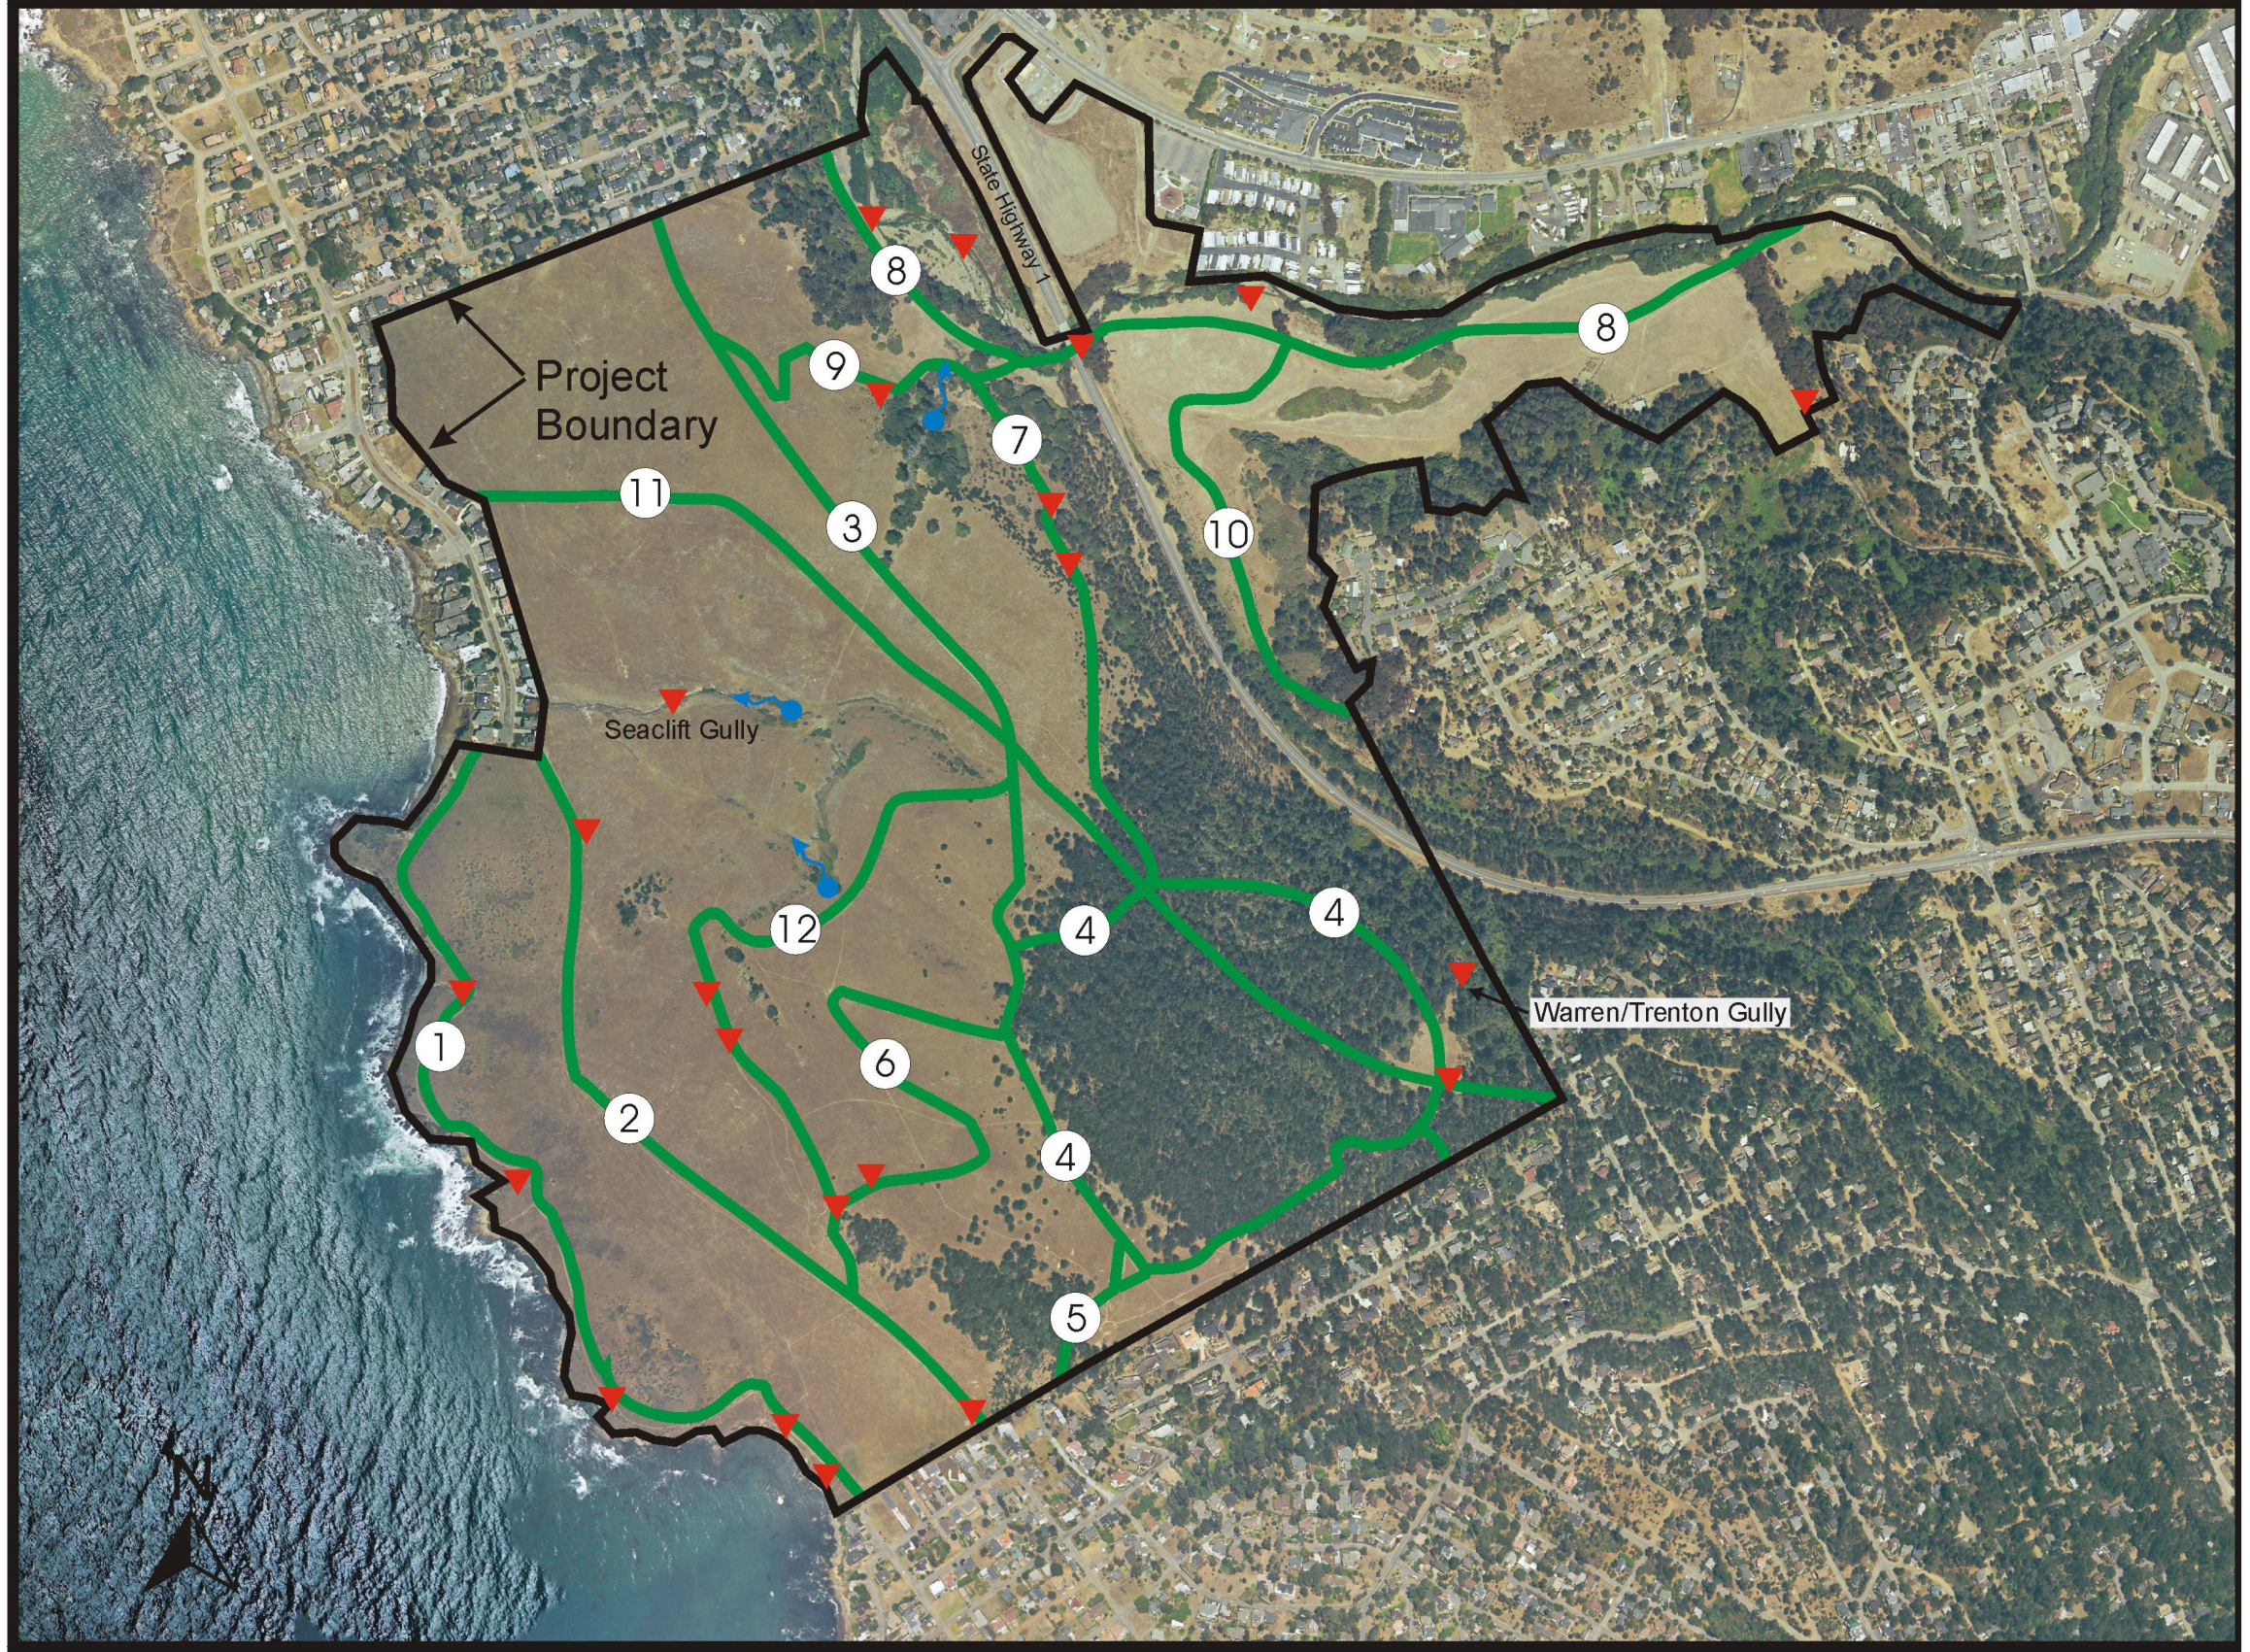
Area of erosion
  - ① Bluff Trail
  - ② Marine Terrace Trail
  - ③ Ridge Trail
  - ④ Forest Loop Trail
  - ⑤ Victoria Lane Trail
  - ⑥ Meander Trail
  - ⑦ Creek to Forest Trail
  - ⑧ Santa Rosa Creek Trail
  - ⑨ Creek to Ridge Trail
  - ⑩ Ramsey Trail
  - ⑪ Wallbridge Trail
  - ⑫ Terrace to Ridge Trail

Base Map: by AirPhoto USA  
Scale: 1 inch = 780 feet

Project improvements near the coastal bluff include a trail system and some soil stabilization work associated with the trail. Erosion and subsequent landward retreat of the coastal bluff will affect the long-range design and location of the bluff trail system. Previous studies addressing bluff retreat on or near the West FRP have been performed. These include onsite study reports by R.T. Wooley (1982) and Donald Asquith (February, 2005); and two bluff retreat studies performed on a private property at the northern cove by Cleath & Associates (1987 and 1998). These reports found that the coastal bluff along the West FRP is eroding.

This retreat rate is based on limited observations over 57 years, and rates may change over short periods of time within small portions of the bluff top. Onsite observations and oblique aerial photos revealed that portions of the bluff face in the northern cove can fail episodically and lose up to a few feet in one event. A network of tensional cracks on the bluff top above the northern cove was also noted, suggesting that the bluff top is unstable.

In addition to bluff retreat caused by direct wave attack, erosion and bluff retreat in the southern cove also occur from stormwater runoff over the bluff top. The runoff flows partly from the upland area of the site, and partly from subdrains and street surfaces at the adjoining residential area. There are two swales that drain this runoff over indentions in the bluff. These bluff indentions extend landward enough to intersect highly folded and weakly resistant shales interbedded in the Cretaceous sandstone bedrock, potentially accelerating bluff retreat in those areas.
