# Cambria Community Services District

Wastewater and Water Department Infrastructure Projects 2015-2018

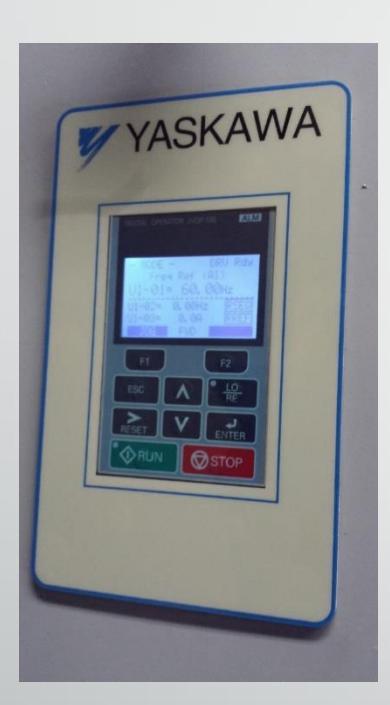
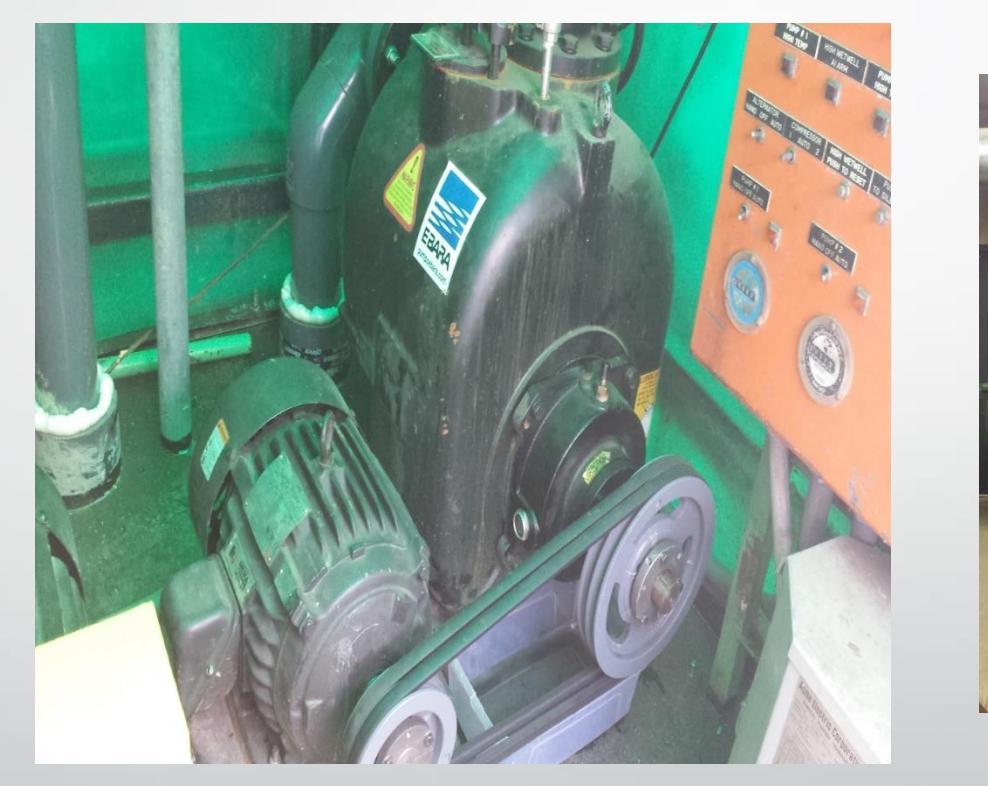
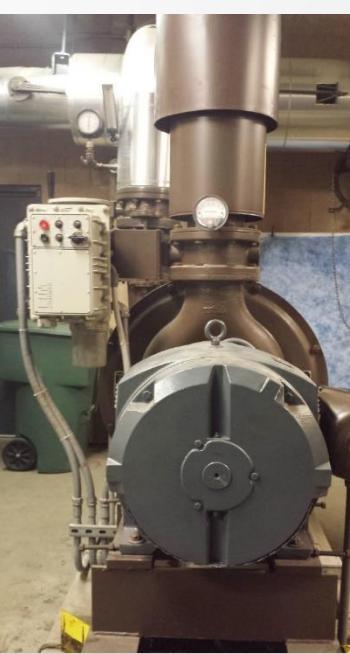
#### Wastewater Treatment & Collection System Plant Improvements March 2015 New controls & new pump assembly on lift station B

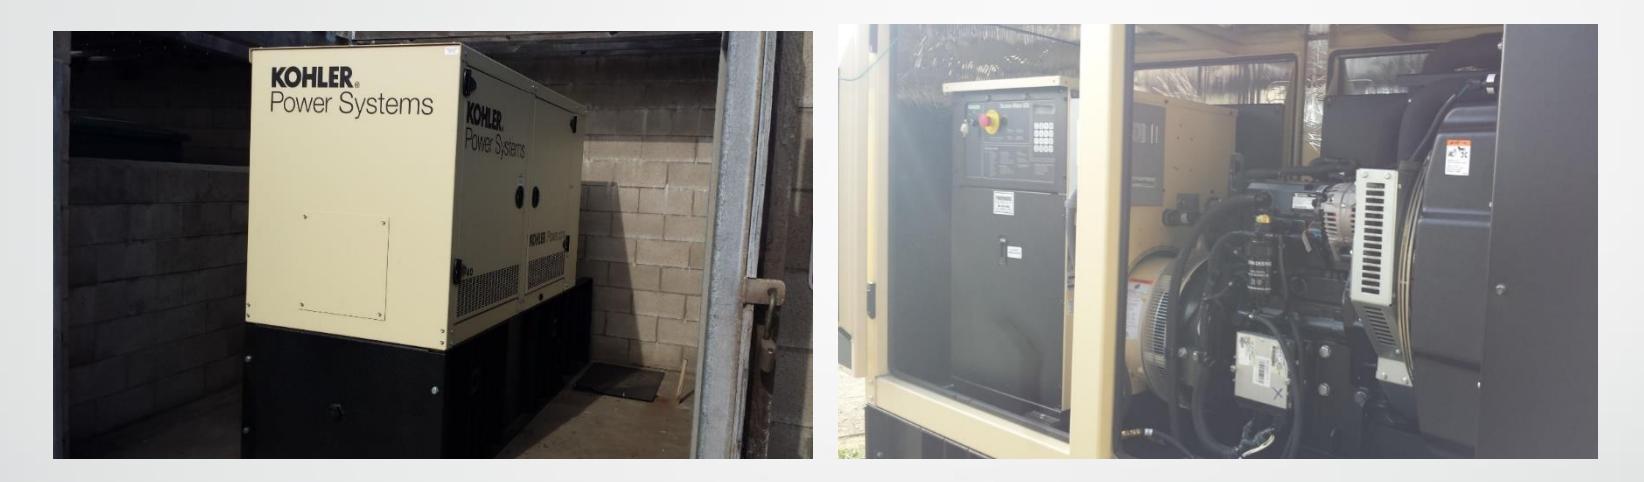
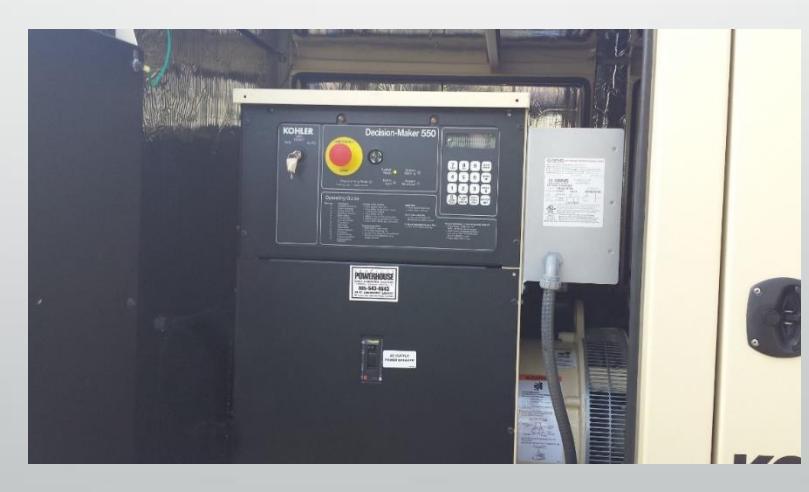
#### Wastewater Treatment & Collection System Plant Improvements April 2015 New generator installed at the Moonstone Beach lift station

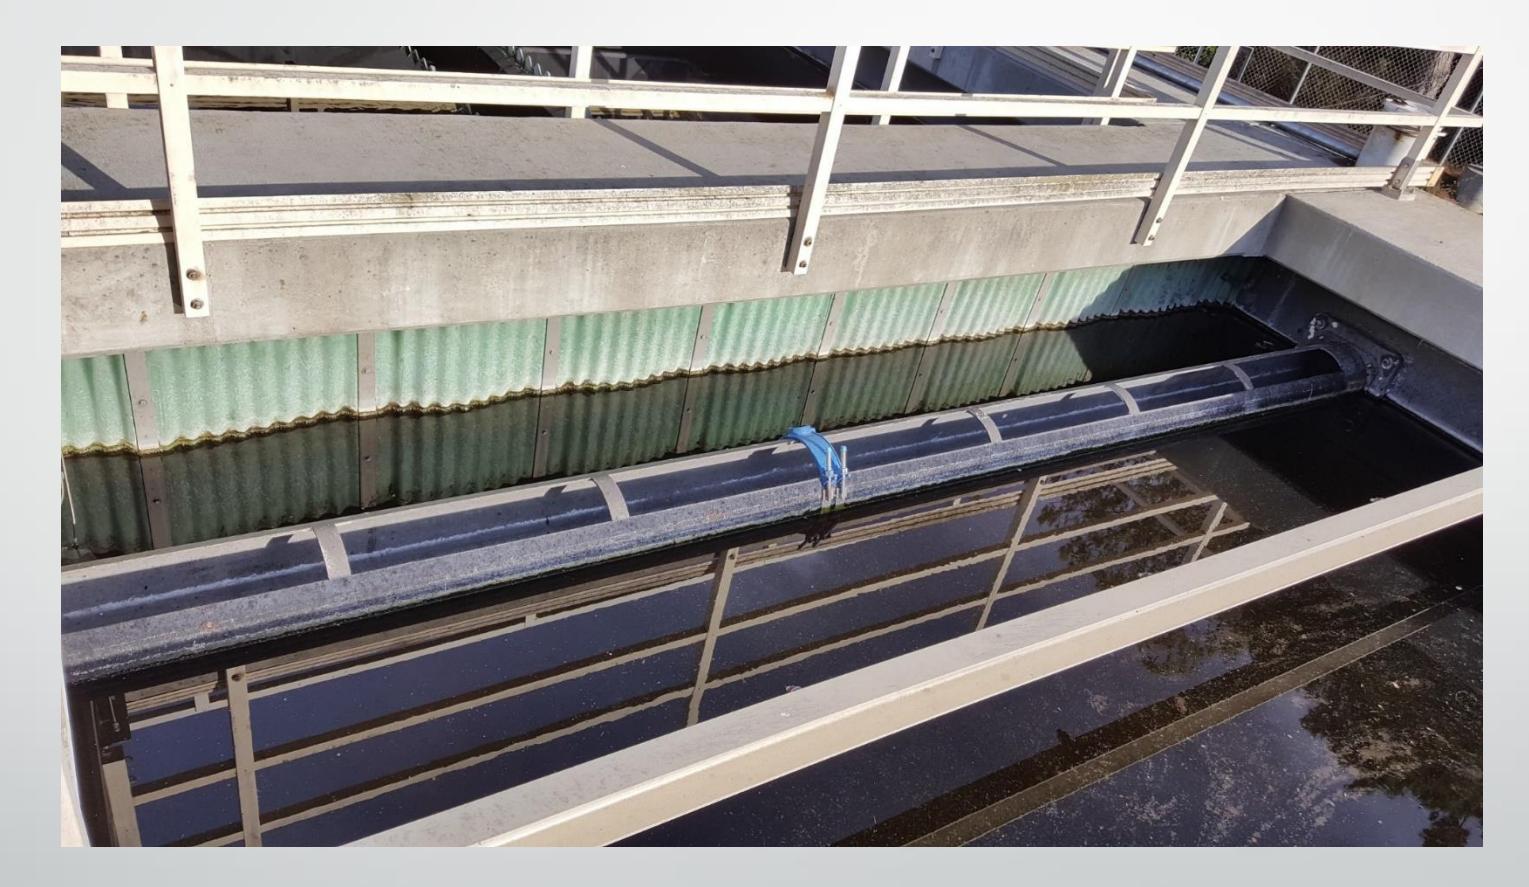
## Wastewater Treatment & Collection System Plant Improvements December 2015 Rebuilt clarifier

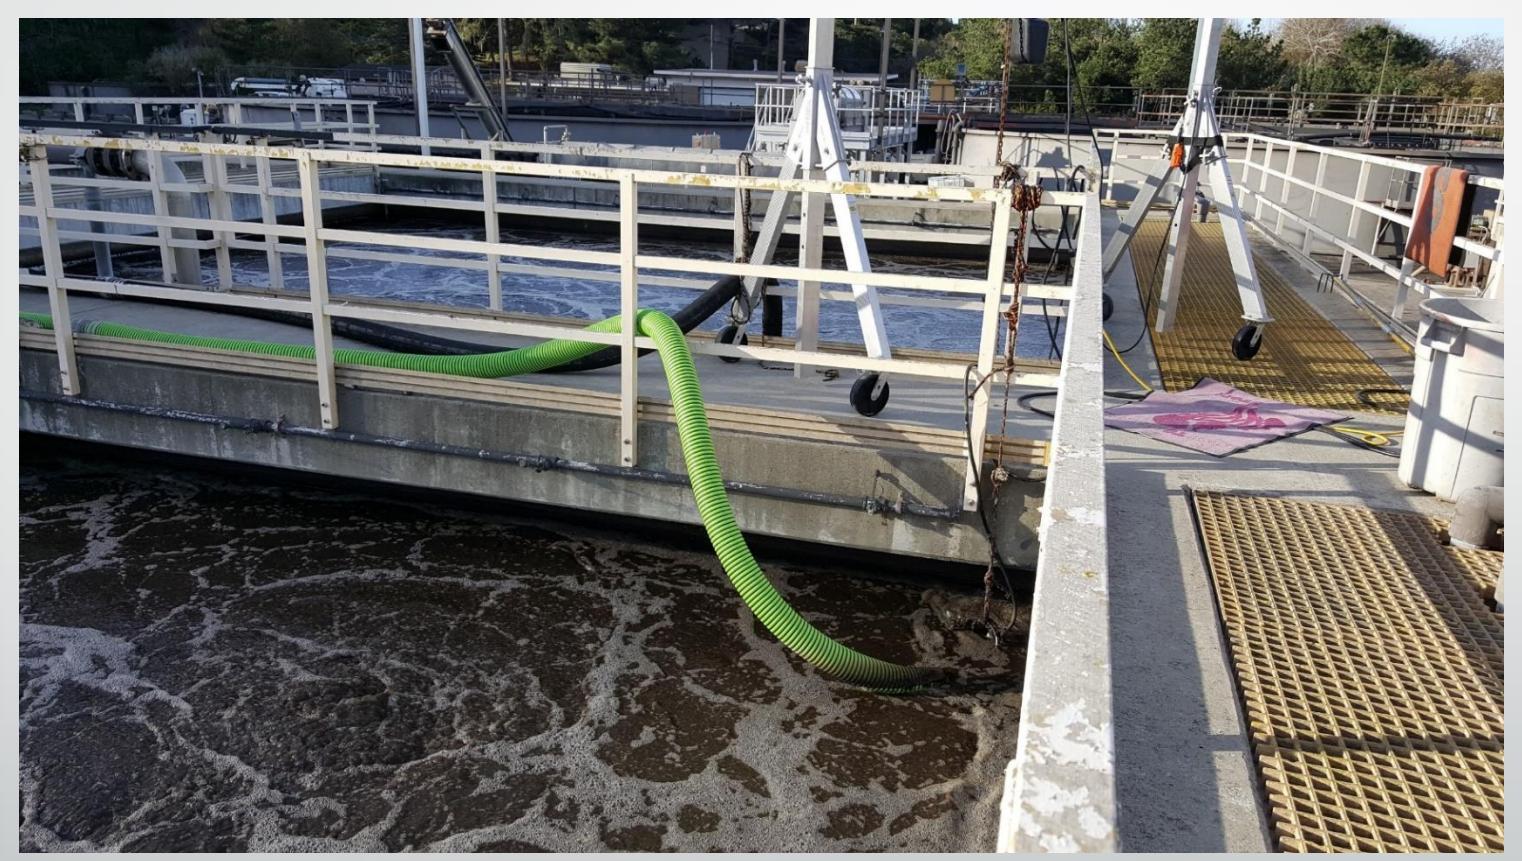
# Incorporated an anoxic zone and reduced nitrate levels from 30-40 P.P.M. to 1.0 P.P.M. or less

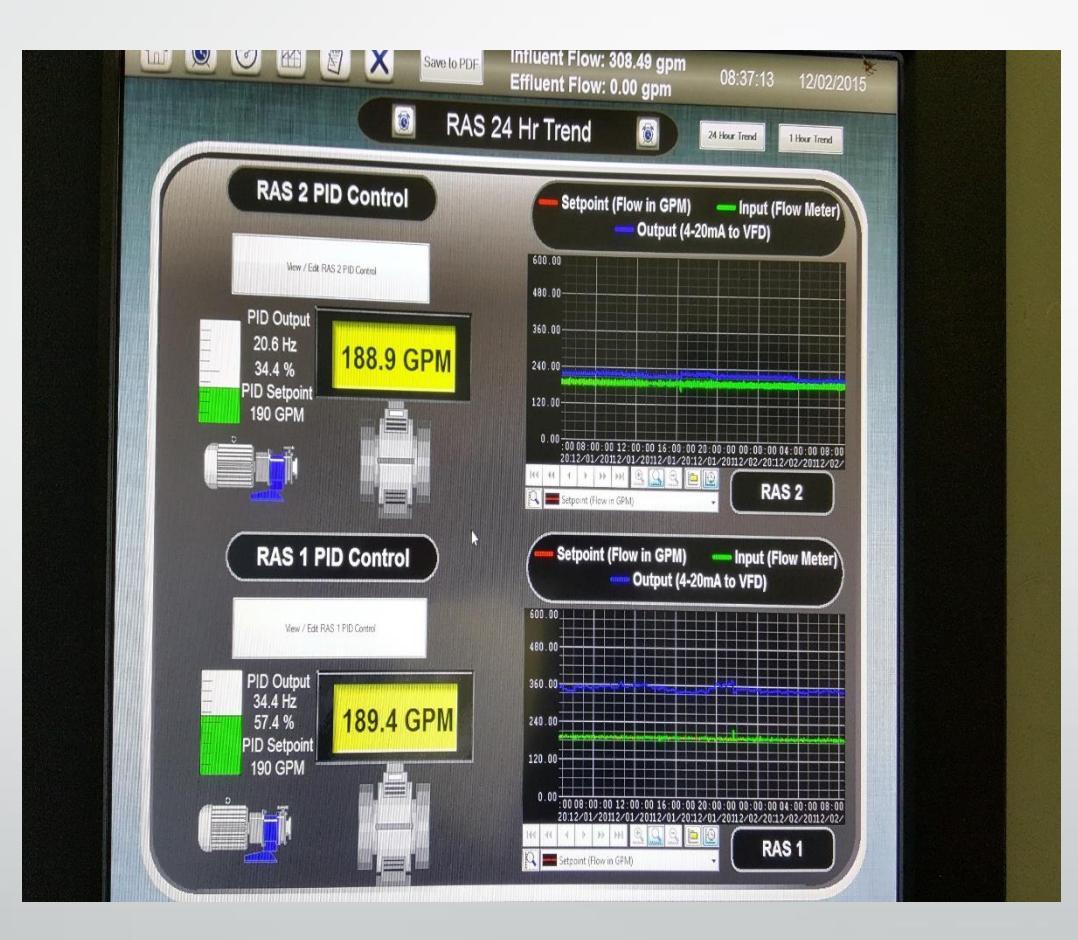
#### Wastewater Treatment & Collection System Plant Improvements December 2015 SCADA controls return activated sludge pumps

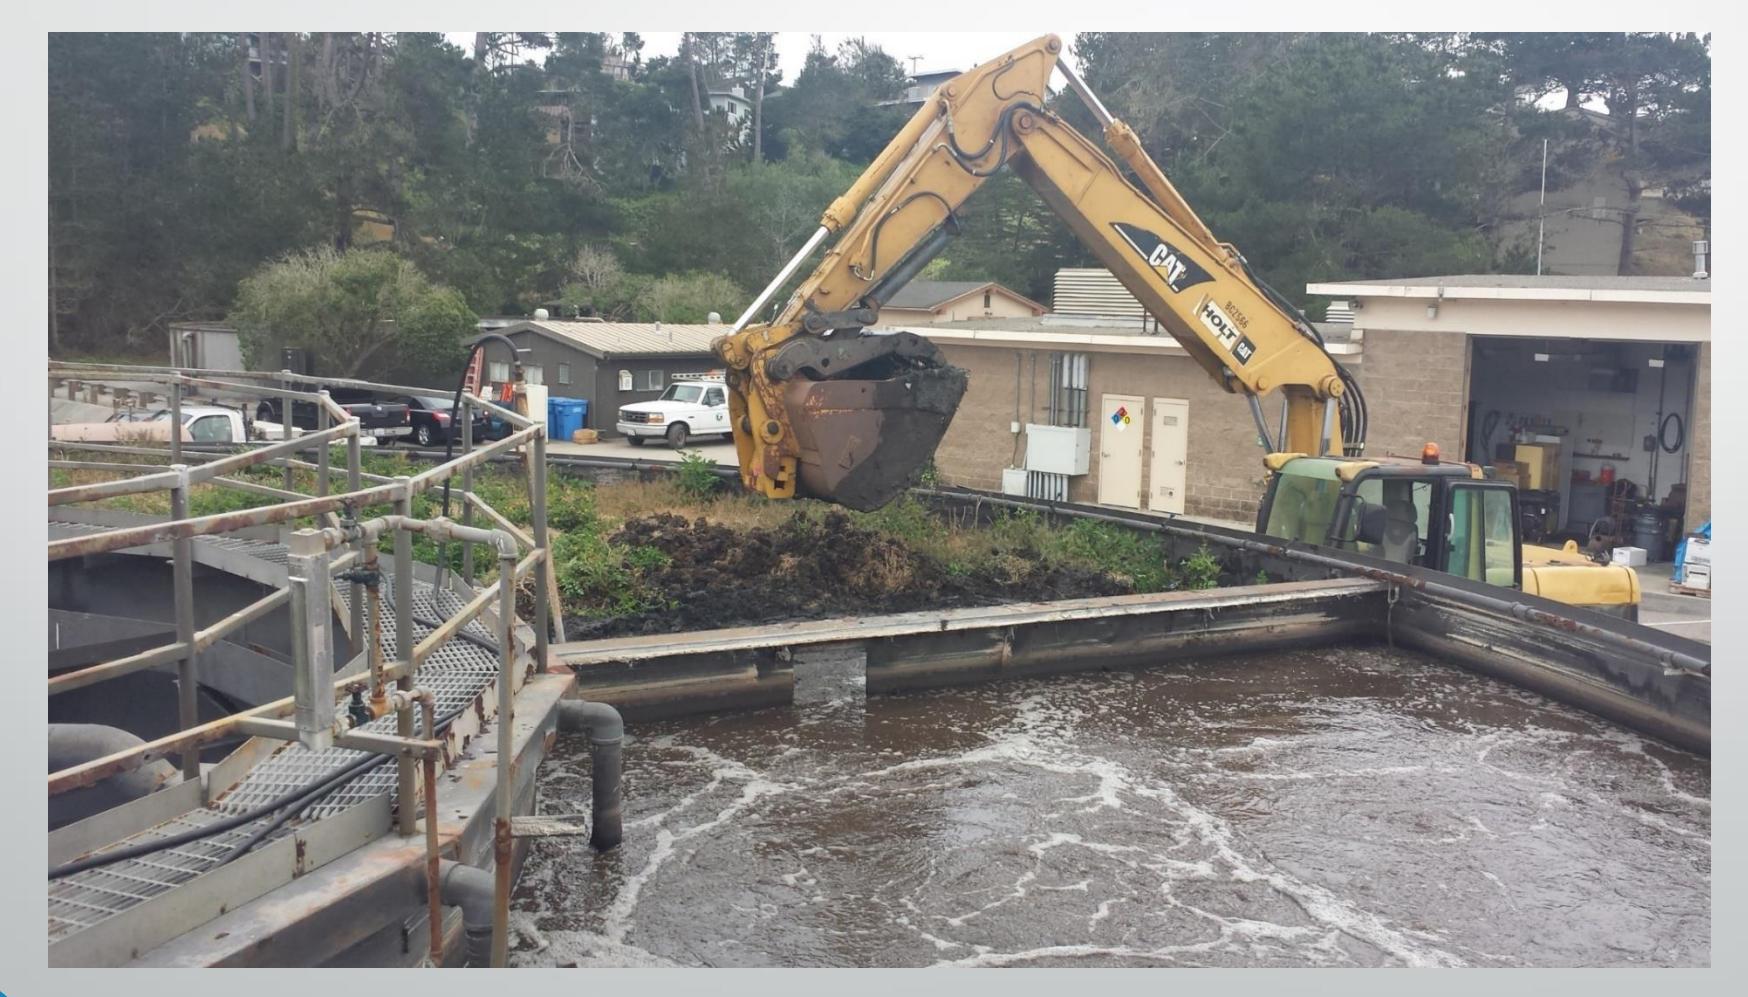
#### Wastewater Treatment & Collection System Plant Improvements December 2015 Put digester into proper operational status. It had never been cleaned

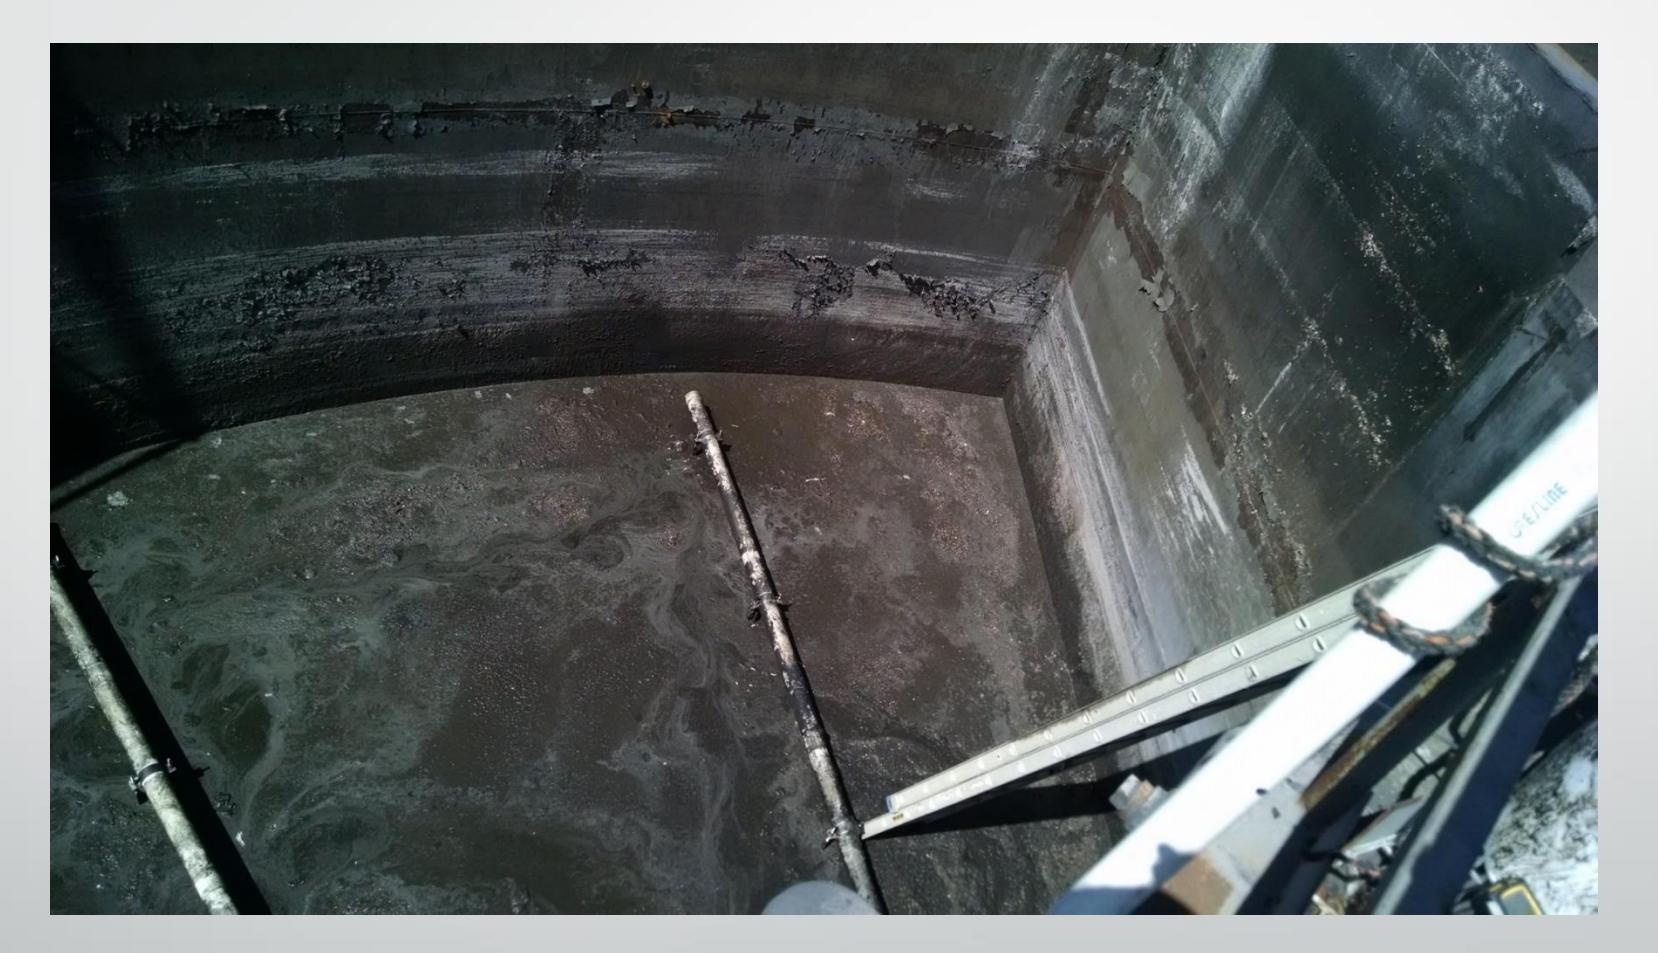
Wastewater Treatment & Collection System Plant Improvements December 2015 Cleaned digester and repaired lines

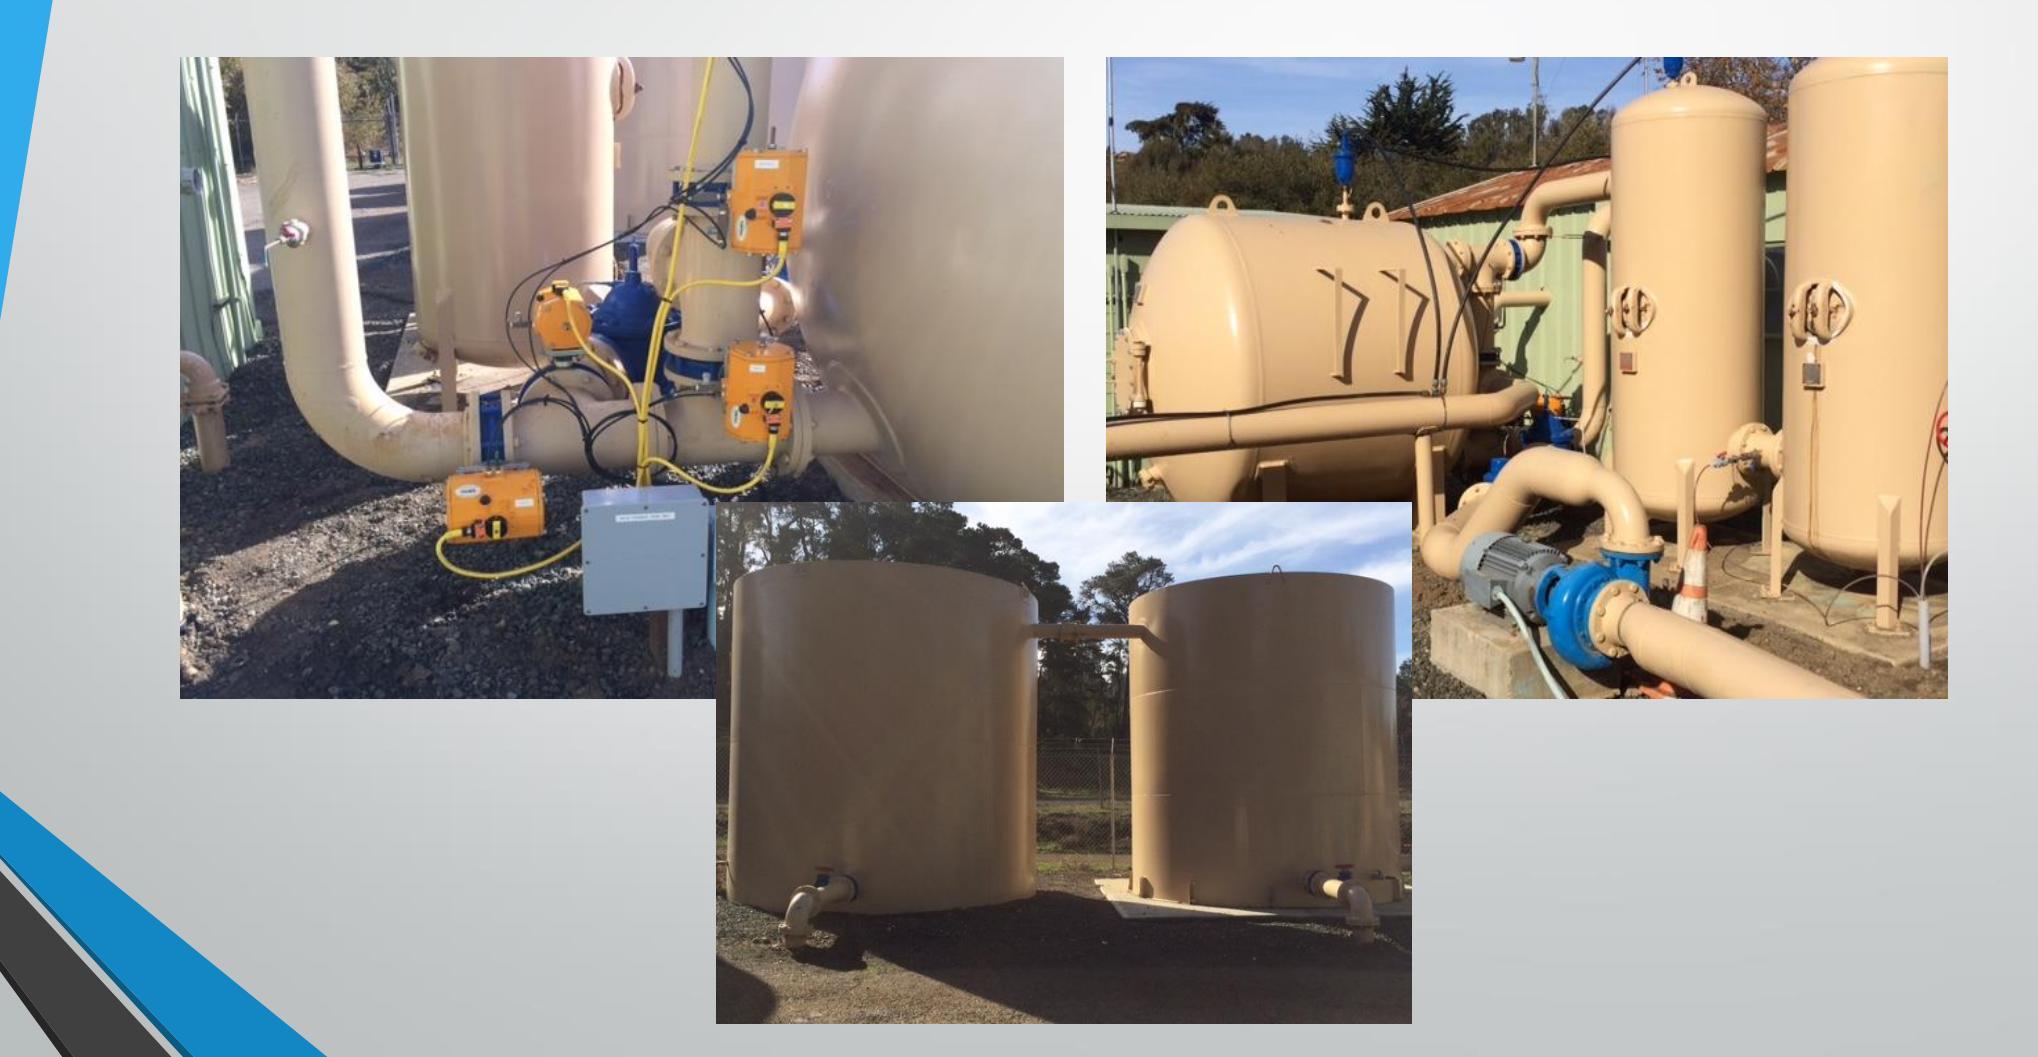
Wastewater Treatment & Collection System Plant Improvements December 2015 Rebuilt filtronics & iron removal water plant completely automated system

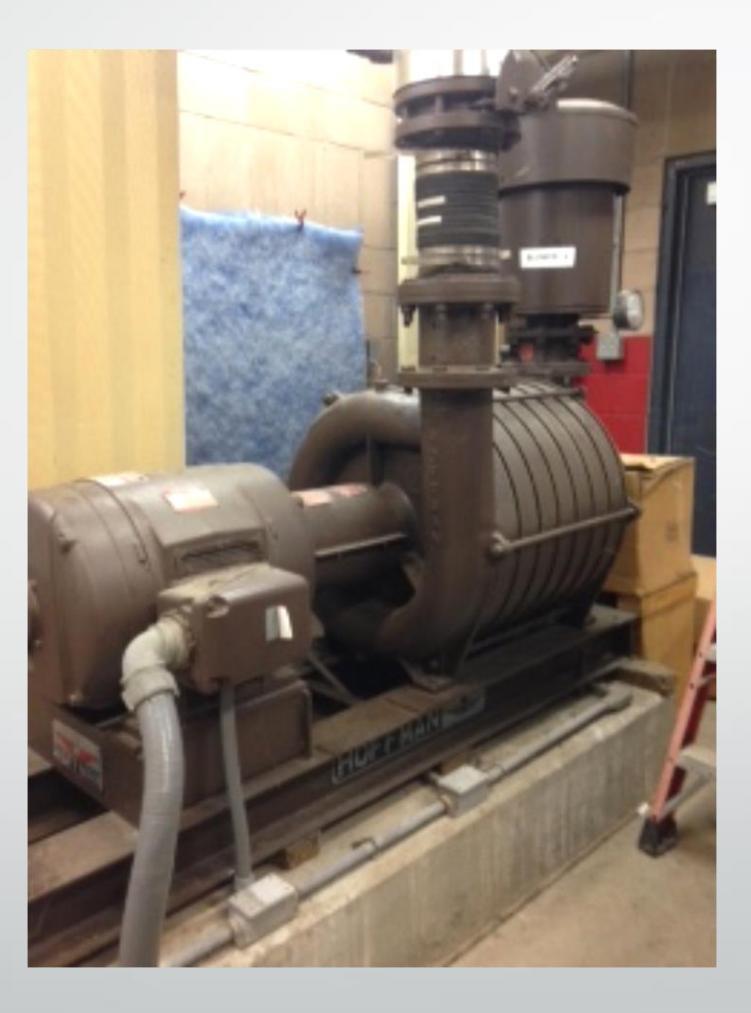
### Wastewater Treatment & Collection System Plant Improvements December 2015 Rebuilt blower

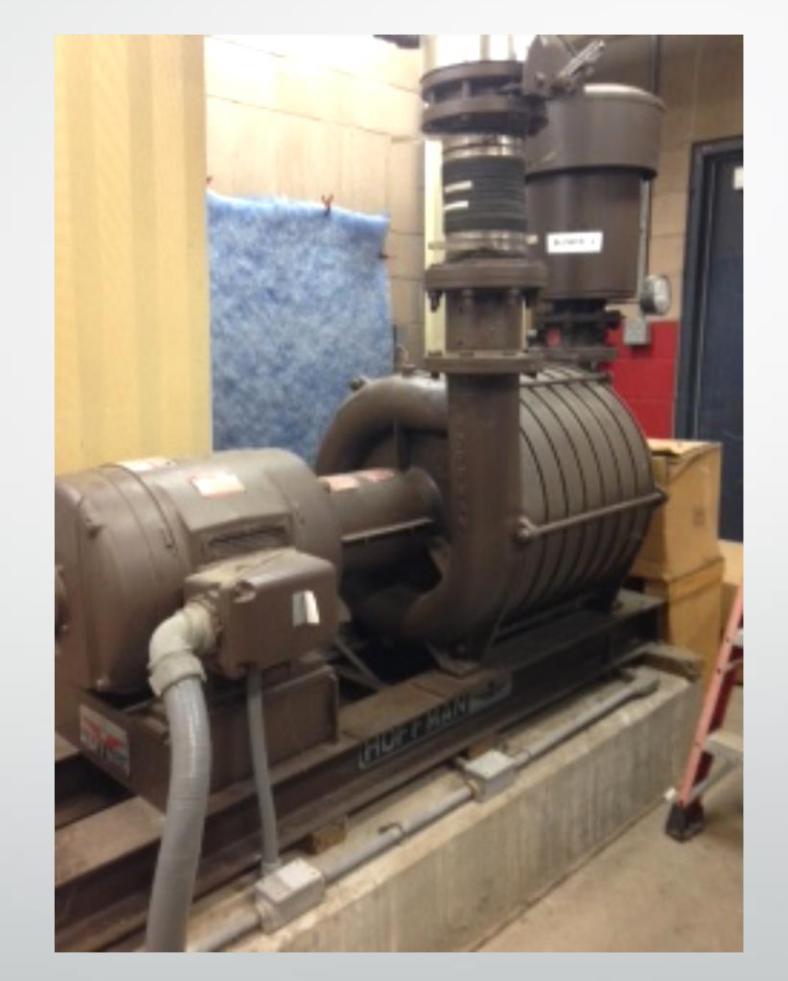
Wastewater Treatment & Collection System Plant Improvements December 2015 Repaired the smaller blower

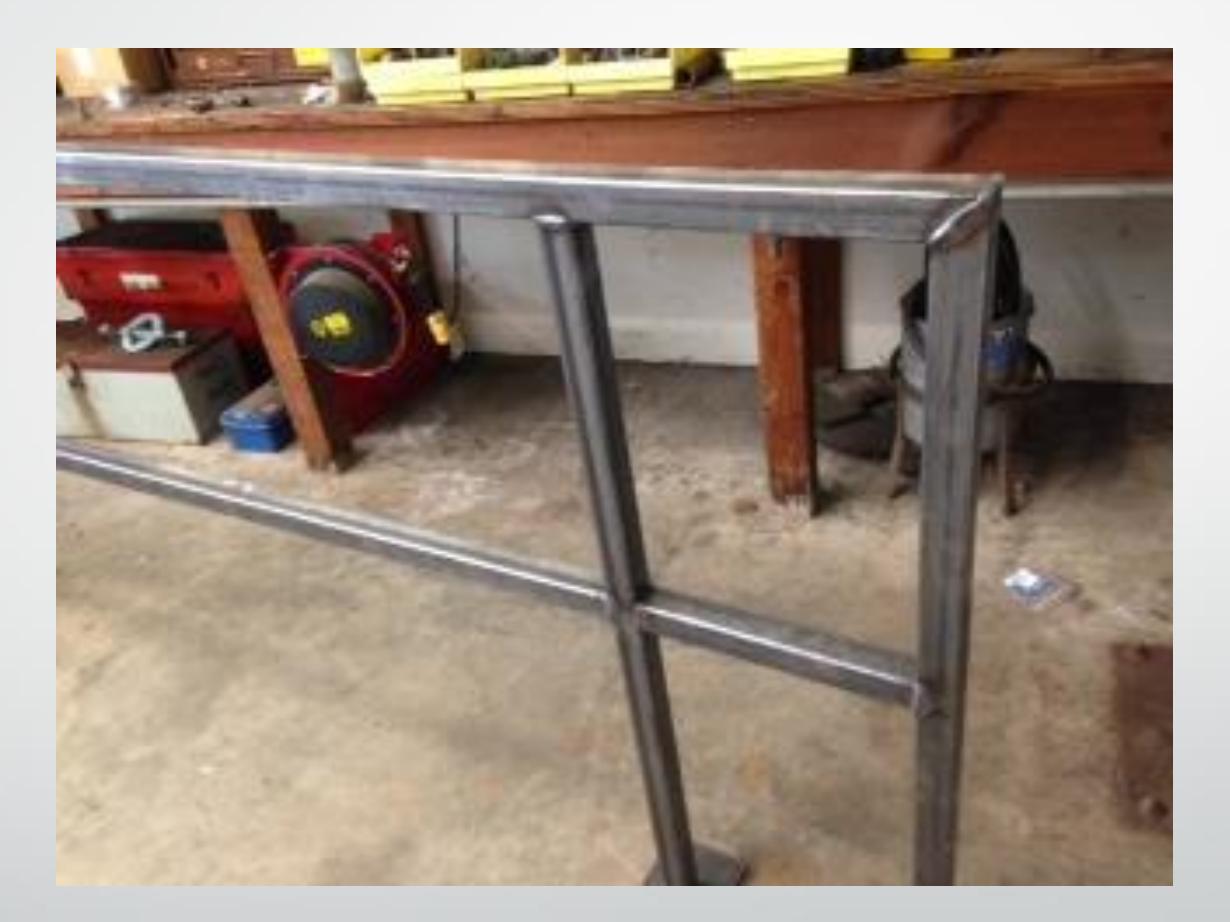
Wastewater Treatment & Collection System Plant Improvements June 2016 Staff replaced the degraded hand rails

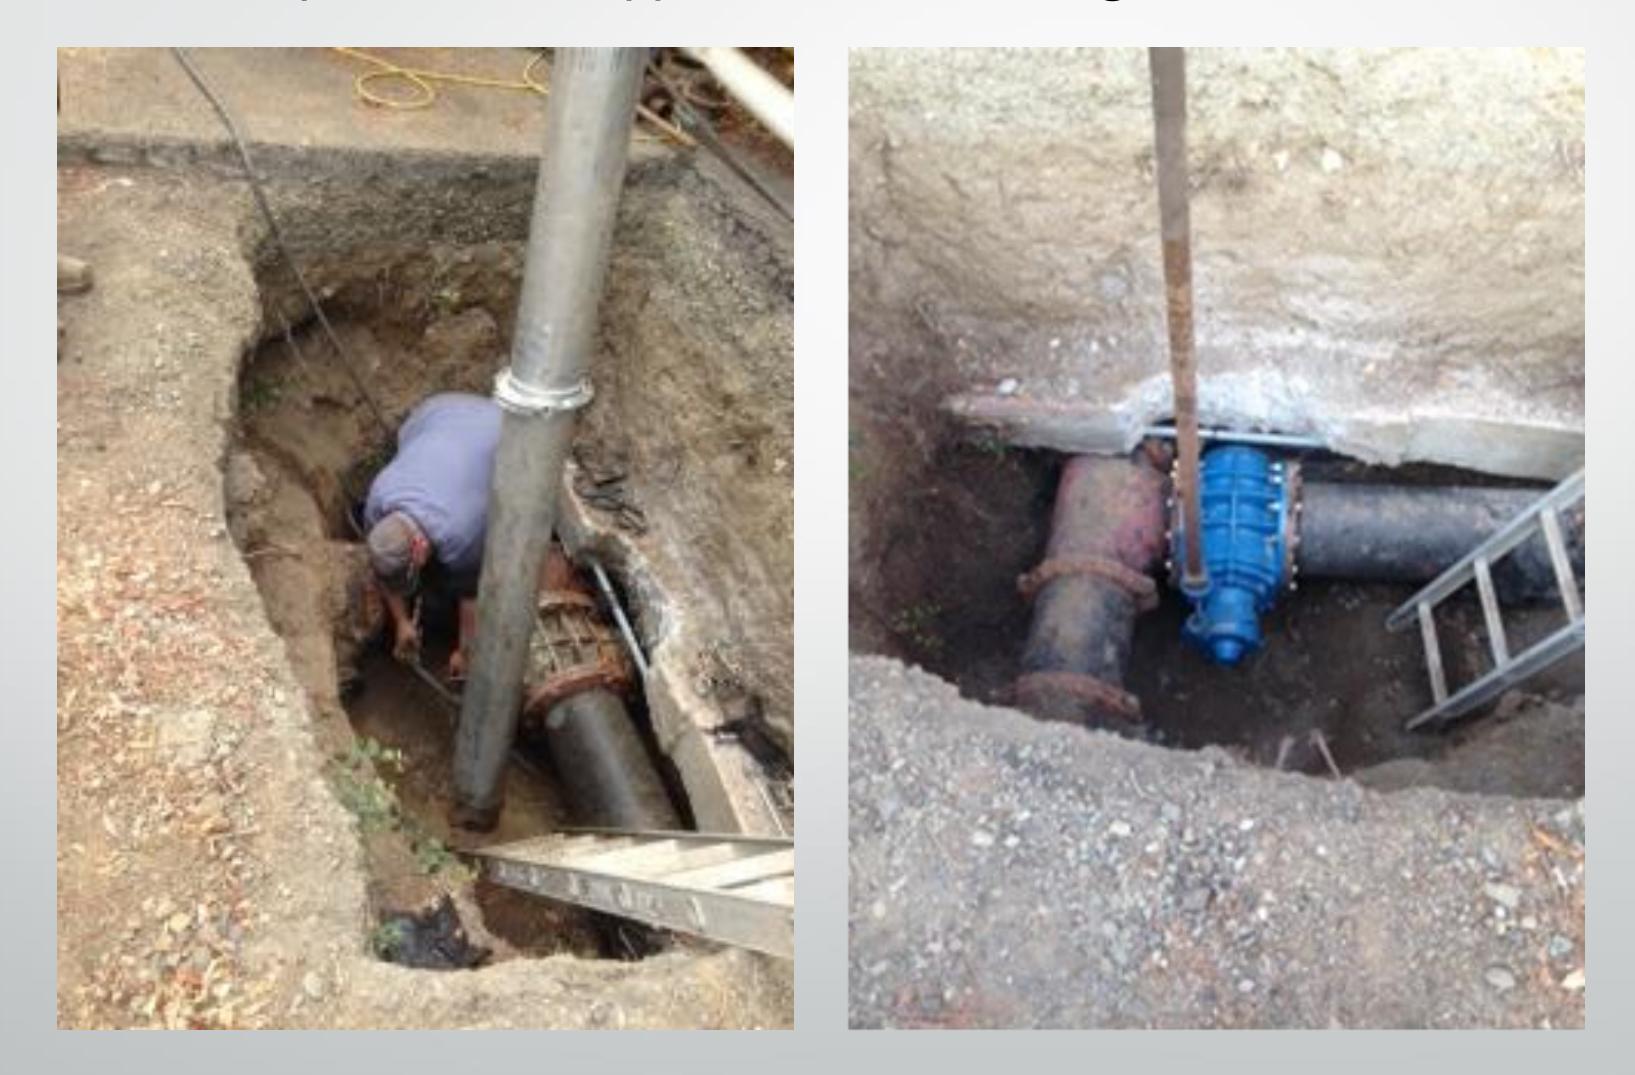
Wastewater Treatment & Collection System Plant Improvements August 2016 Replaced the bypass valve at the grit chamber

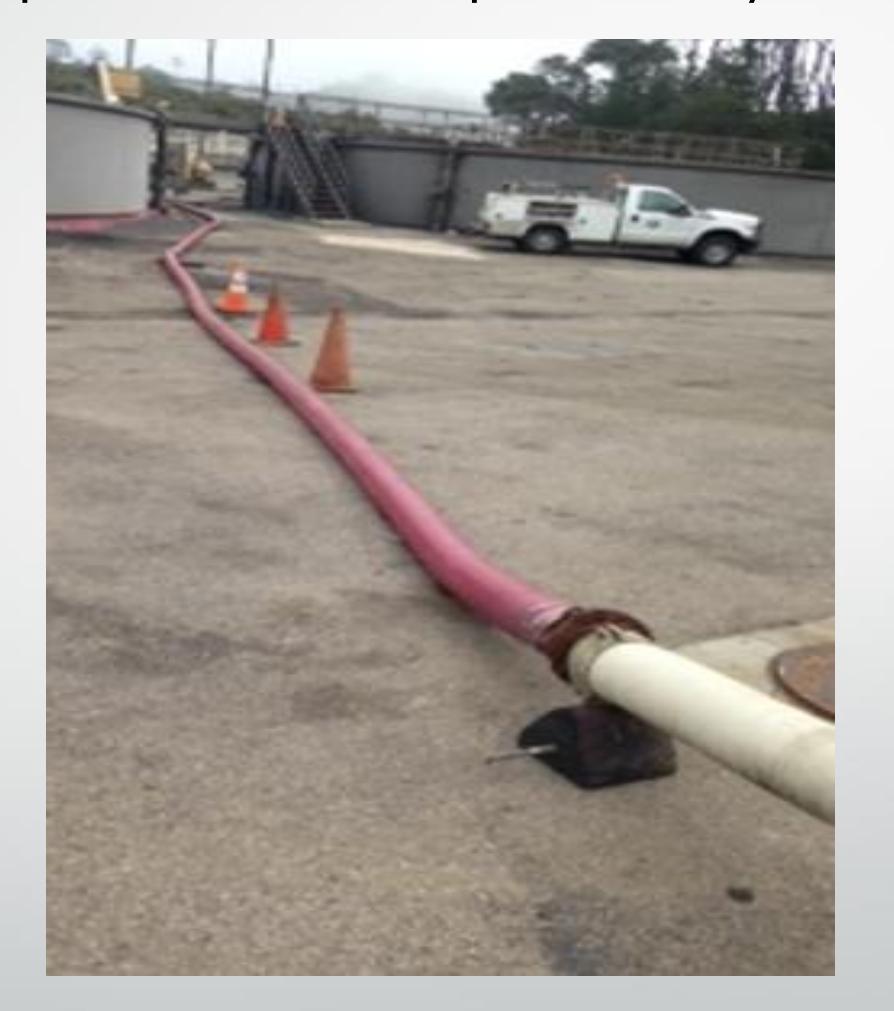
#### Wastewater Treatment & Collection System Plant Improvements August 2016 After the bypass valve was replaced they cleaned the lines

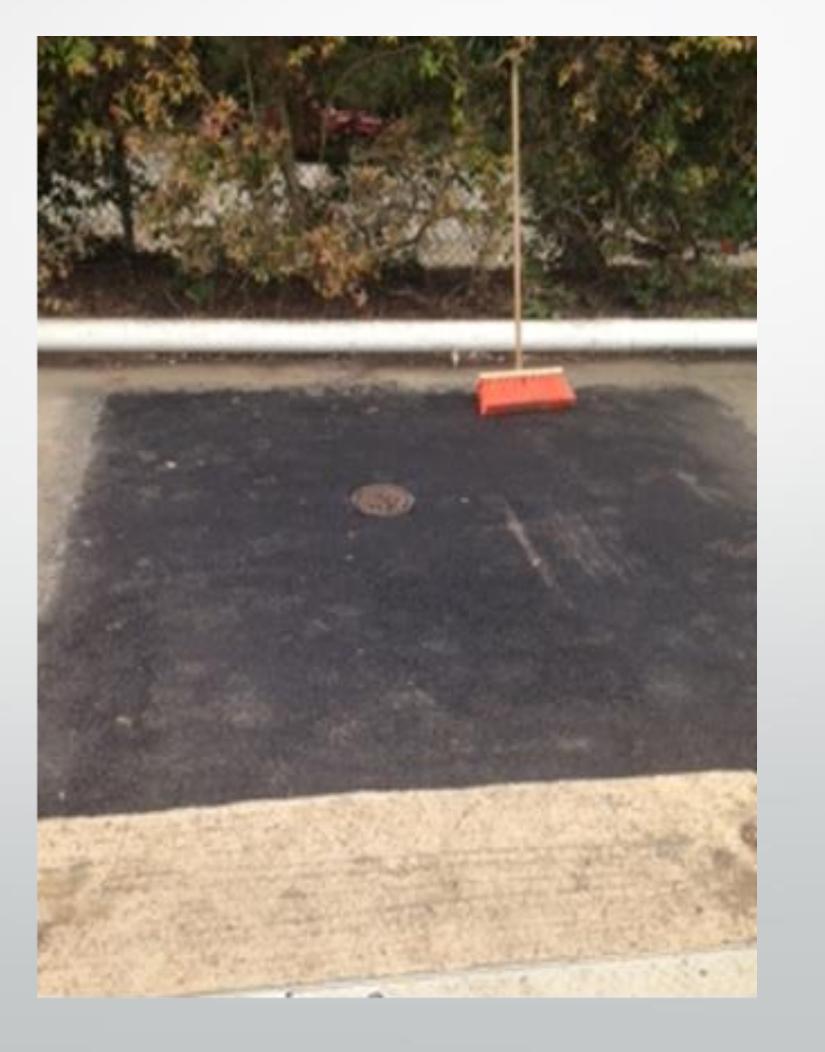
# Wastewater Treatment & Collection System Plant Improvements August 2016 After the bypass valve was replaced, they installed new asphalt. This was a major undertaking

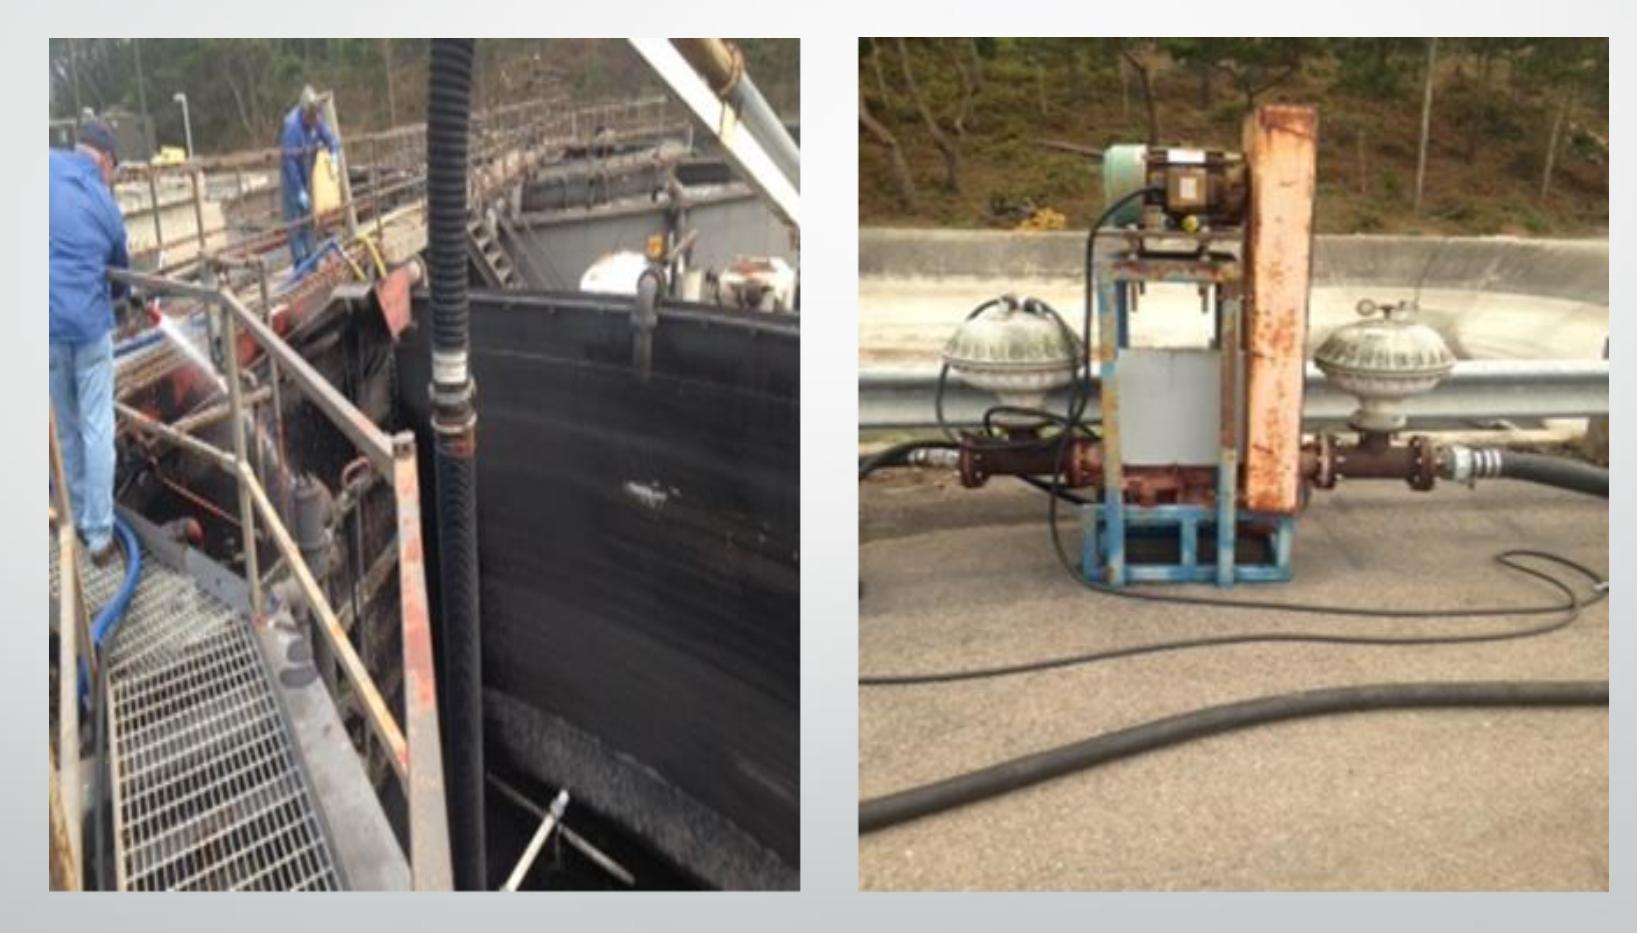
Wastewater Treatment & Collection System Plant Improvements August 2016 The department emptied the flow effluent equalization ponds and pumped sludge to the digesters

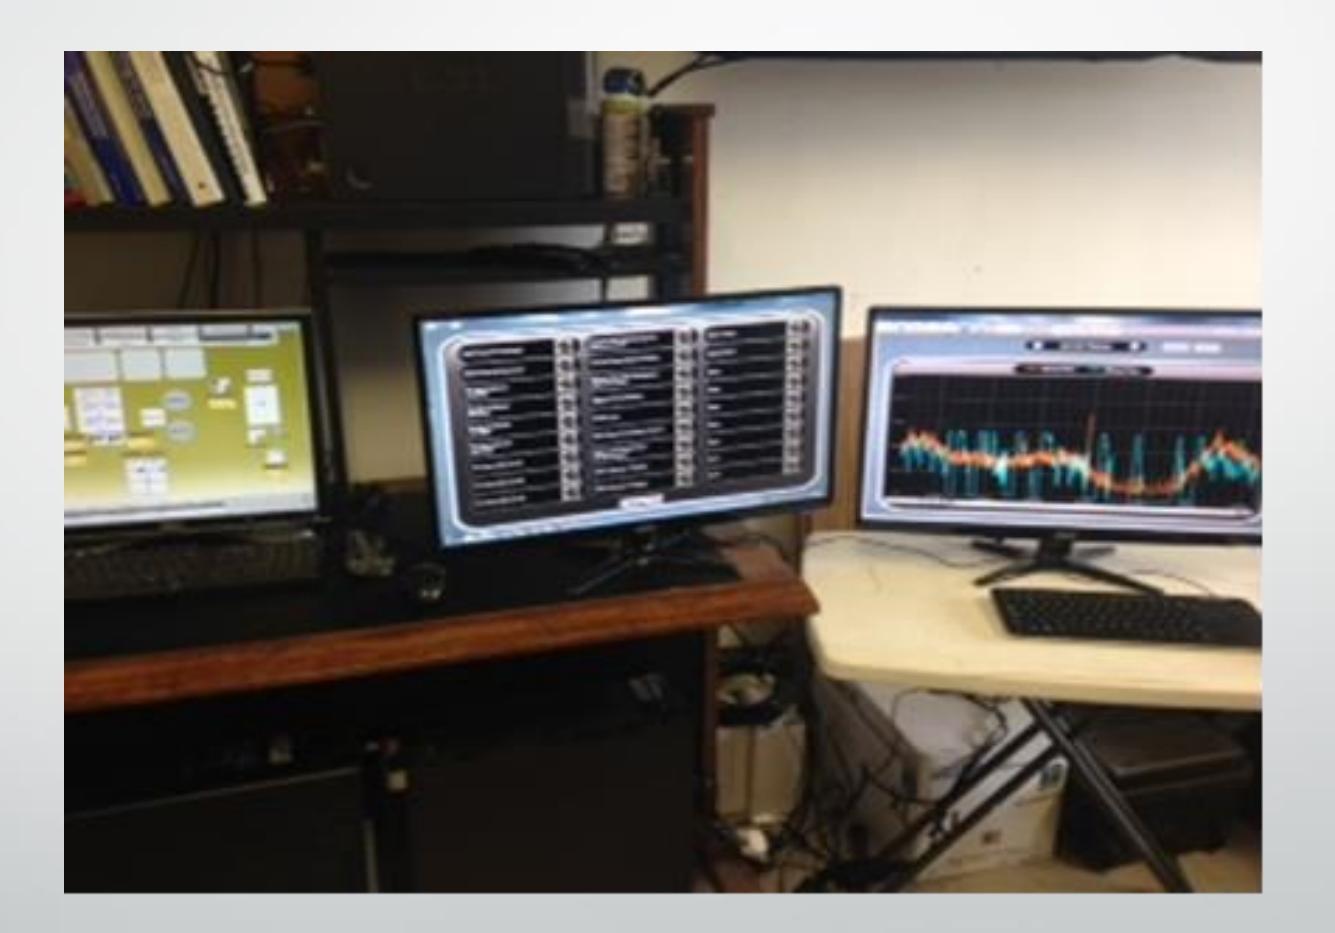
Wastewater Treatment & Collection System Plant Improvements August 2016 Completed SCADA upgrades

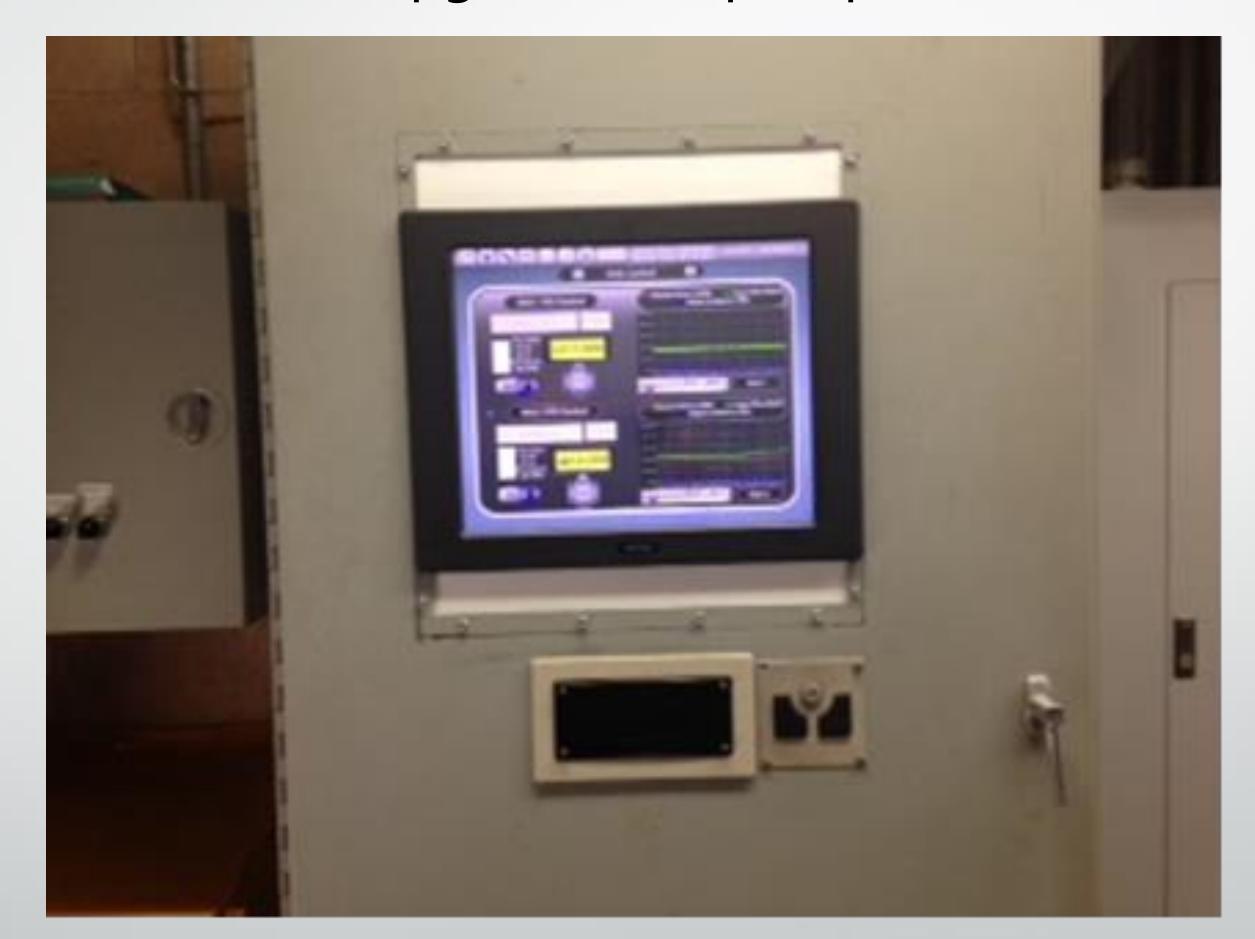
#### Wastewater Treatment & Collection System Plant Improvements August 2016 SCADA upgrades for pump controls
