# Cambria Community Services District

Wastewater and Water Department Infrastructure Projects 2015-2018

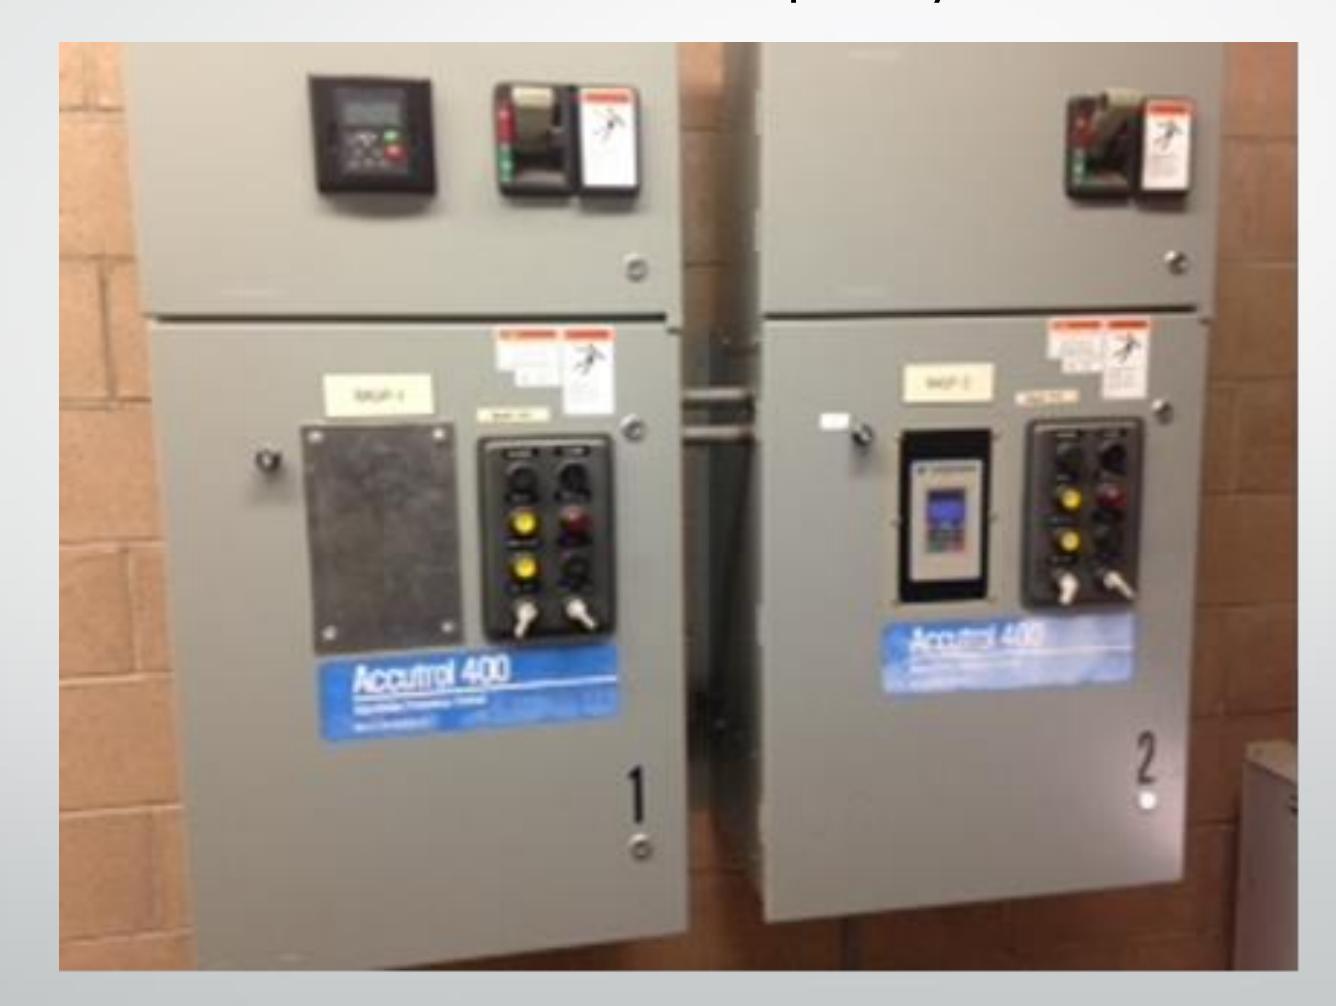
#### Wastewater Treatment & Collection System Plant Improvements August 2016 Installed variable frequency drives

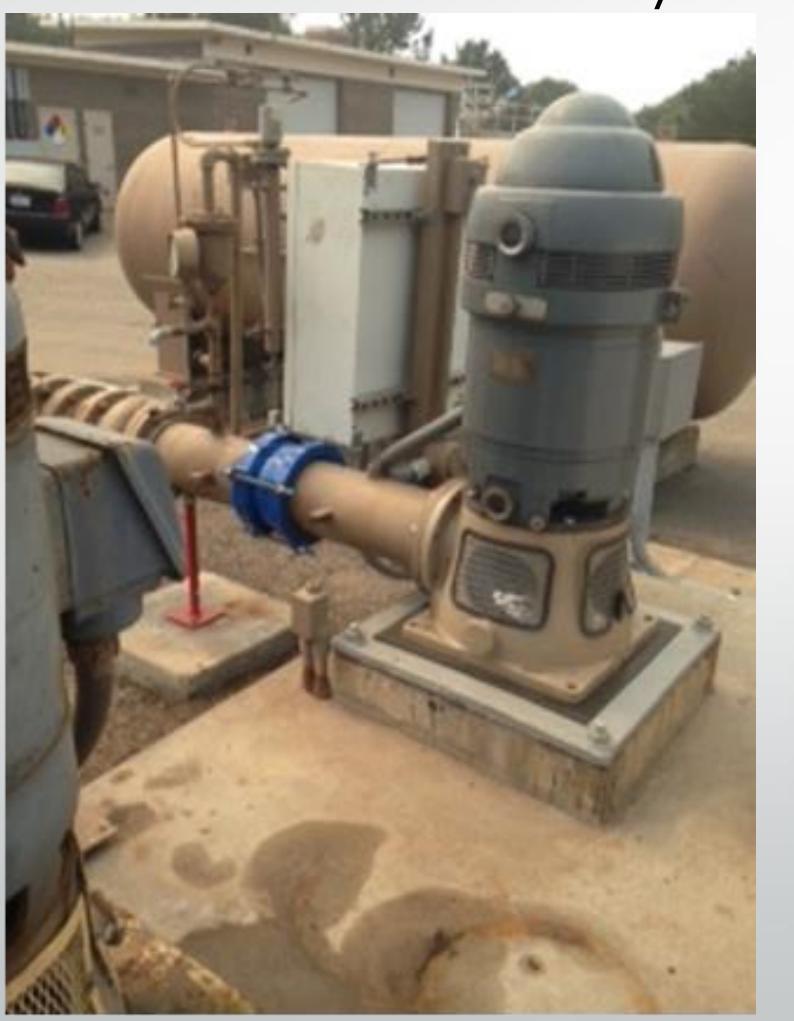
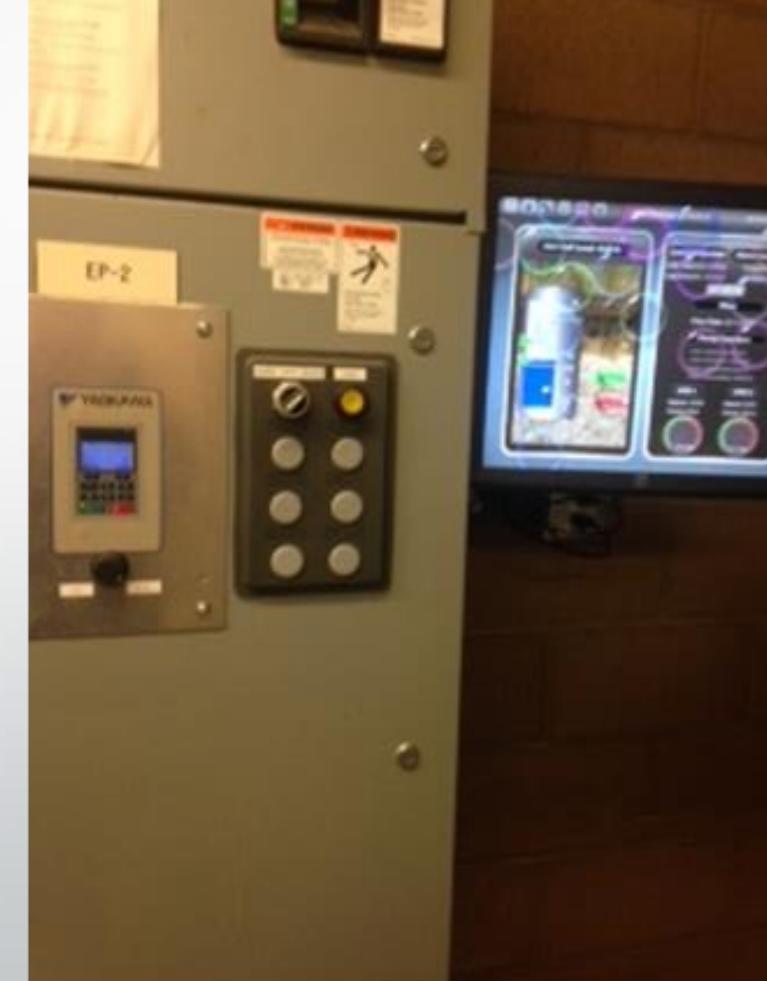
### Wastewater Treatment & Collection System Plant Improvements August 2016 Fixed both effluent pumps and variable frequency drives. Pumps replaced and fully automated

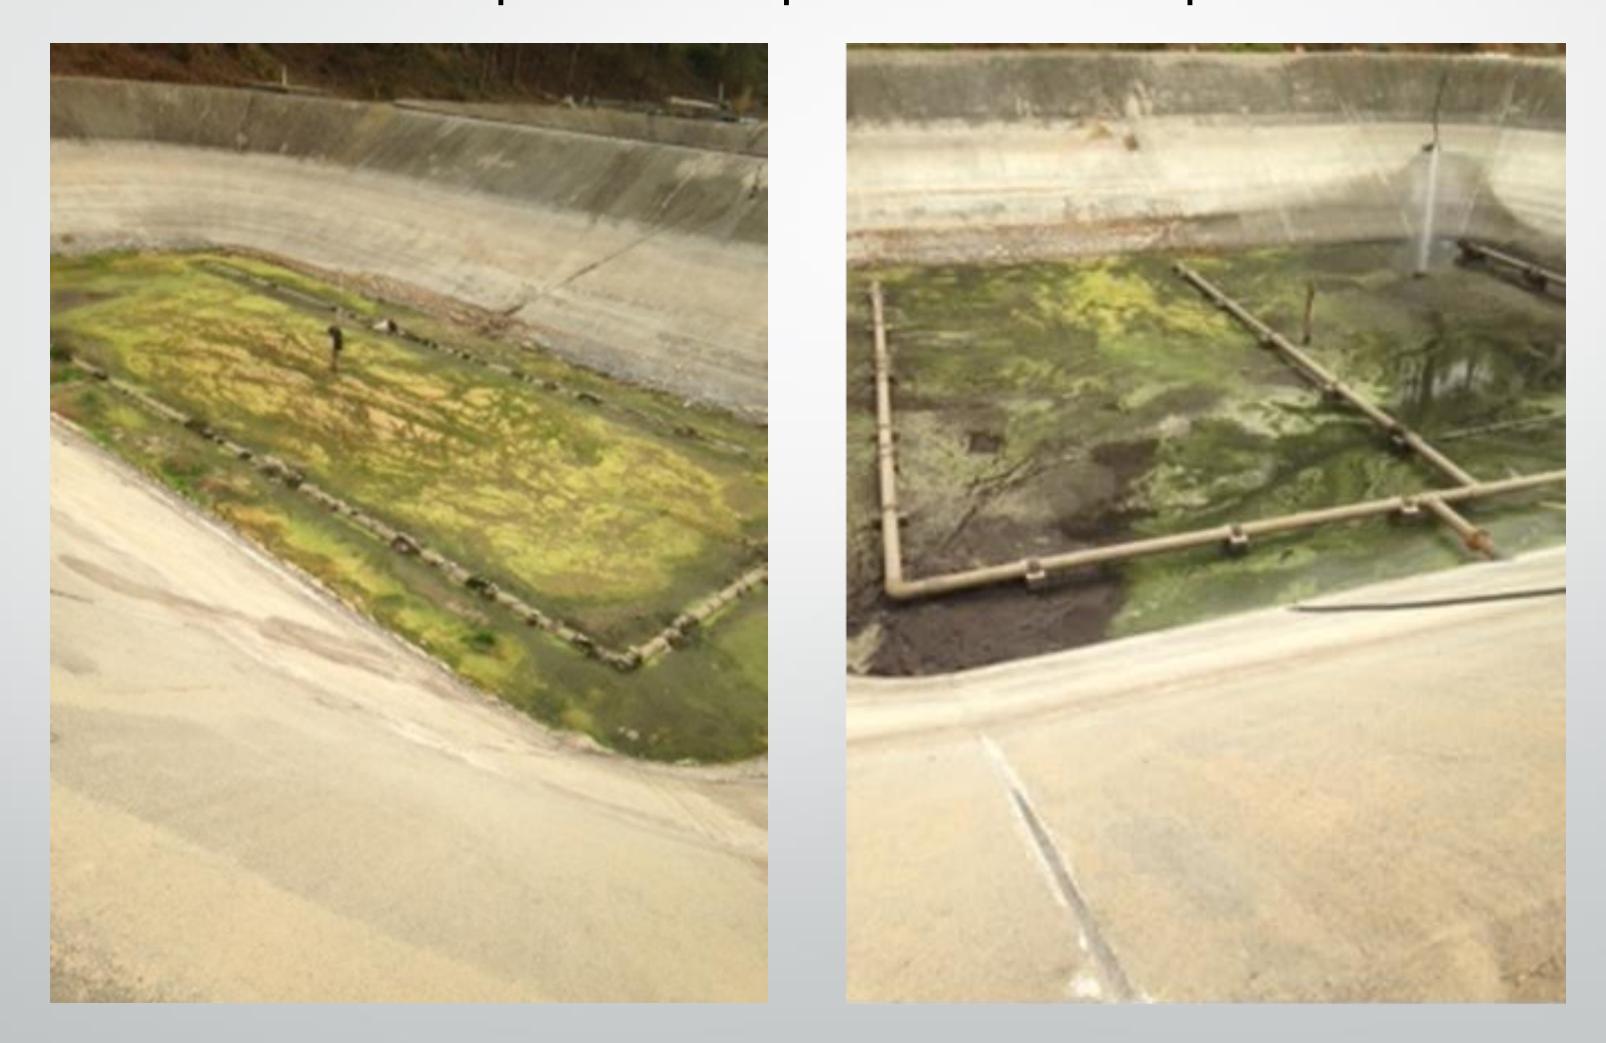
#### Wastewater Treatment & Collection System Plant Improvements August 2016 The flow effluent equalization ponds were emptied and cleaned

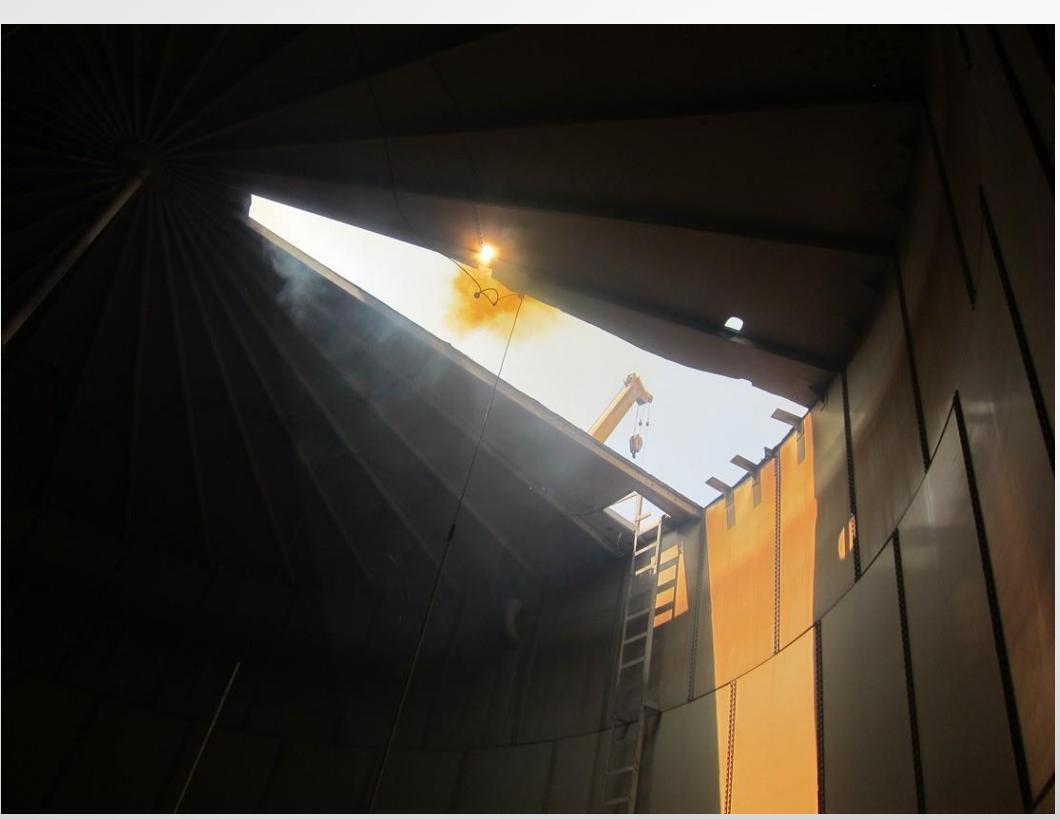
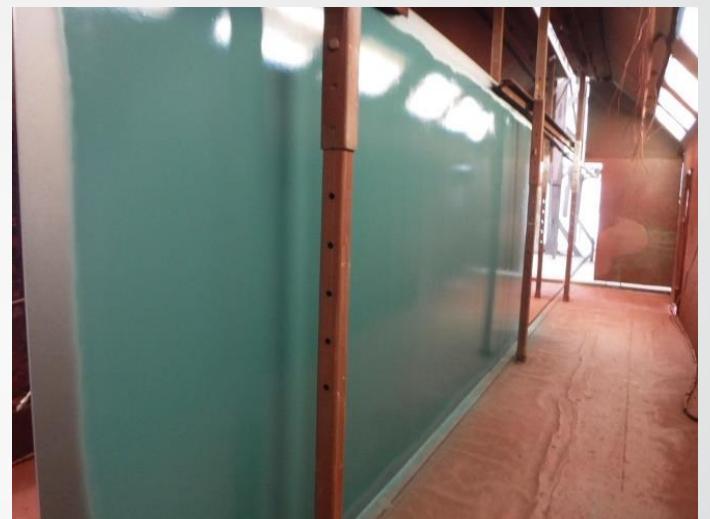
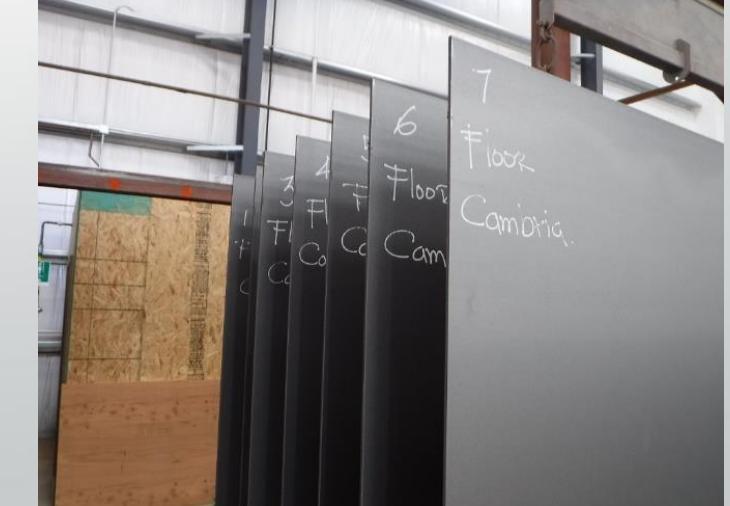
# Wastewater Treatment & Collection System Plant Improvements August 2016 Replaced the Fiscalini Tank

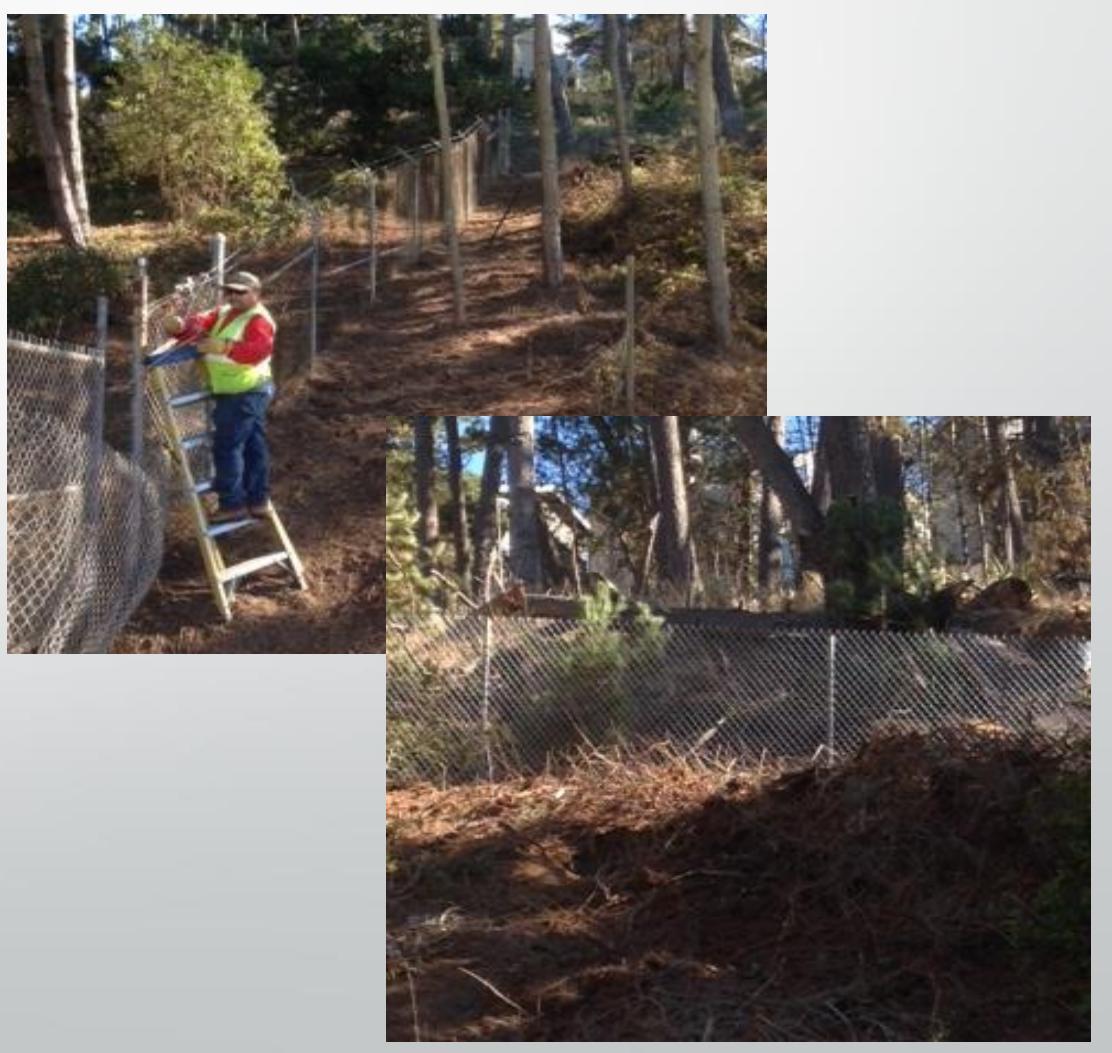
Wastewater Treatment & Collection System Plant Improvements August 2016 through October 2016 The fences along the perimeter of the plant were repaired

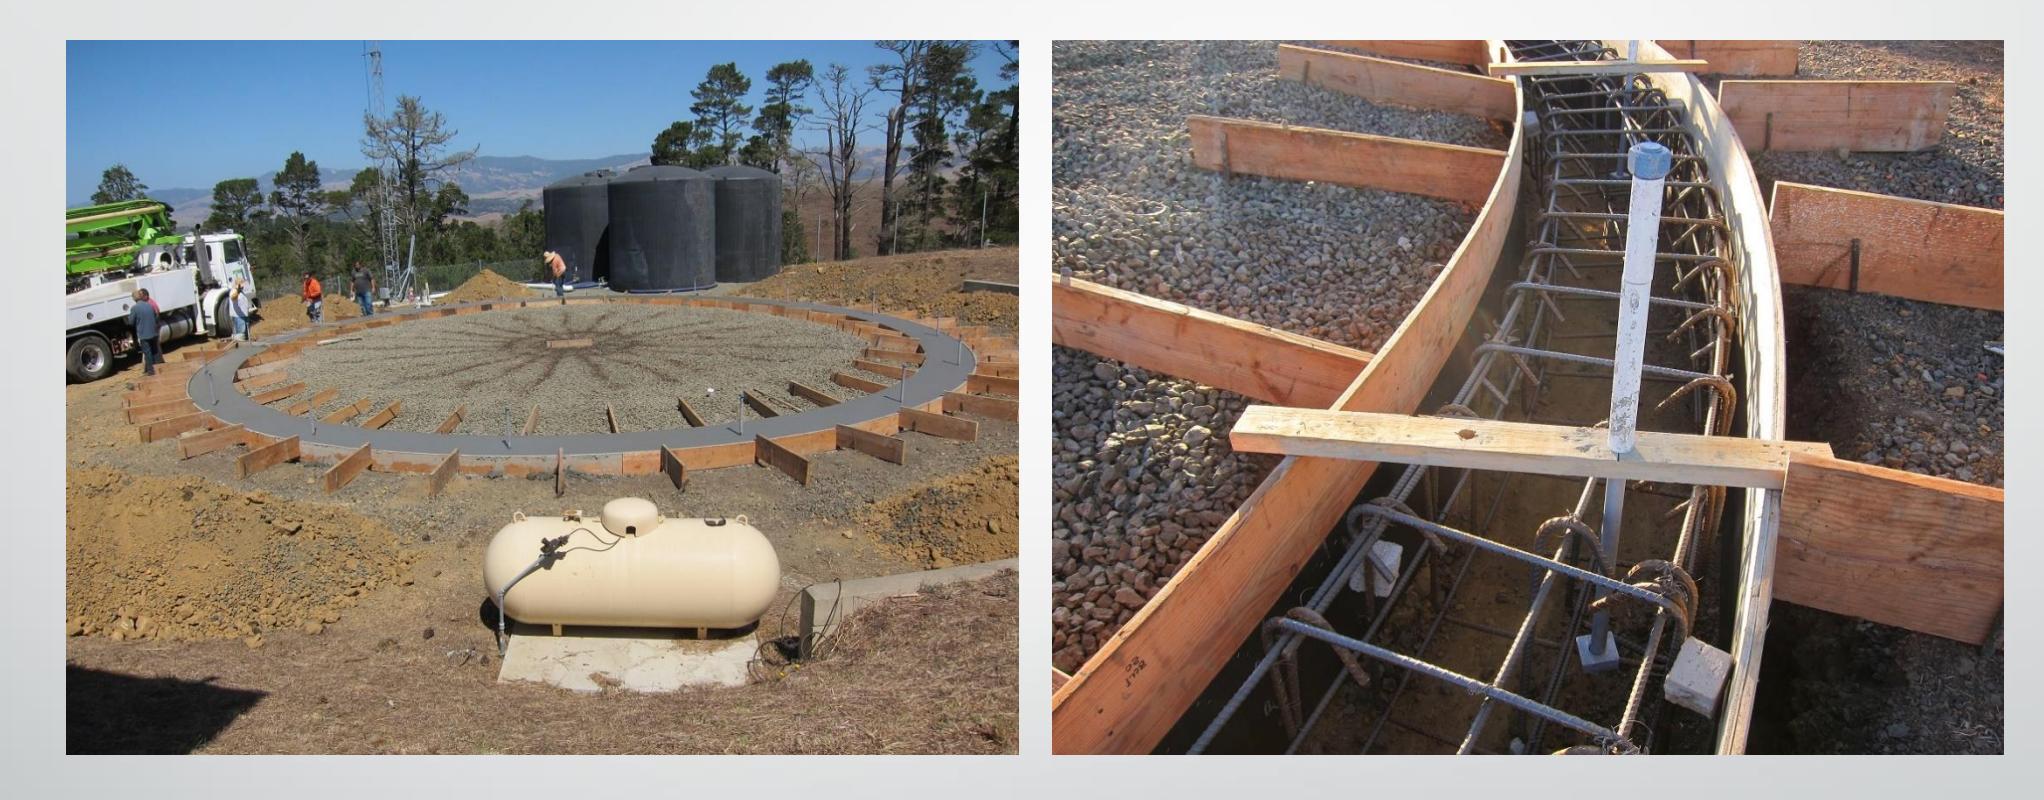
Wastewater Treatment & Collection System Plant Improvements September 2016 Replaced the Fiscalini Tank

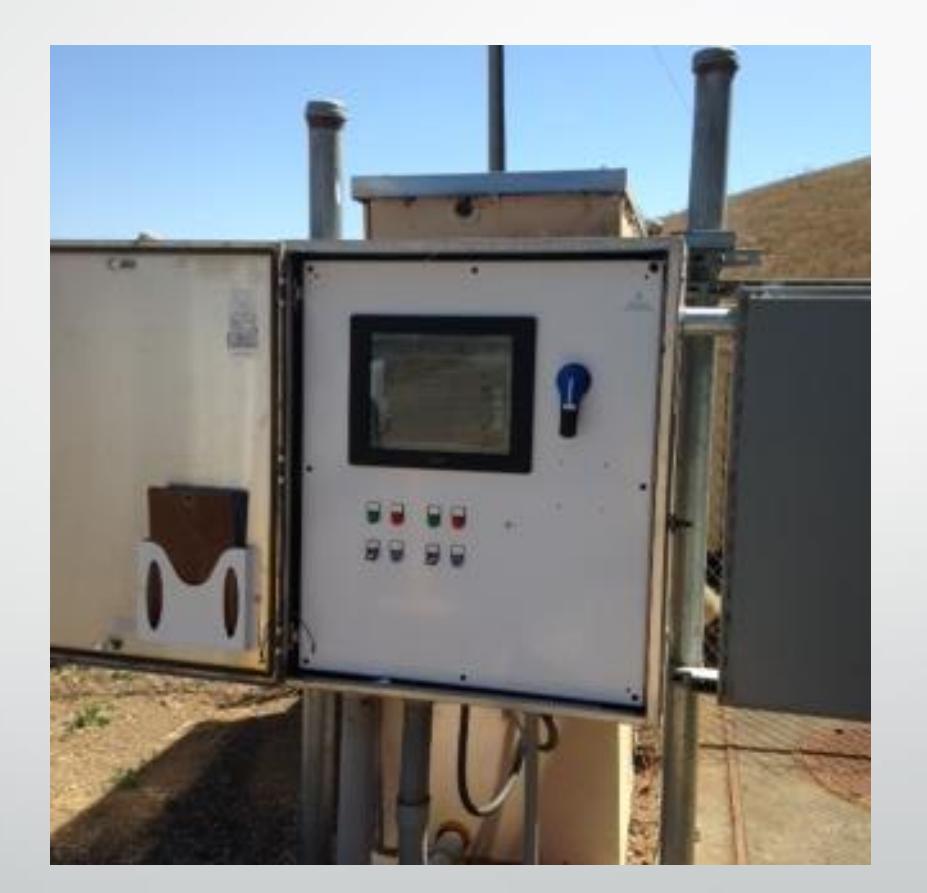
#### Wastewater Treatment & Collection System Plant Improvements September 2016 Installed new controls at lift station B4

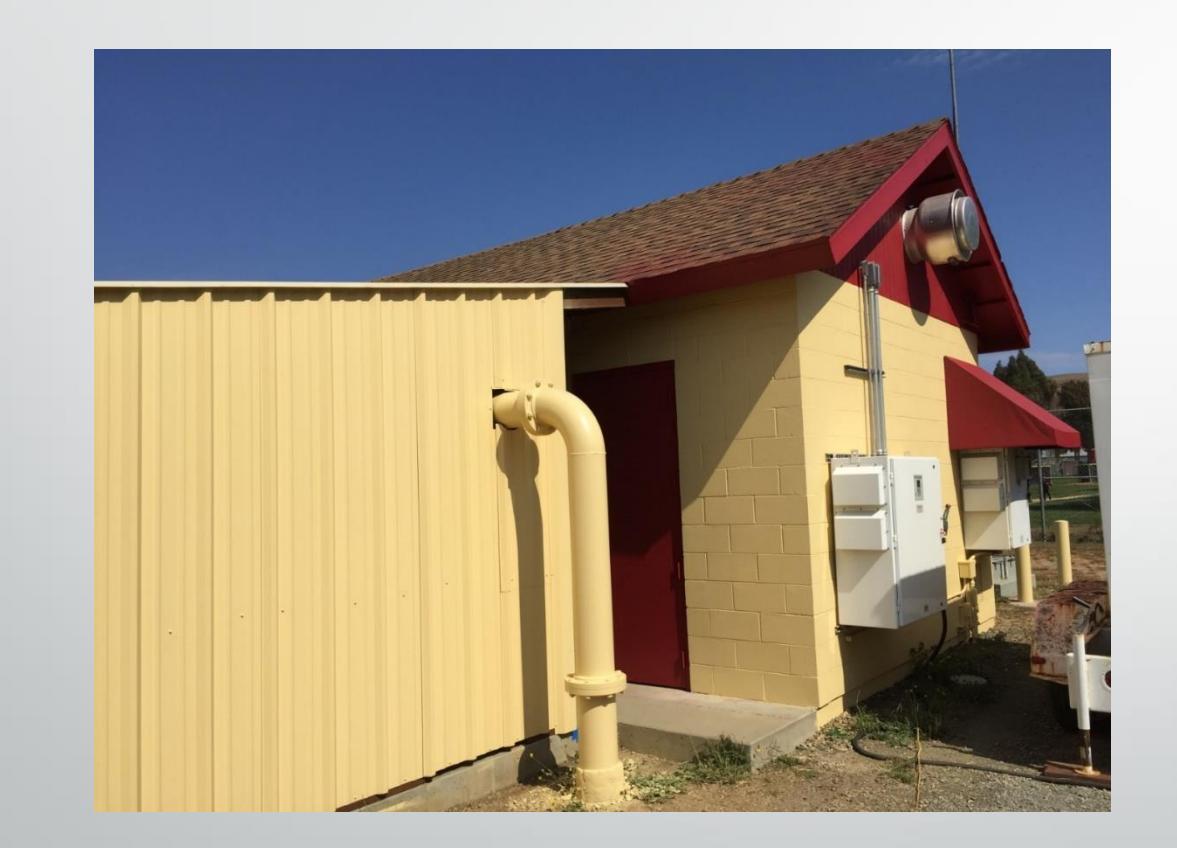
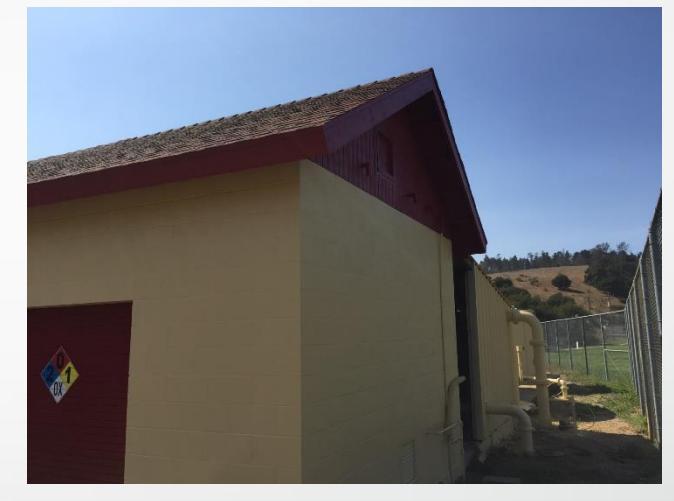
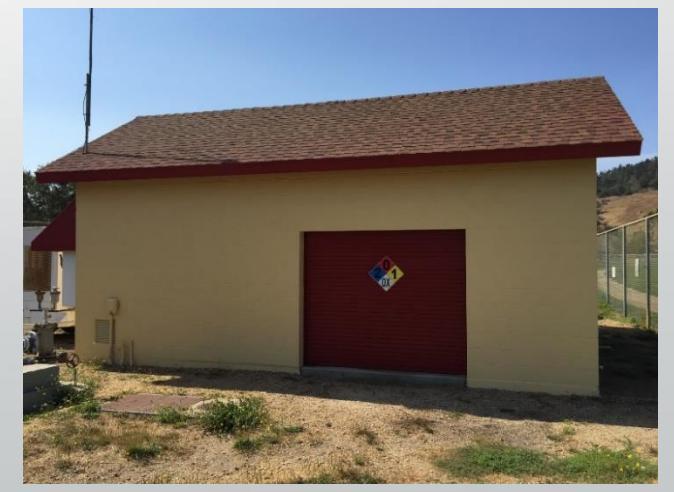
# Wastewater Treatment & Collection System Plant Improvements September 2016 Completely rebuilt SR4 well and fully automated with fail safe capability. They also painted the SR4 building

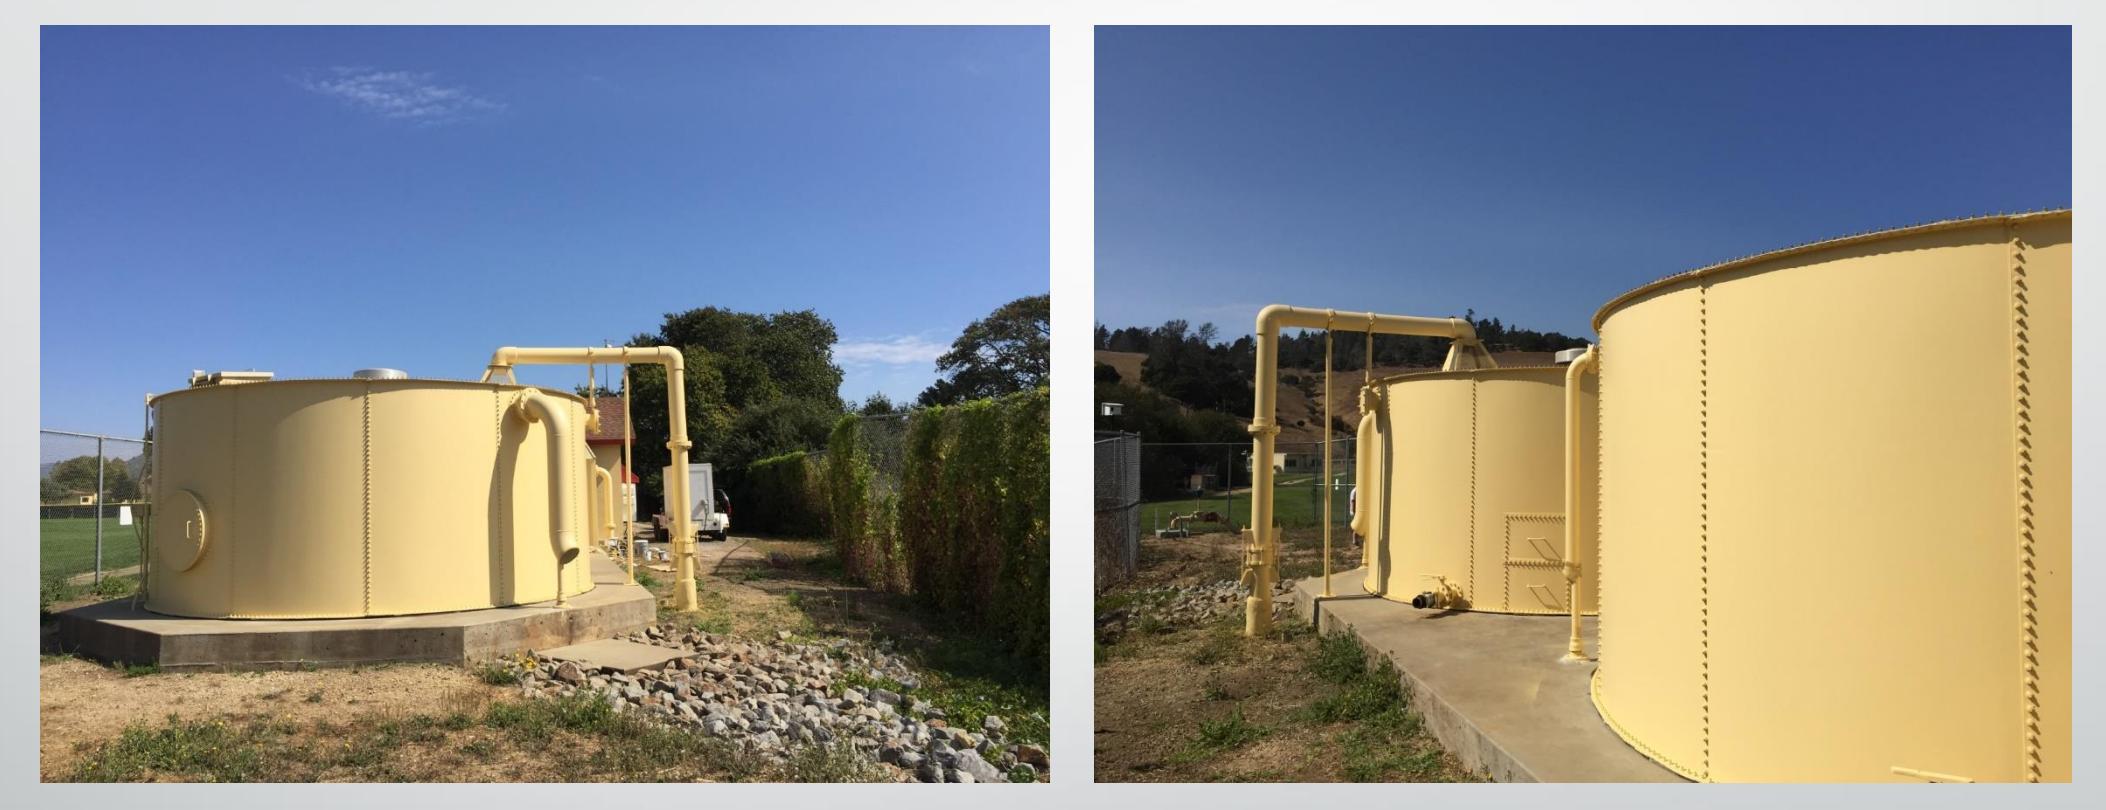
Wastewater Treatment & Collection System Plant Improvements September 2016 They painted the SR4 well tanks

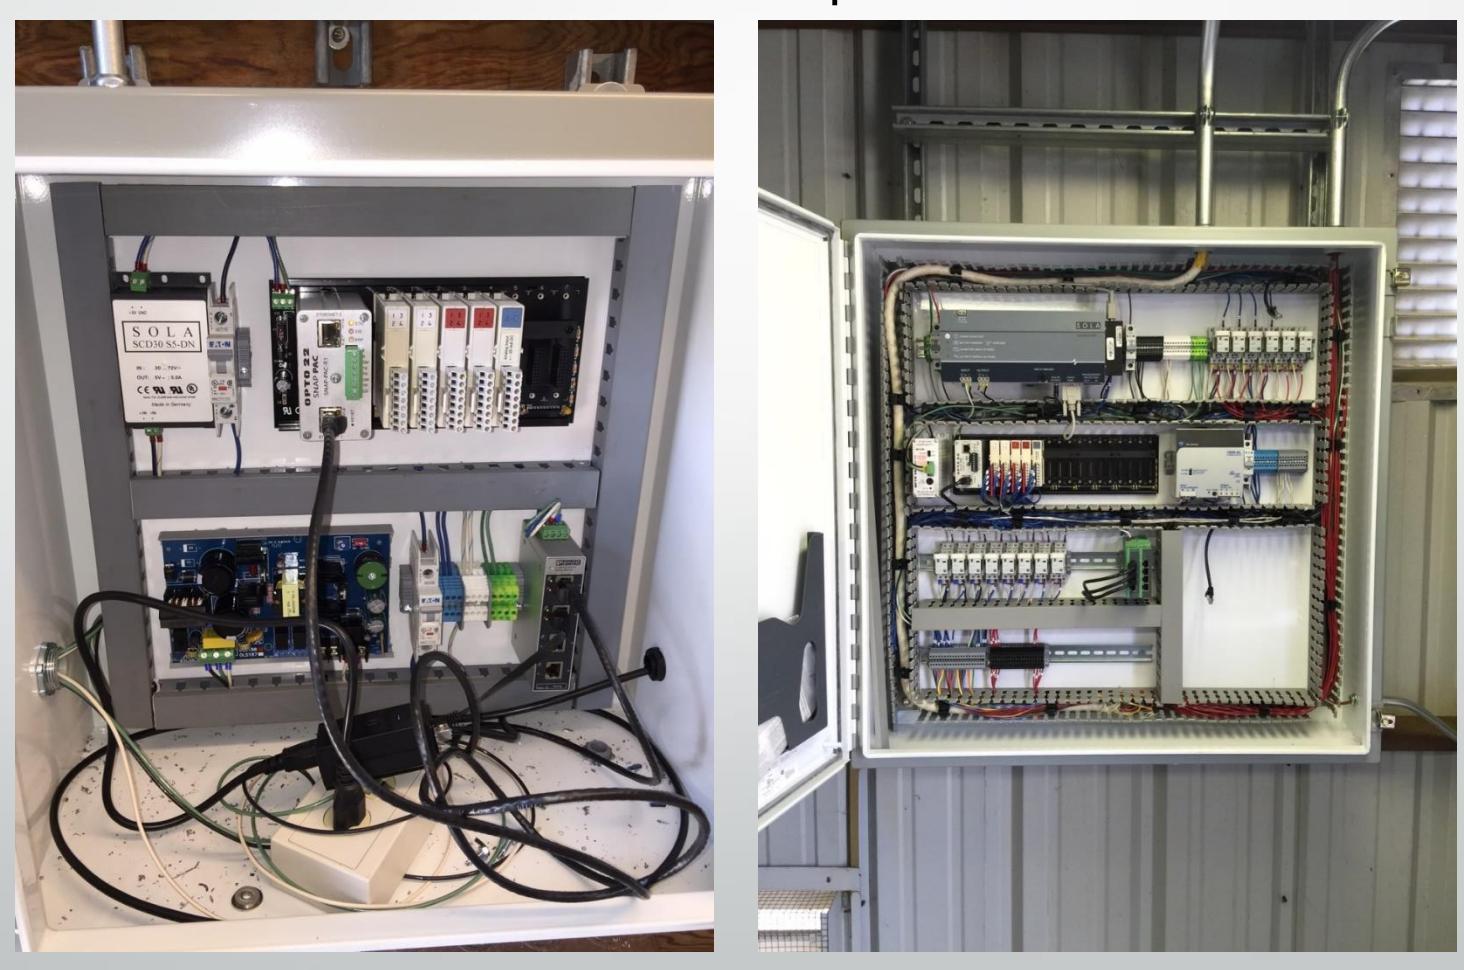
#### Wastewater Treatment & Collection System Plant Improvements October 2016 Improvements to the control panels before and after pictures

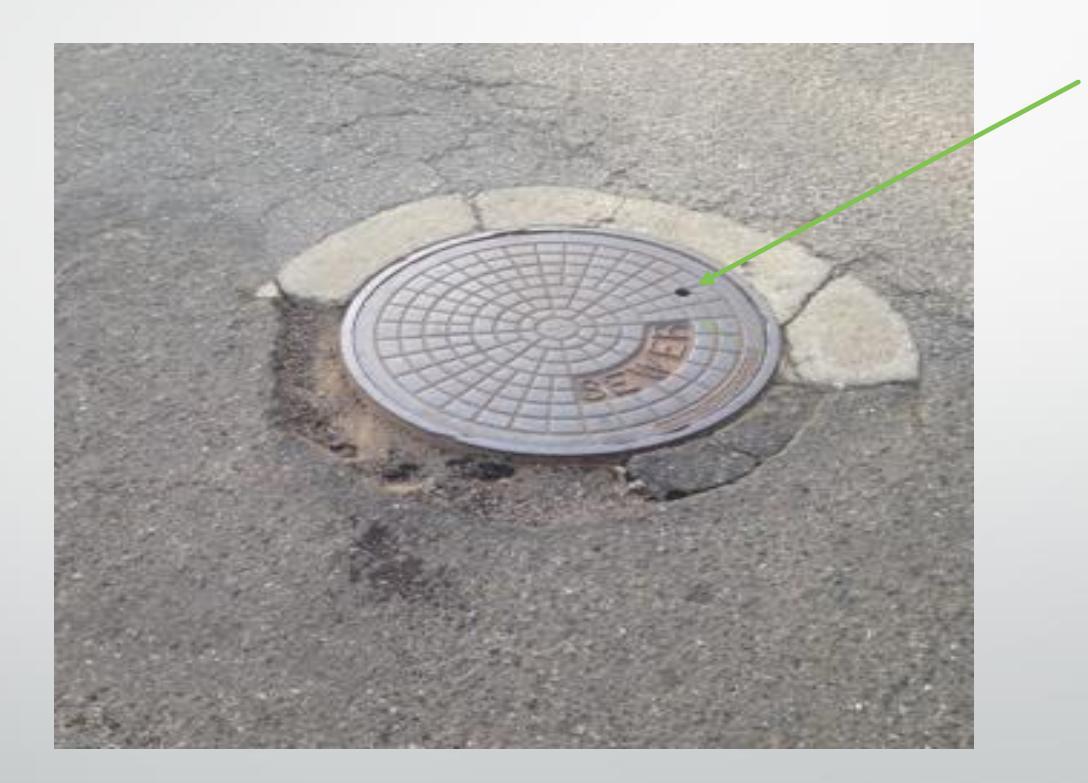
# Wastewater Treatment & Collection System Plant Improvements October 2016 At least 45 manholes have been repaired and replaced Twenty manhole inserts have been installed, thus reducing intrusion and infiltration

This hole represents 5 gallons per minute of flow or 7200 gallons per day from one mahole

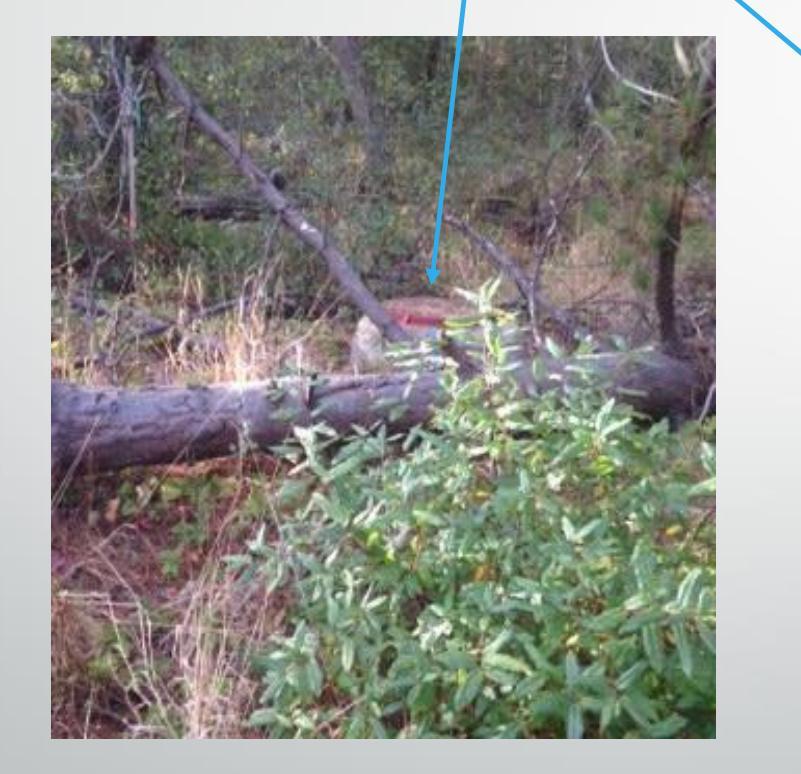
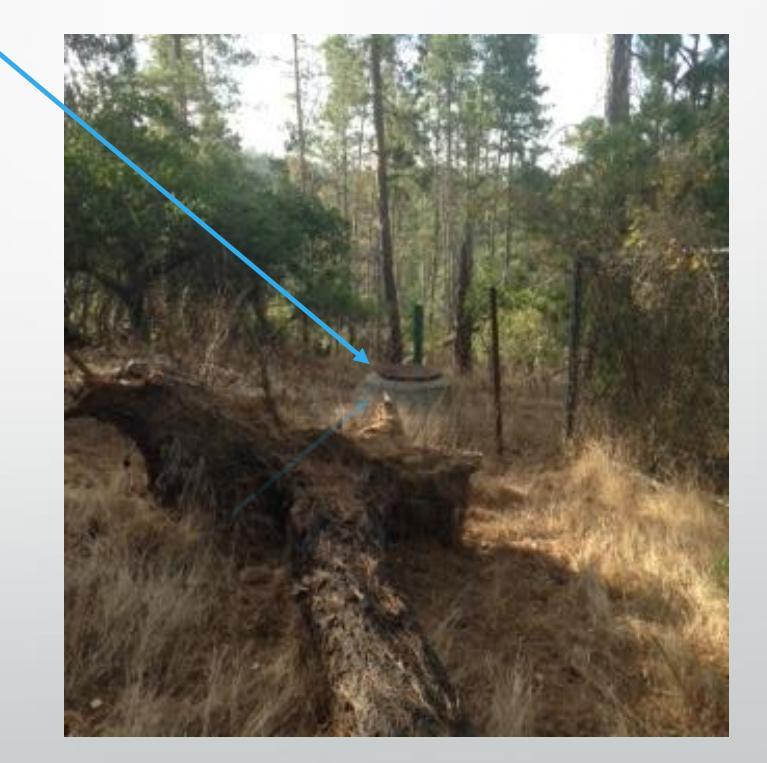
# Wastewater Treatment & Collection System Plant Improvements October 2016 The staff identified manholes that needed access

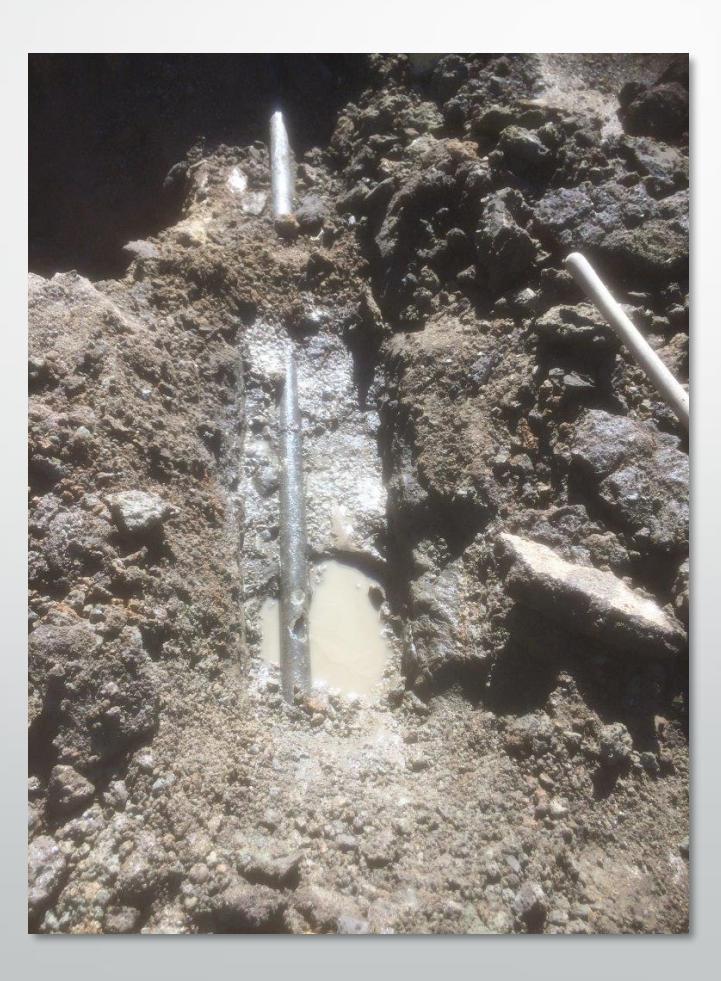
Wastewater Treatment & Collection System Plant Improvements November 2016 The 2" abandoned pipe on Pineridge was repaired on November 2, 2016 Ongoing repairs to the distribution system continue

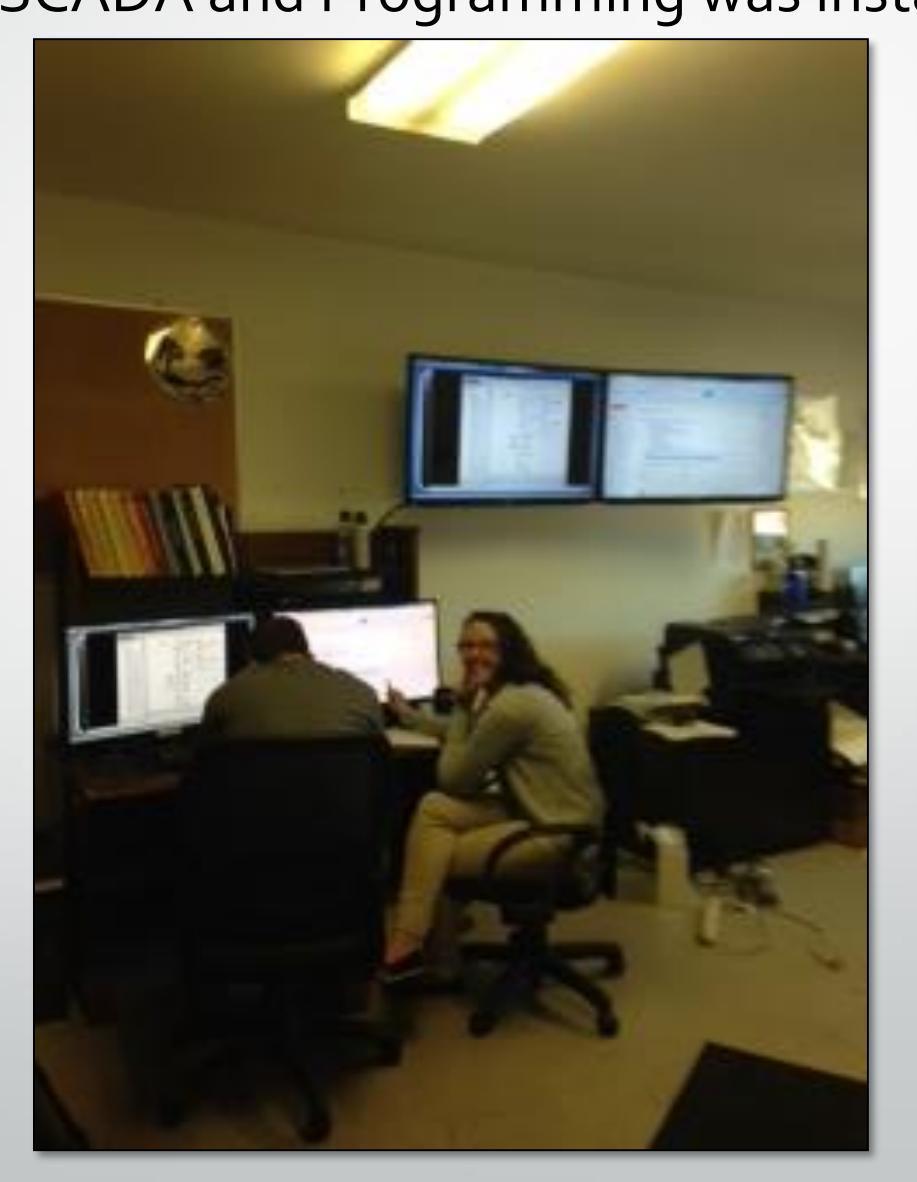
Wastewater Treatment & Collection System Plant Improvements November 2016 New SCADA and Programming was installed

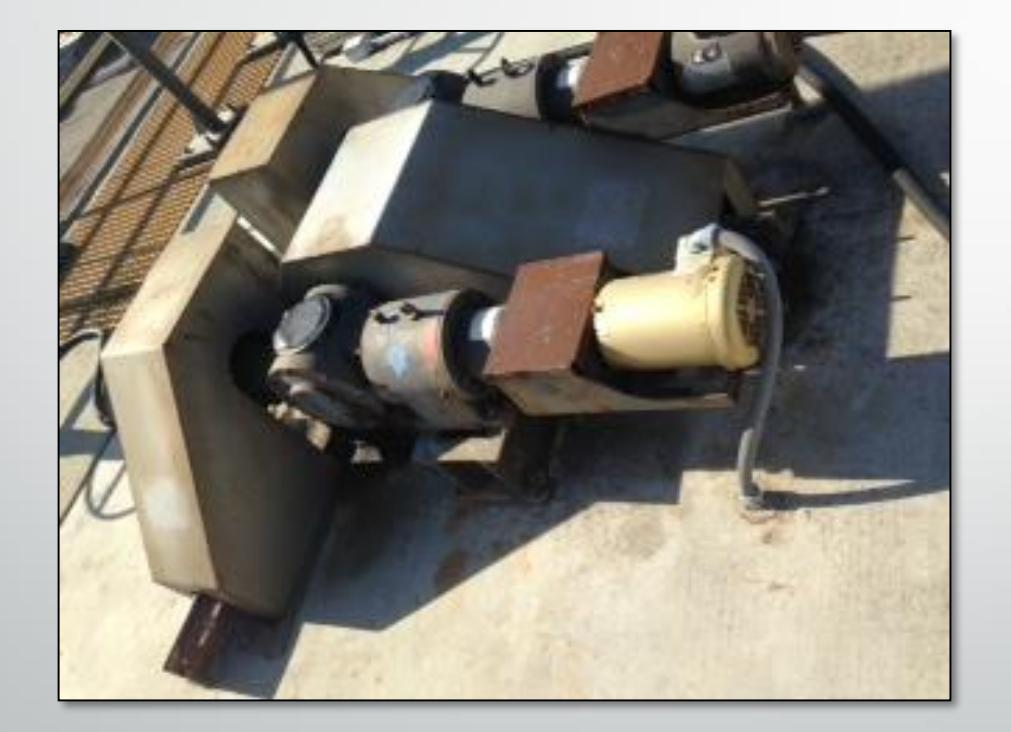
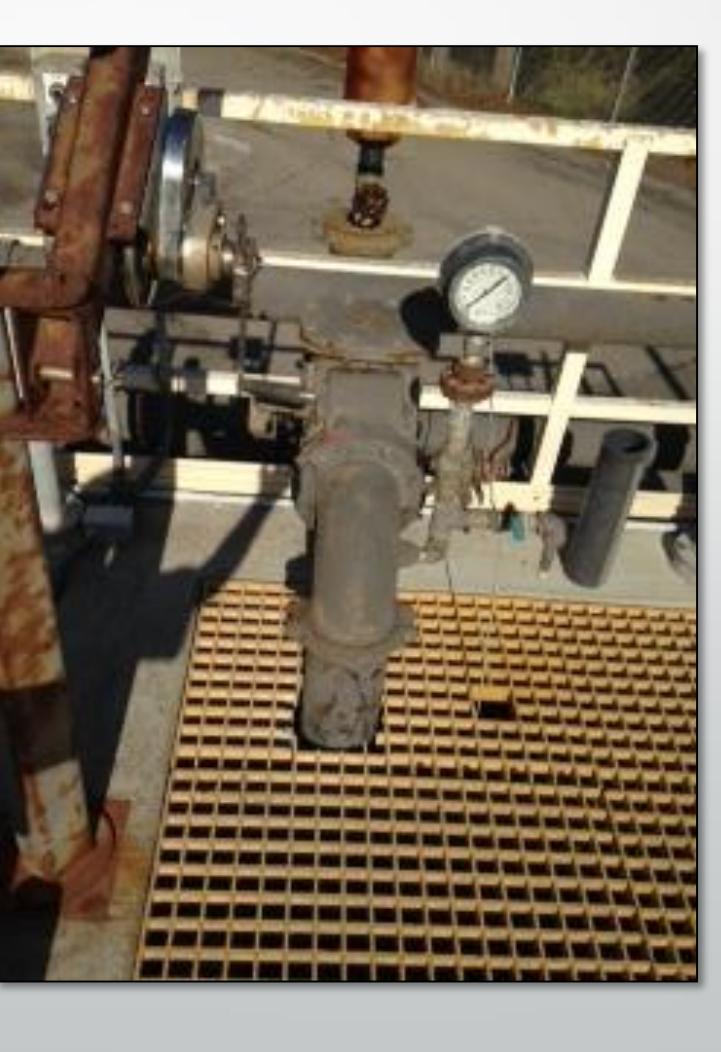
Wastewater Treatment & Collection System Plant Improvements November 2016 Both drive motors were replaced for clarifiers 1 and 2 Both waste activated sludge pumps were replaced

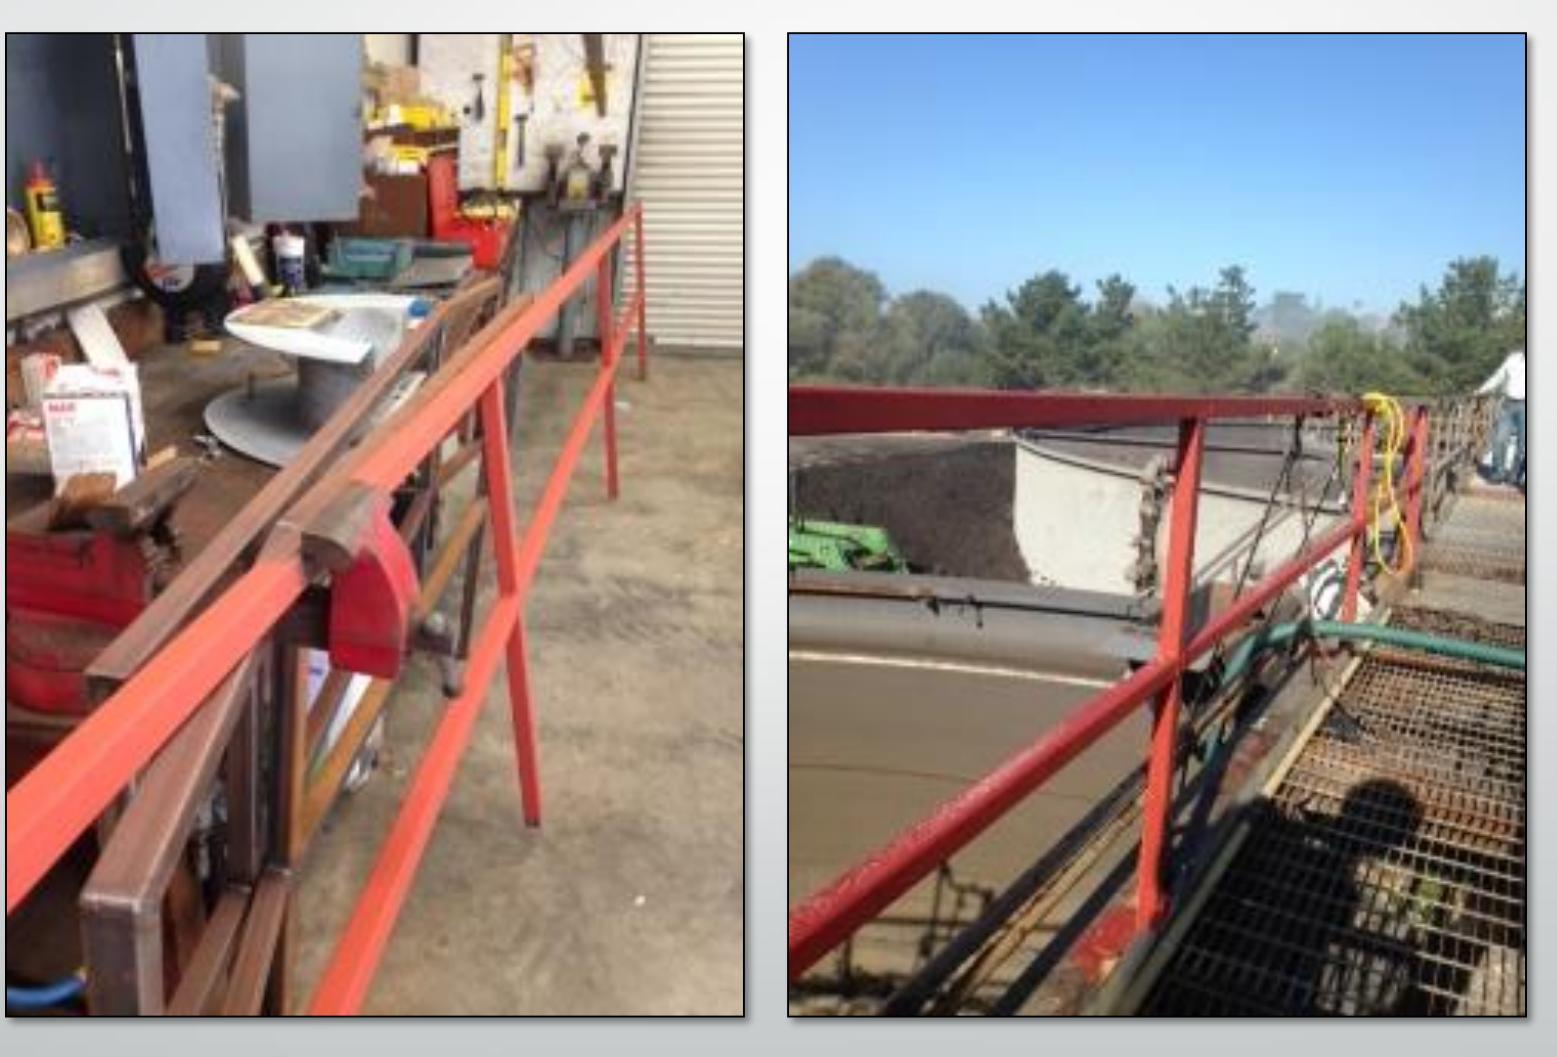
Wastewater Treatment & Collection System Plant Improvements November 2016 New handrails were installed
