# Cambria Community Services District

Wastewater and Water Department Infrastructure Projects 2015-2018

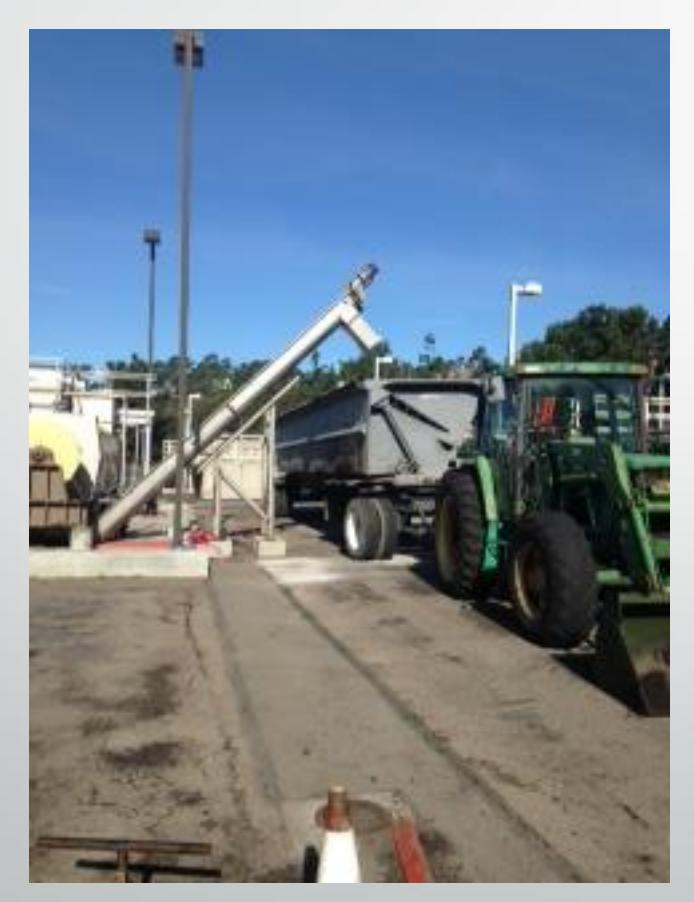
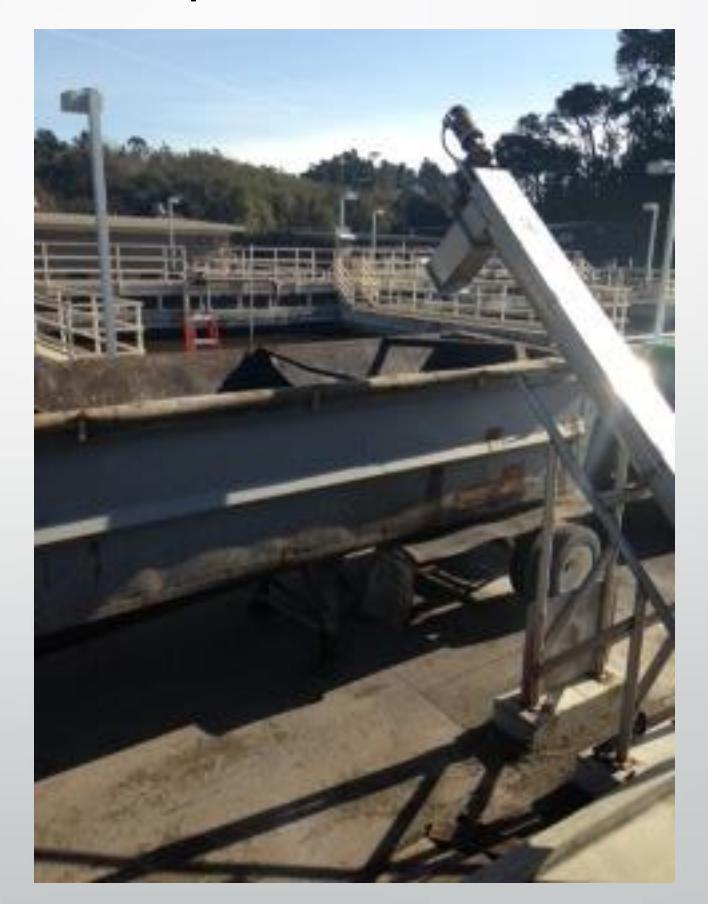
Wastewater Treatment & Collection System Plant Improvements December 2016 Sludge was collected in the new trailer and the digestors are functioning properly for the first time in many years It also reduced plant odor

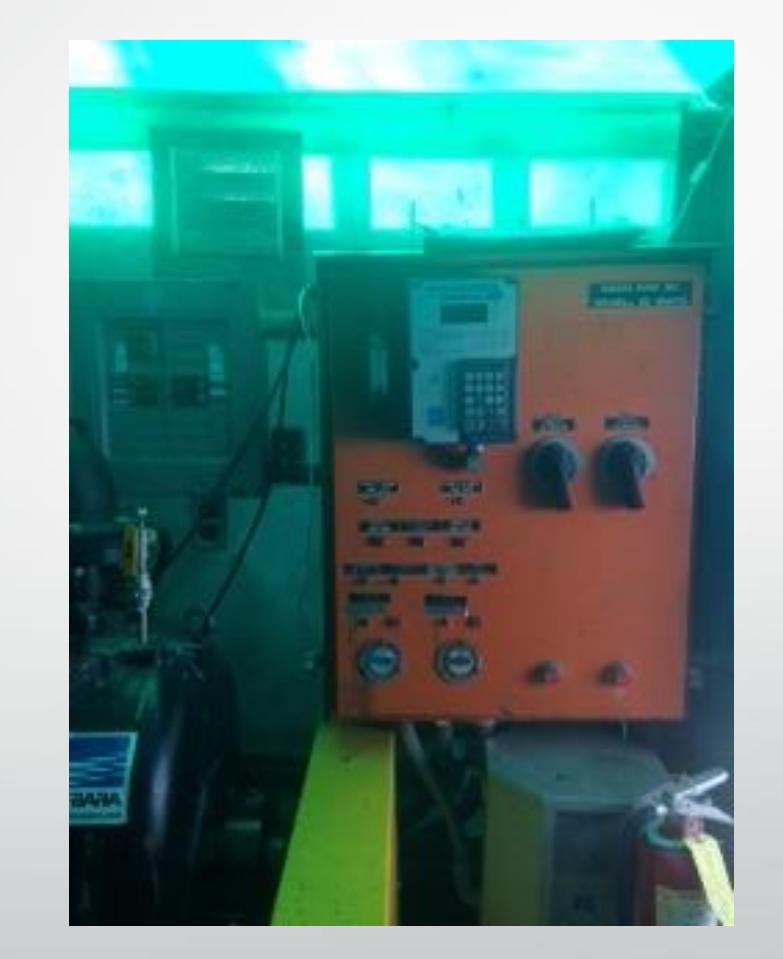
Wastewater Treatment & Collection System Plant Improvements December 2016 The old lift station panel 9 was replaced

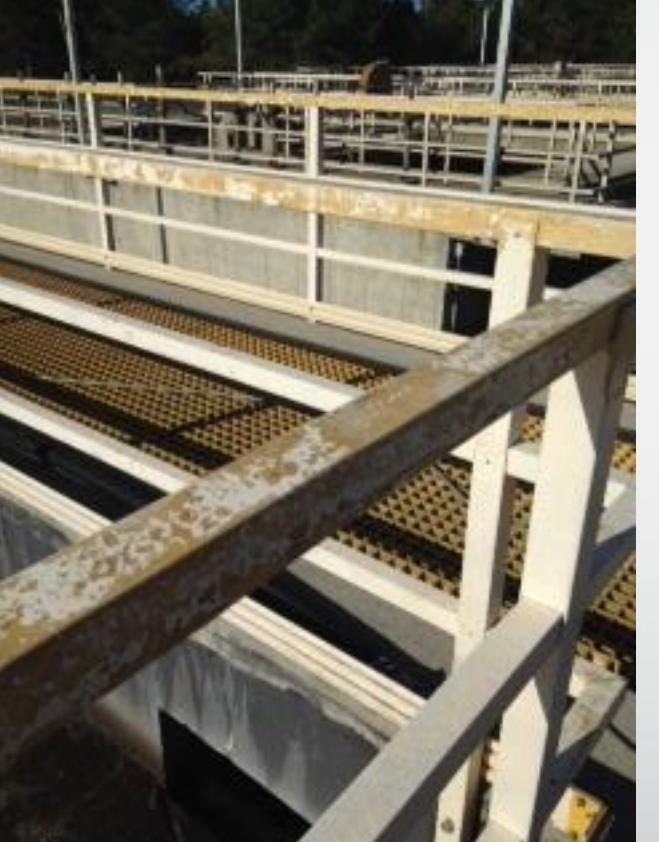
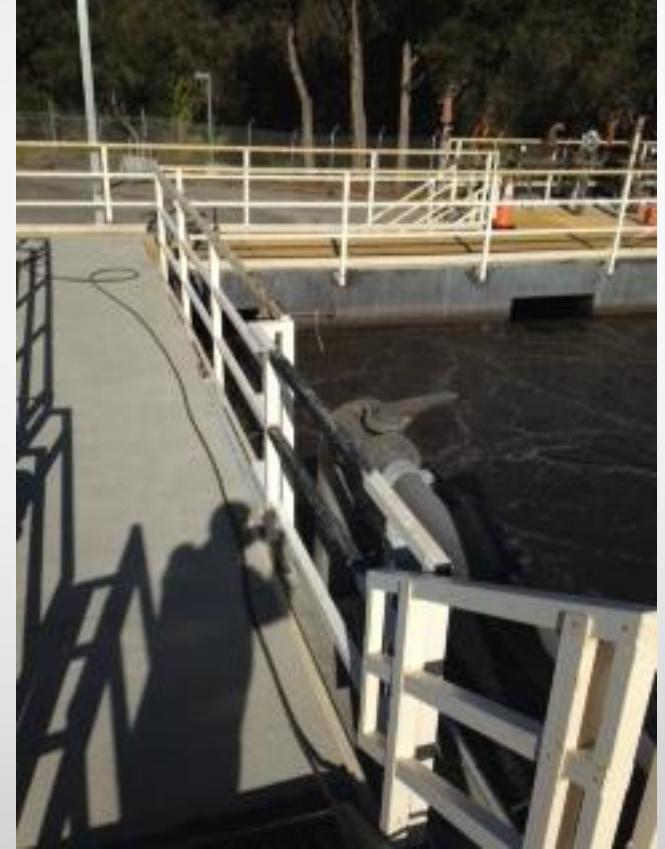
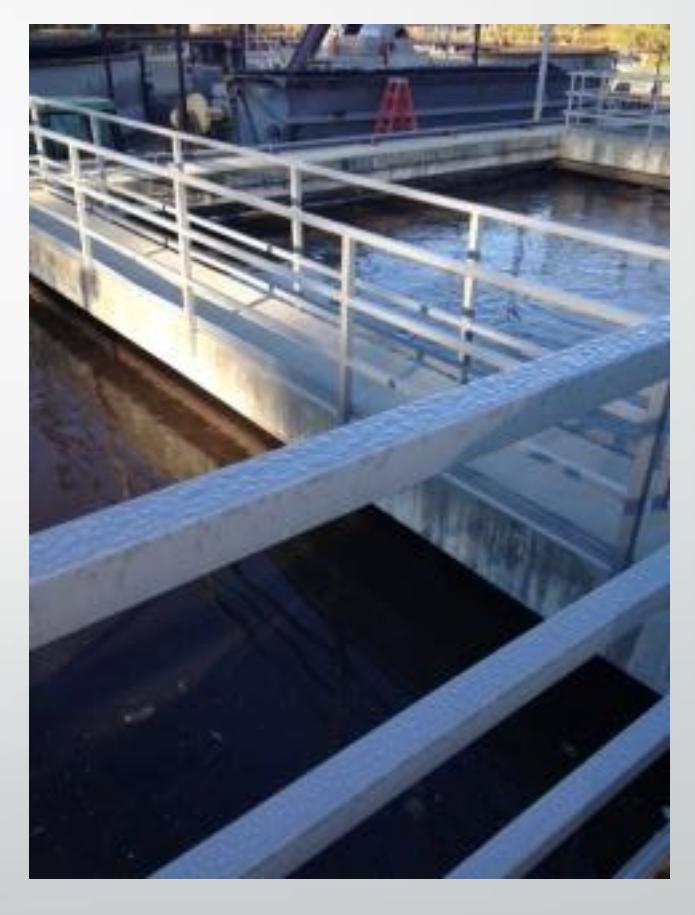
#### Wastewater Treatment & Collection System Plant Improvements December 2016 All handrails have been completely painted

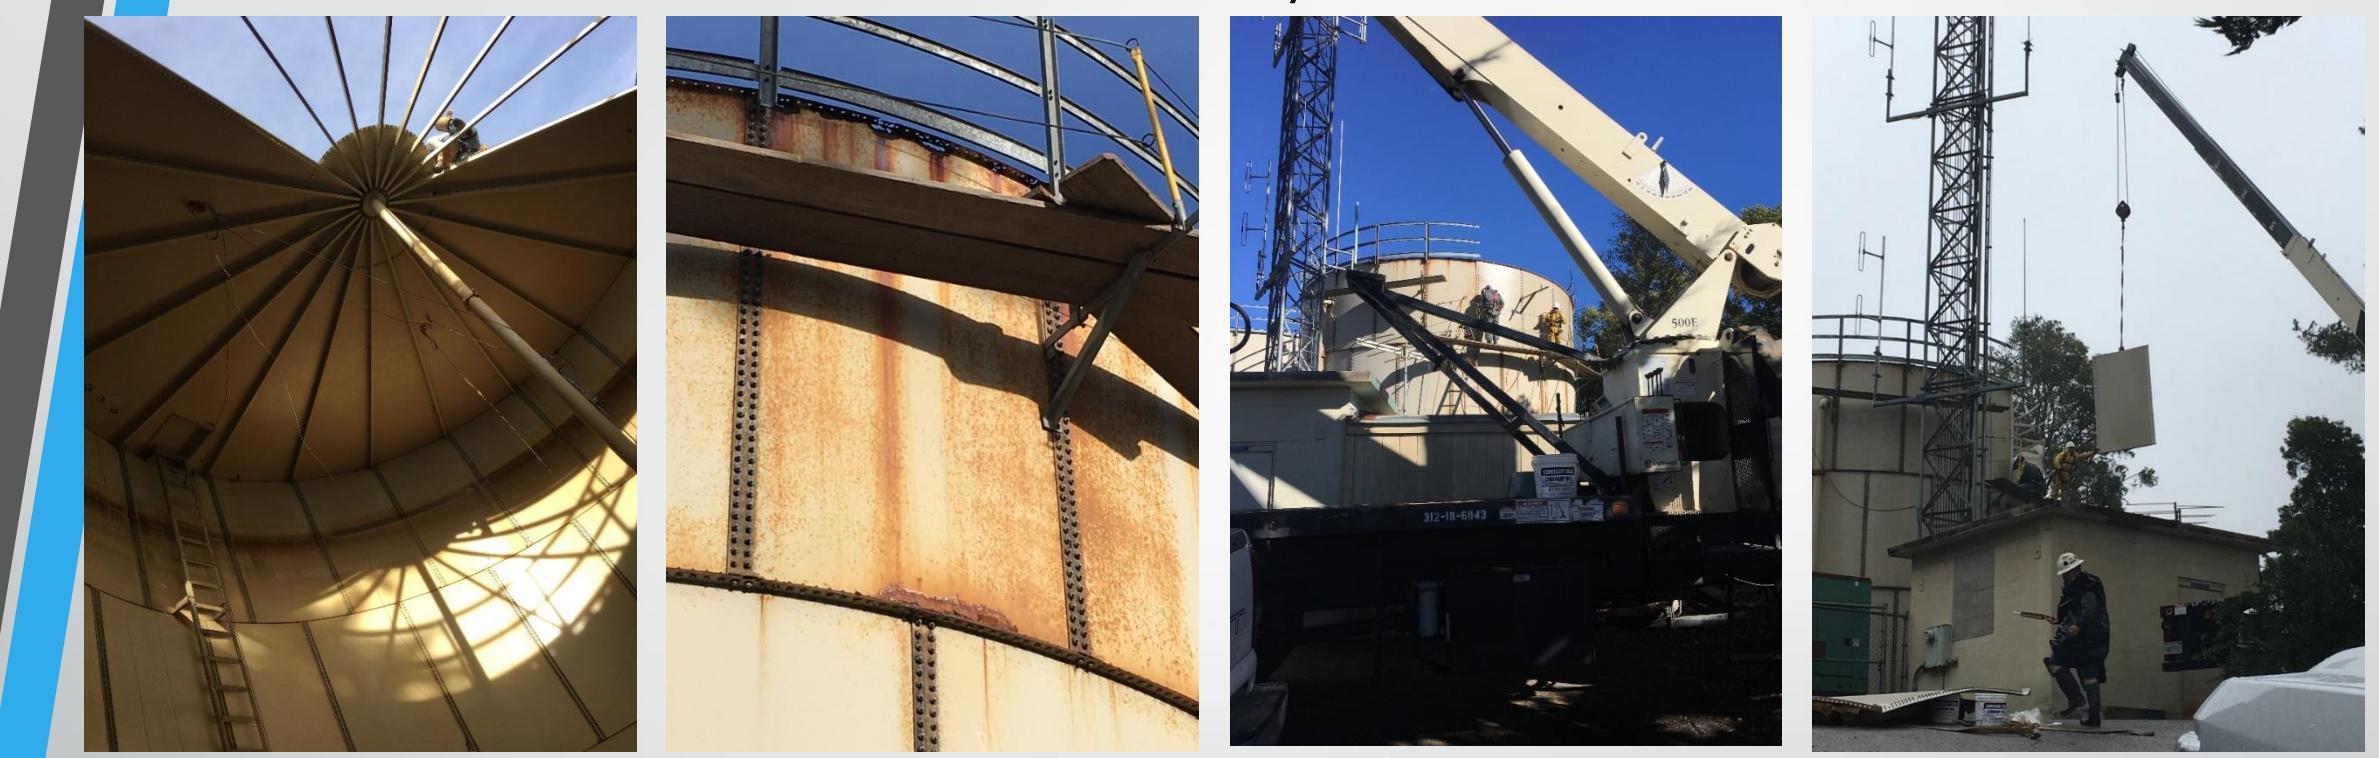
Superior Tank removed the most severely corroded roofing in January 2018 After removal of the roof and rust scale, it was determined that 3 shell panels were too far gone to bolt to Everyone agreed that changing the contract to add the replacement of those shell panels would increase the likelihood that this tank can stay in service for the desired five more years

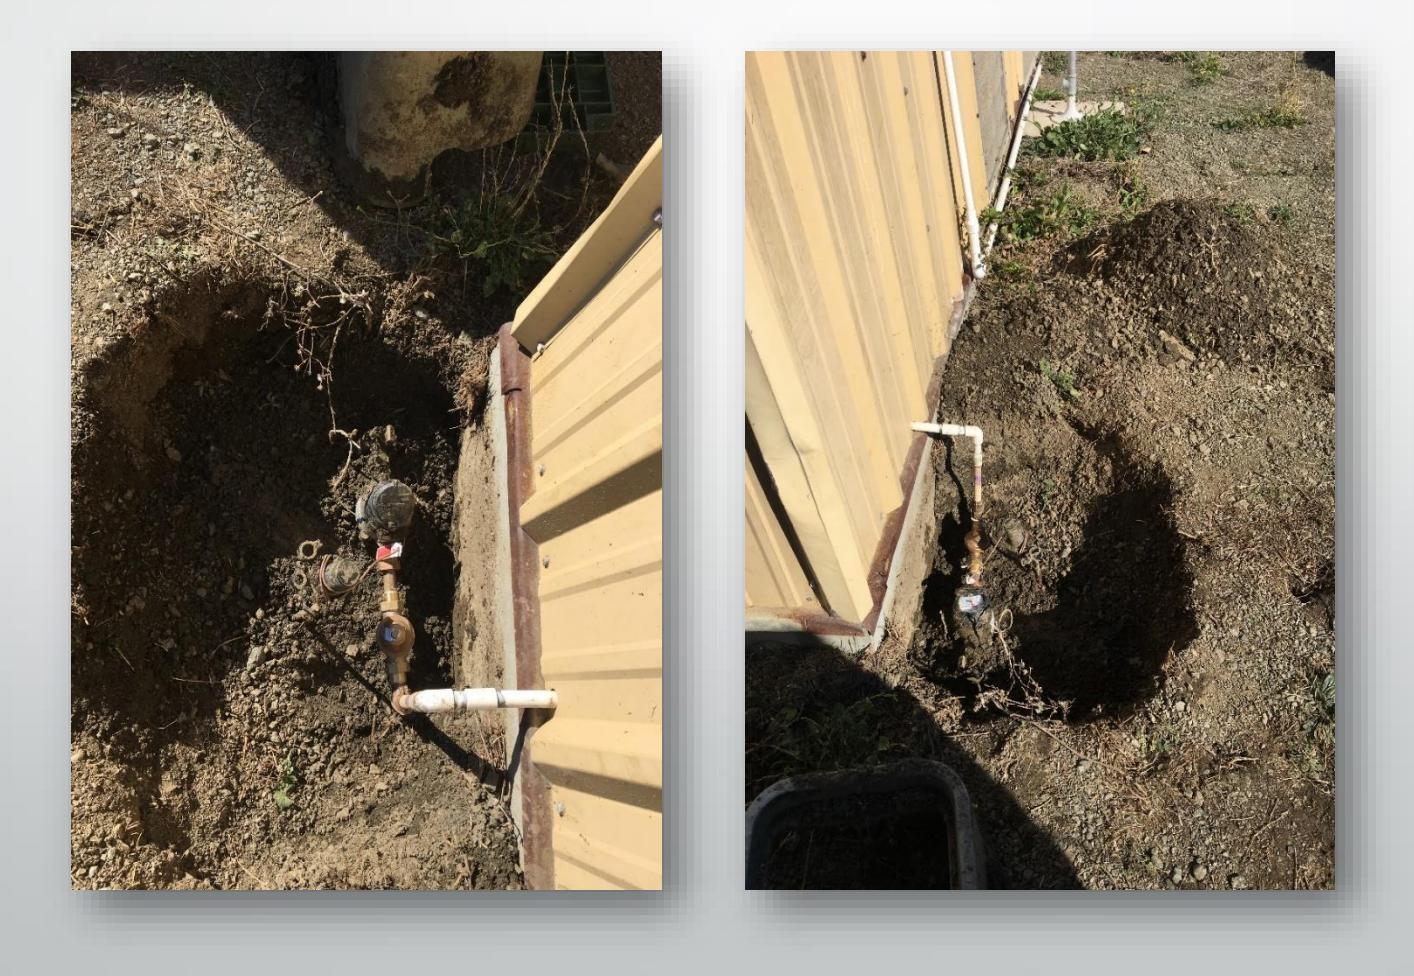
The water that goes through the regulator is for the chlorine analyzer and the turbidimeter for the entire SS wellfield This pressure regulator is located at SS3
