Cambria Community Services District Grant Agreement # 4600010880 Project 3 – Emergency Water Supply Project Completion Report

1 EXECUTIVE SUMMARY

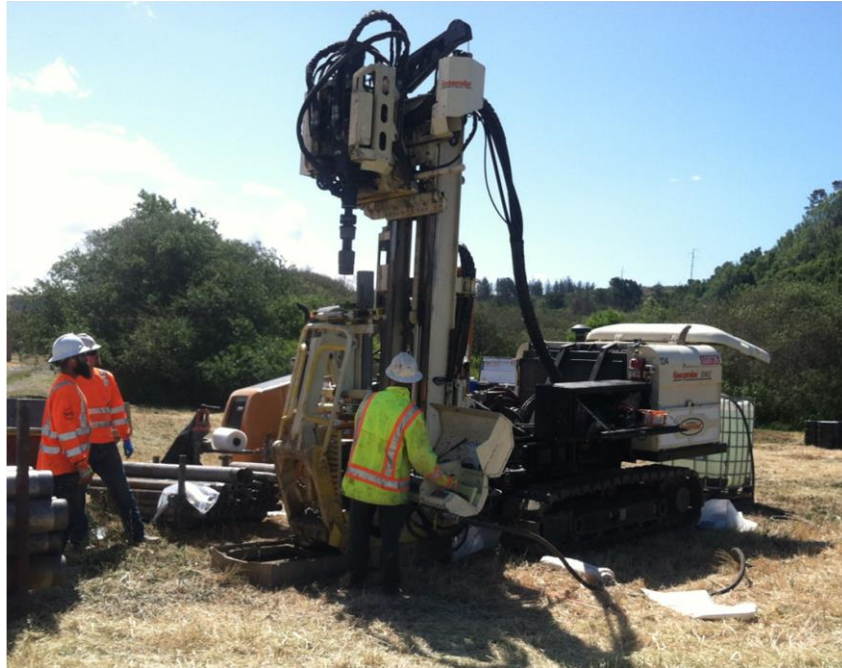
Monitoring Well Installation

The early project construction activities included installation of the monitoring well and re-injection well within the CCSD's potable well field. Besides being incorporated into the final project, this work also supported a follow up tracer study, which was required to support Title 22 permitting. The initial project construction activity was completed via a task order under the master consulting services agreement between the CCSD and CDM Smith. The monitoring well was installed during the week of May 19, 2014 by National Well Drilling using a rotary sonic drill rig. This well is located between the re-injection well and existing potable wells.

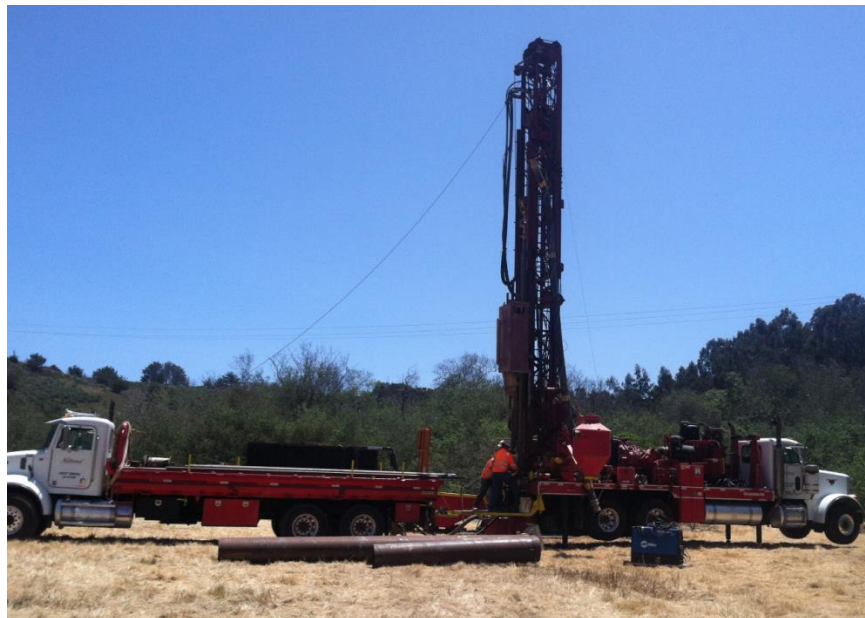
Re-injection Well Installation

During the week of May 26, 2014 the project's re-injection well was installed by National Well Drilling. This well was installed using a rotary mud drilling rig. As with the monitoring well, this initial project work was completed via a task order authorization under the master consulting services agreement between the CCSD and CDM Smith.

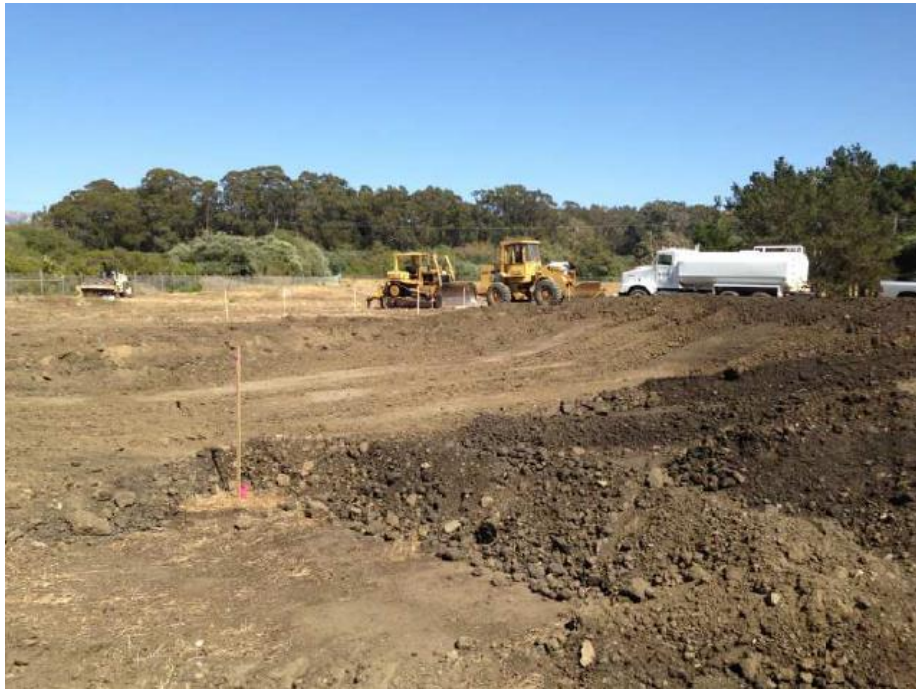
Initial Clearing & Grubbing at Evaporation Pond

Mobilization onto the project site by CDM Constructors Inc. (CCI), the primary design-build contractor, occurred during the week of August 25, 2014. Sansome Construction served as one of CCI's larger subcontractors, installing much of the civil/site work. Initial efforts focused on clearing and grubbing the former wastewater storage basin, which had been out of service for several years and was overgrown with small brush and weeds. The old basin was not lined, whereas the Title 27 permit for the evaporation pond required a triple liner system. Therefore the pond surfaces had to be prepared for installation of the initial liner system.

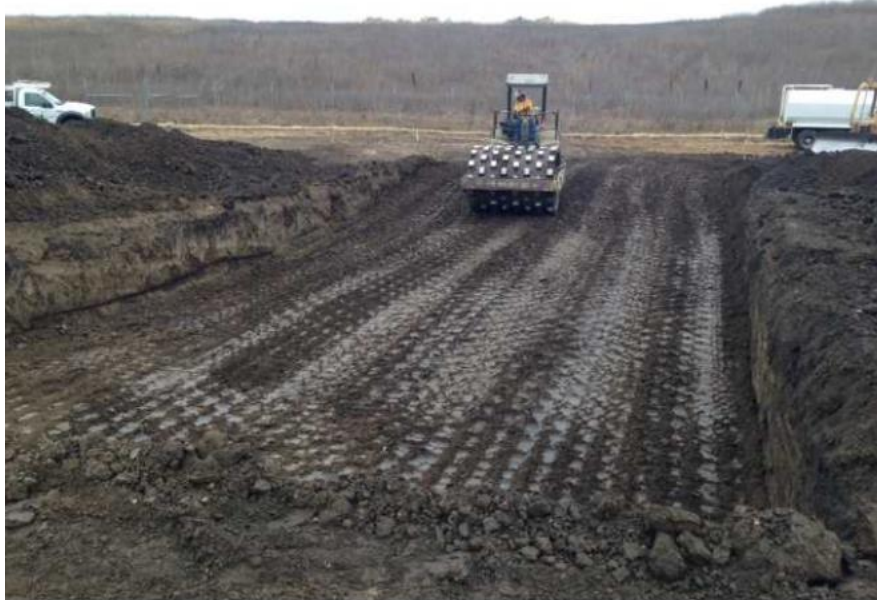
Re-compaction at the AWTP Site

The advanced water treatment plant (AWTP) site was over-excavated and re-compacted to prevent the equipment from settling. Following re-compaction, forms were set for the supporting concrete slabs that were placed below each shipping container, transfer tanks, and outdoor mounted equipment (transfer pumps and the advanced oxidation, ultraviolet treatment unit).

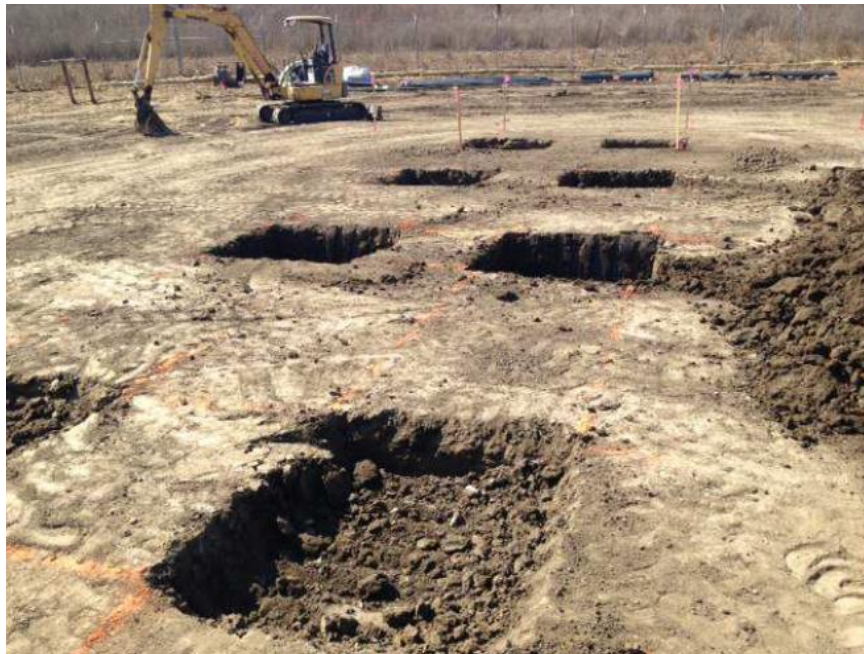
Excavation into Re-compacted Area for Shipping Container Support

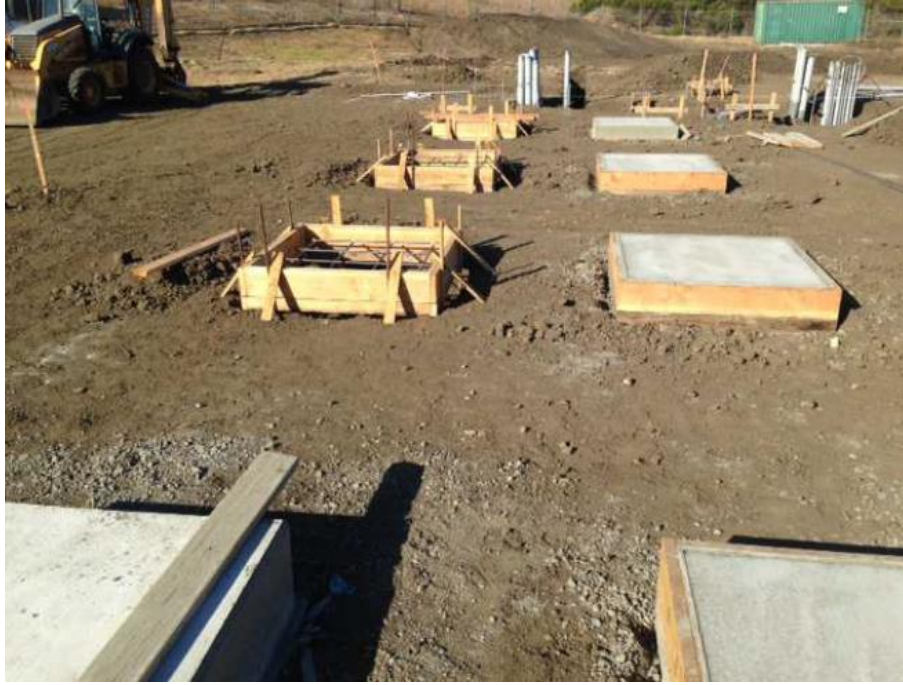
Forms Set for Shipping Container Support

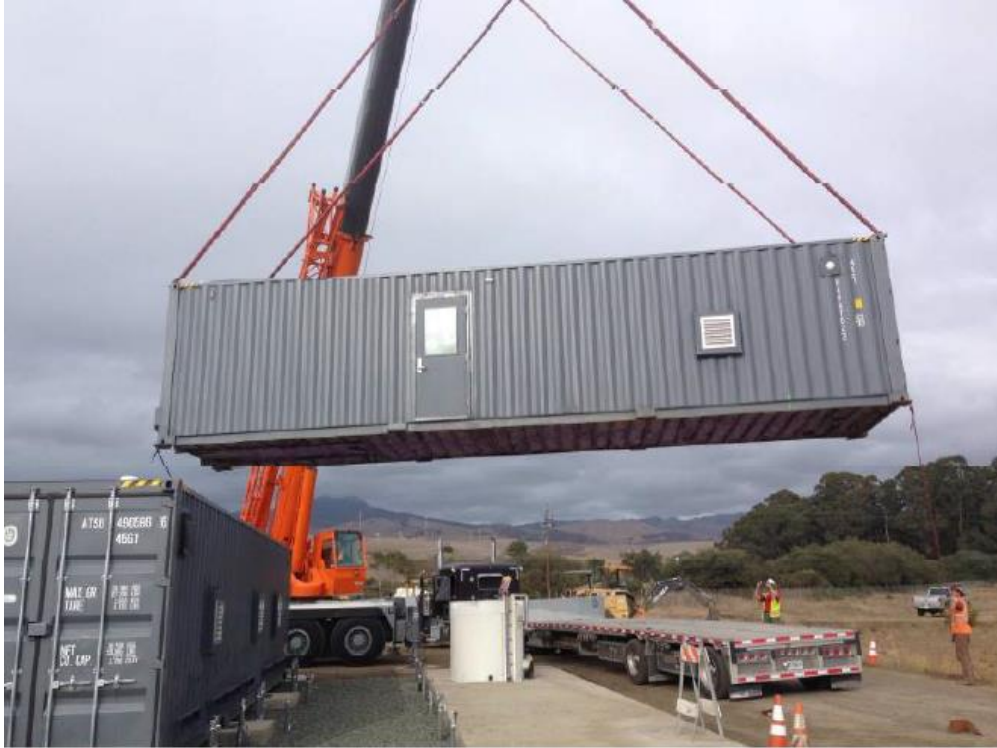
Shipping container unit In process of being set into position

Initial preparations for major equipment pre-purchasing began via a task order under the CCSD - CDM Smith master consulting services agreement. These initial tasks included contacting various suppliers, negotiating costs, developing equipment purchasing agreements, and initiating shop drawings. The final purchase of the equipment occurred under the design-build contract with CCI. The earliest equipment to arrive on site was the advanced oxidation ultraviolet unit, which arrived during the week of September 22, 2014. The shipping container mounted equipment arrived on site during the middle of October 2014. The containerized units consisted of three reverse osmosis containers (two with 2-stage RO, one for the 3rd stage of RO), the micro-filter container, a chemical feed pumping container, and the control room container.

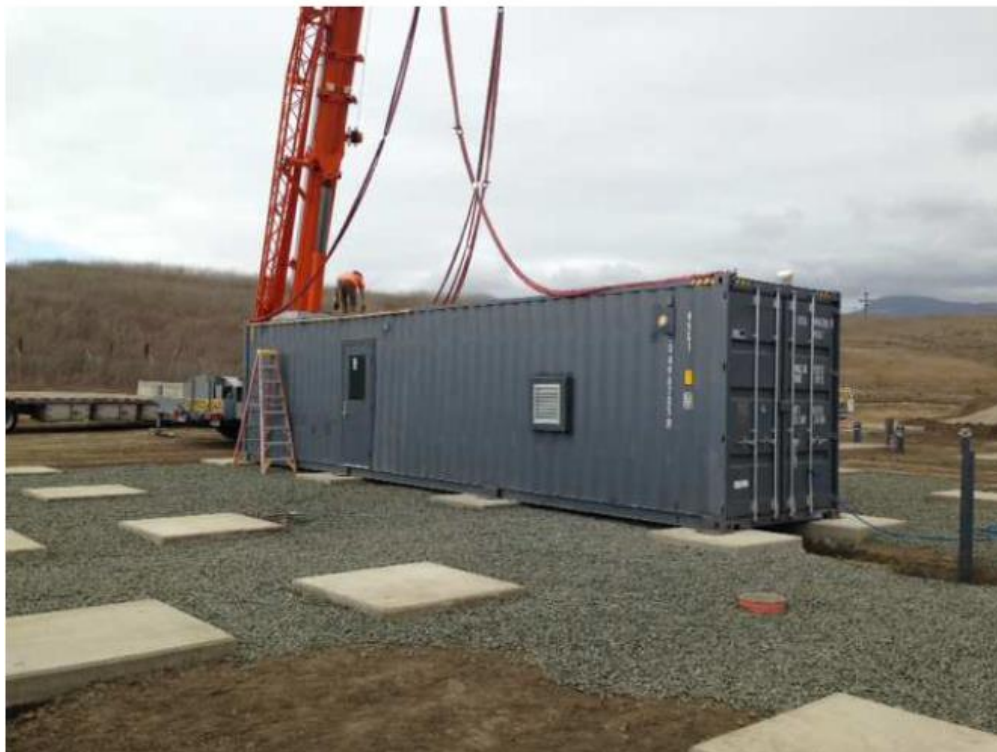
Shipping container set into position

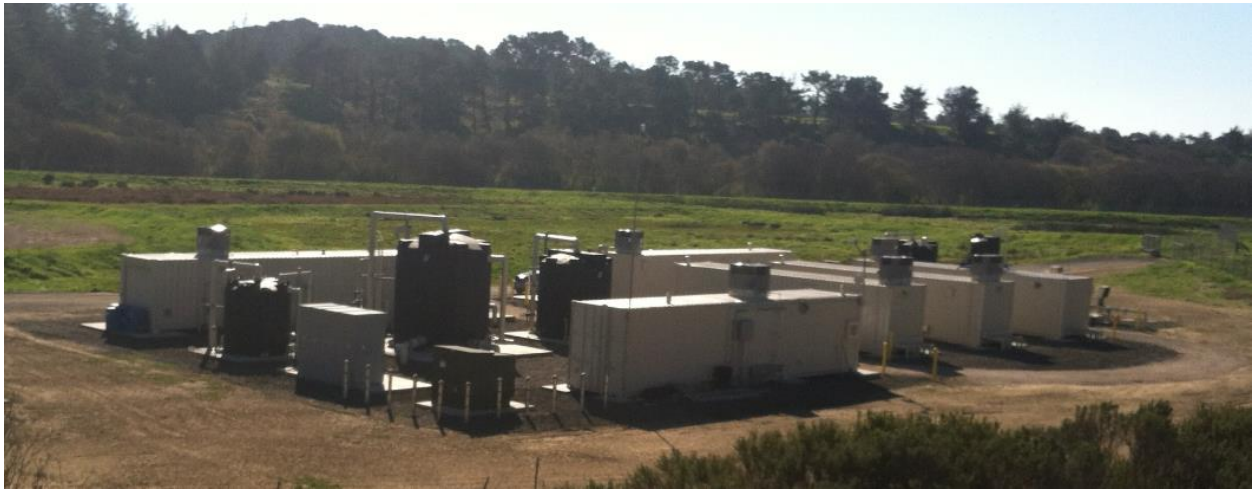
View of Completed AWTP

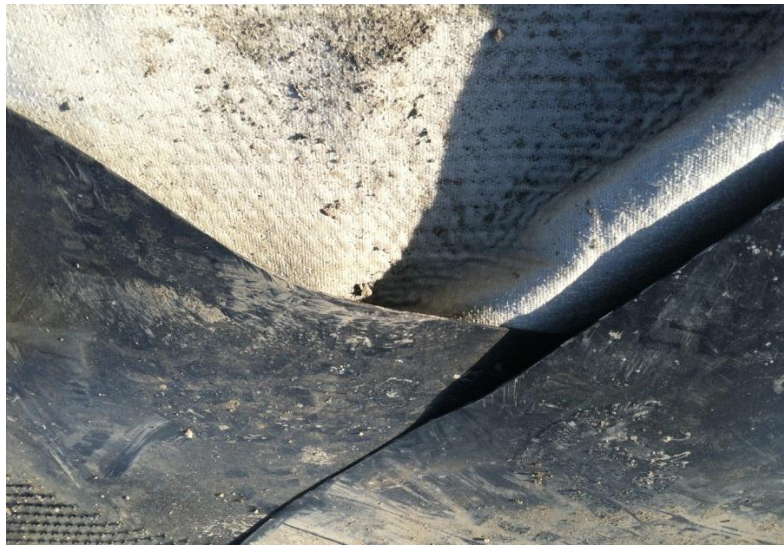
Exposed basin liner close up showing clay liner (white) covered by two 60-mil thick HDPE liners

The basin lining system consisted of an initial geo-synthetic clay liner placed over a prepared subgrade. The clay liner was followed by a 60-mil thick, high density polyethylene (HDPE) intermediate liner. A second 60-mil thick liner was then placed as the final interface with the stored water. Texturing of the HDPE between the liners allows for the passage of water, which is for purposes of detecting any leakage. The liner installation was completed by International Lining Technology, with independent monitoring by Geo-Logic Associates. A report entitled, "Final Construction Quality Assurance Report, Brine Evaporation Pond Improvements," was completed by Geo-Logic, which contains additional details.

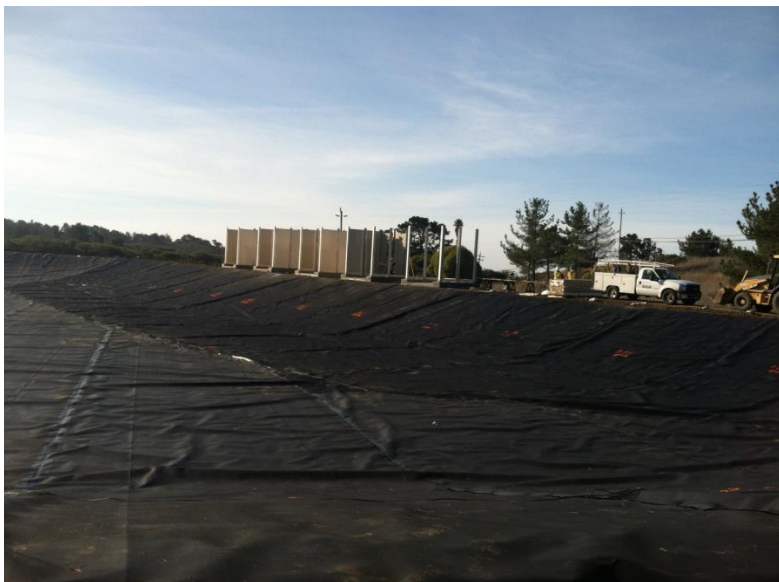
Mechanical Evaporator Sound Enclosures being installed

During equipment testing, it was discovered that some back-drafting was occurring due in part to the sound enclosures placed around each mechanical evaporator. This was rectified by placing a concrete slab around the evaporators to capture and return mist that was settling in between the evaporators back into the basin.

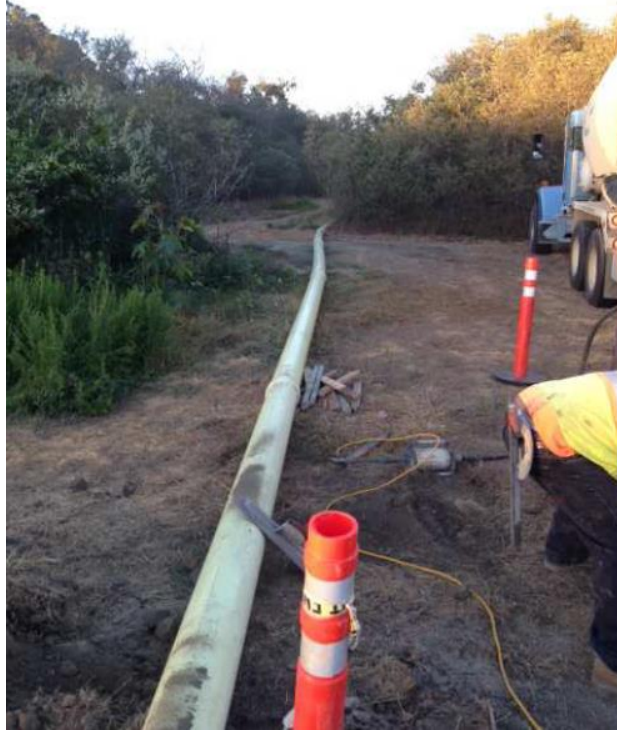
YeloMine Pipe between AWTP and Re-injection Well

The treated product water pipeline from the AWTP to the re-injection well consisted of 1,700 feet of 8-inch diameter “YelowMine” PVC piping. The YeloMine pipe contains UV inhibitors and a restrained flexible joint system, which facilitated it being laid along the ground surface, thus avoiding the need to trench this entire reach.

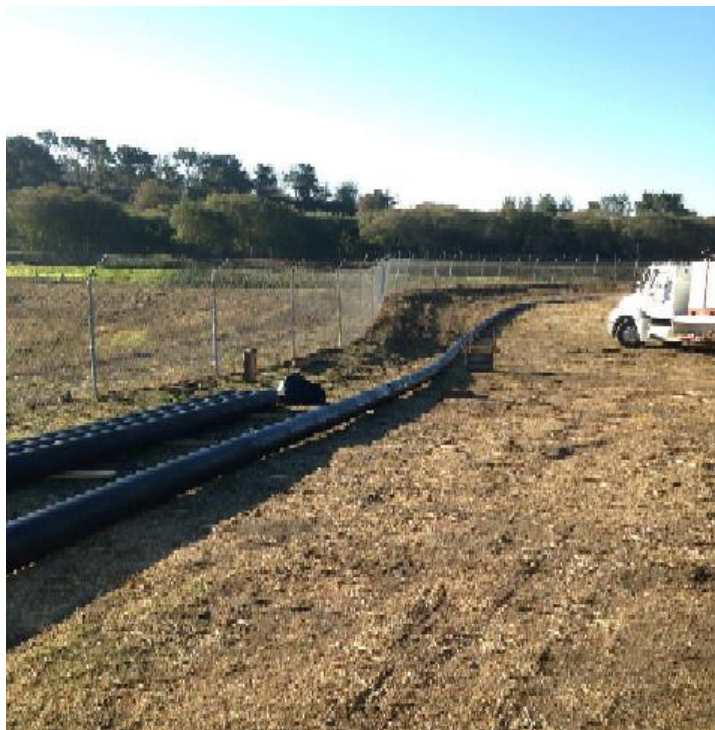
HDPE Pipeline between AWTP and Evaporation Basin

The RO concentrate pipeline from the AWTP to the evaporation pond consisted of 1,200 feet of double contained, fused high density polyethylene pipe. The installed system consisted of an inner 4-inch diameter carrier pipeline, and an outer 10-inch diameter containment pipeline. The pipeline was installed in a trench from the AWTP to the Van Gordon Creek crossing. At Van Gordon Creek, it was installed using horizontal directional drilling. After crossing under the creek, the dual-pipe system was laid on the ground surface from the Van Gordon Creek crossing to its discharge at the evaporation basin.

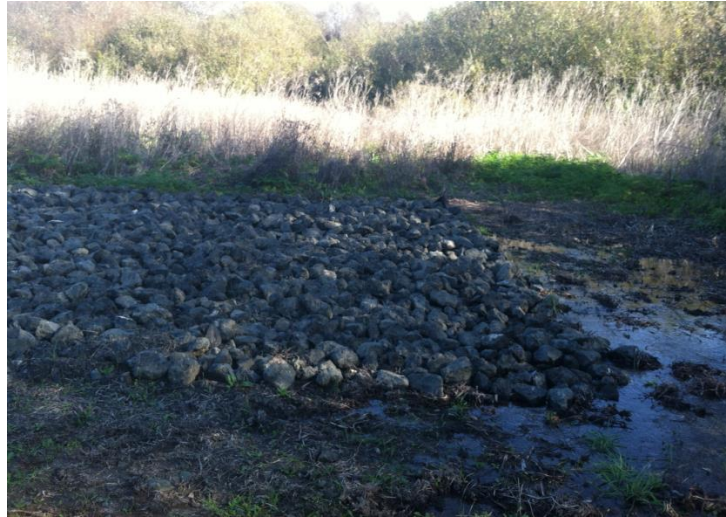
Lagoon Water Discharge Structure Outside of Tree Drip Line at Upper San Simeon Creek lagoon

The lagoon water pipeline consisted of 1,300 feet of 4-inch diameter fused high density polyethylene piping. This pipeline was installed in a trench from the AWTP to the Van Gordon Creek crossing location. It was then installed under the creek using horizontal directional drilling. After crossing under the creek, it was continued above ground until reaching a surface discharge structure at a location just outside of the tree drip line near the head of the upper San Simeon Creek lagoon. A short reach was buried in the proximity of the discharge structure to allow its discharge to occur under the discharge structure to create a gentle sheet flow.
