B. HYDROLOGY

Fiscalini Ranch Preserve Master EIR

Draft Master EIR

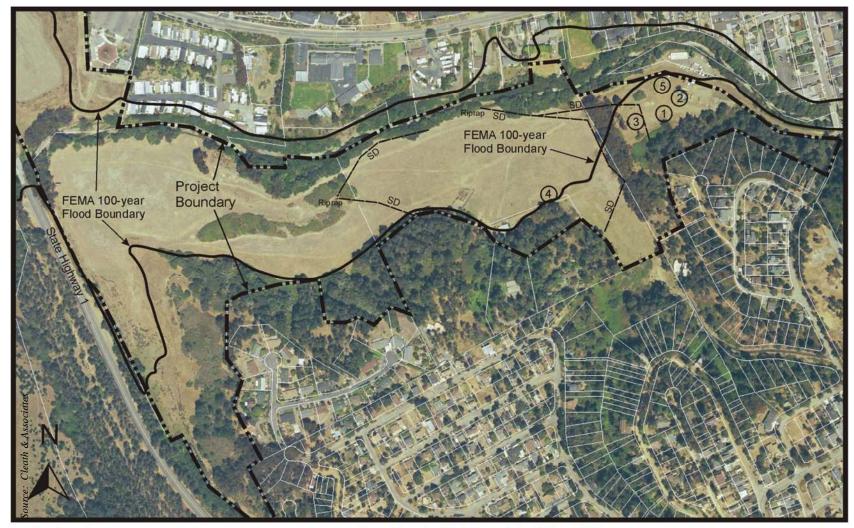
100-year Flood Hazard Map FIGURE V-5

Explanation

① Future Community Center Location

2 Parking Lot

3 Restroom

4 Storage/Maintenance Building

5 Relocated Pump House

SD Storm Drain Pipe

Santa Rosa Creek drains a watershed area of approximately 45 square miles, rising from sea level to the crest of the Santa Lucia Mountains at approximately 2,000 feet. Floods downstream in the watershed (including the East FRP and the northeast portion of the West FRP) tend to be high magnitude, but short duration events (Questa Engineering Corp., 2002). FEMA mapped areas of the Santa Rosa Creek floodplain that lie within the 100-year flood boundary (1985, 2004). Most of the East FRP and the northeast corner of the West FRP lie within the boundary. The 100-year flood boundary in the East FRP is shown on Figure V-5.

According to the FEMA Flood Insurance Study, San Luis Obispo County (2004), flood levels in a 100-year flood event would be within approximately one foot of the ground surface in the vicinity of the proposed parking lot and community center (refer to Figure V-5). Flooding during a 500-year flood event would inundate these areas with just under four feet of water. Flood levels during a 100-year event is predicted in the FEMA study to inundate the westernmost soccer field nearly two feet depth. Table V-2 shows flood elevations and ground surface elevations at four locations within the East FRP, and also shows predicted discharges at the Highway 1 bridge.

During a 100-year storm event flood levels are anticipated to rise above the Santa Rosa Creek top of bank and sheet flow across the site, as shown in Figure III-8. The restroom structure is proposed to be designed to be a minimum of one foot above the 100-year flood elevation. A storage and maintenance building is proposed to be located immediately adjacent to the 100-year flood boundary (refer to Figure V-5).
